BEAR CREEK CORRIDOR ASSESSMENT CITY OF GRANDE PRAIRIE

Report Prepared for:
CITY OF GRANDE PRAIRIE

Prepared by:
MATRIX SOLUTIONS INC.

Version 1.0
September 2018
Grande Prairie, Alberta

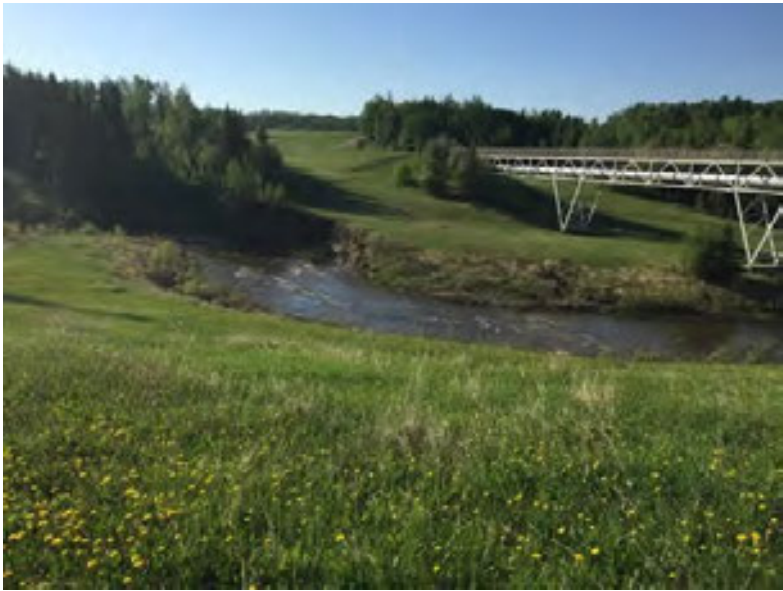
5. Bear Creek left bank conditions between 68 Avenue and pedestrian bridge.

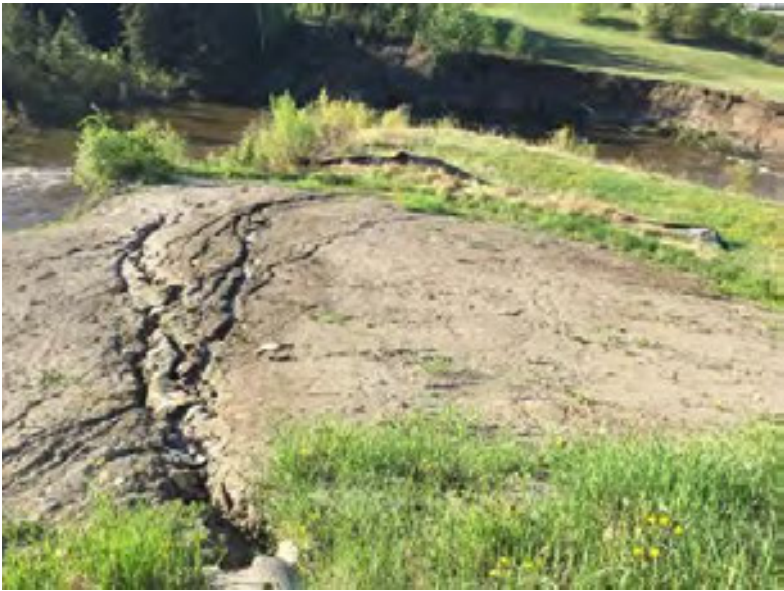
6. Local drainage issue (foreground) and left bank erosion (background).

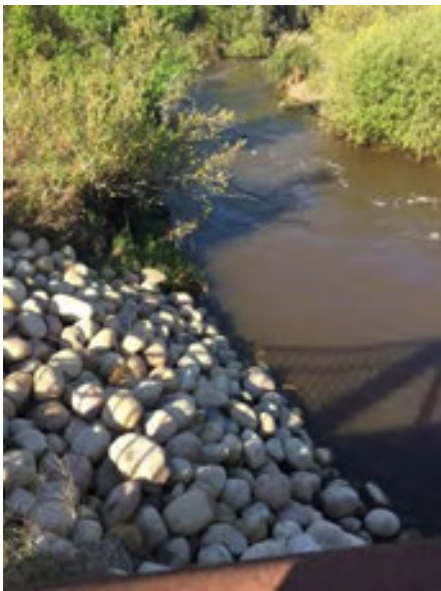
17. Erosion protection at pedestrian bridge near 79 Avenue, right bank upstream of bridge.

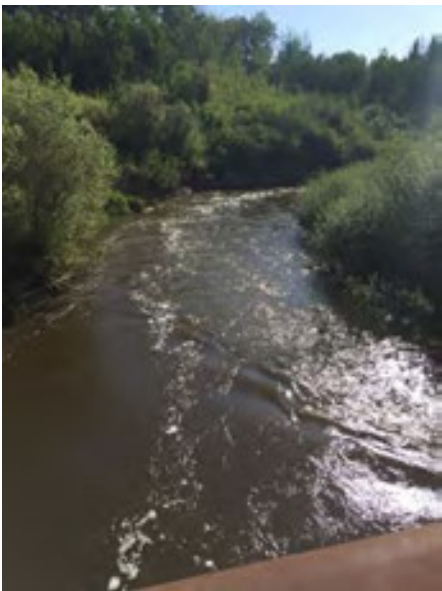
18. Bank conditions downstream of pedestrian bridge near 79 Avenue.

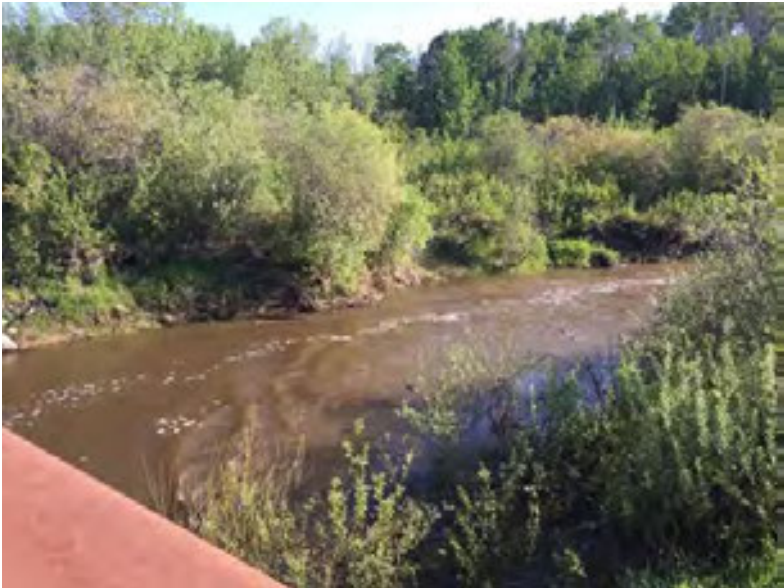
21. Pedestrian bridge near 79 Avenue downstream left bank condition.

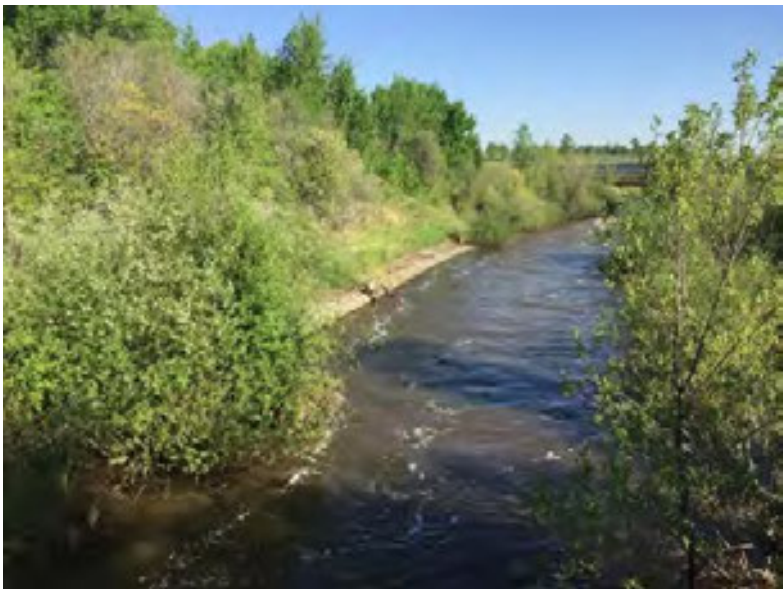
23. Gabion bank protection along right bank upstream of pedestrian bridge, near 84 Avenue bridge.

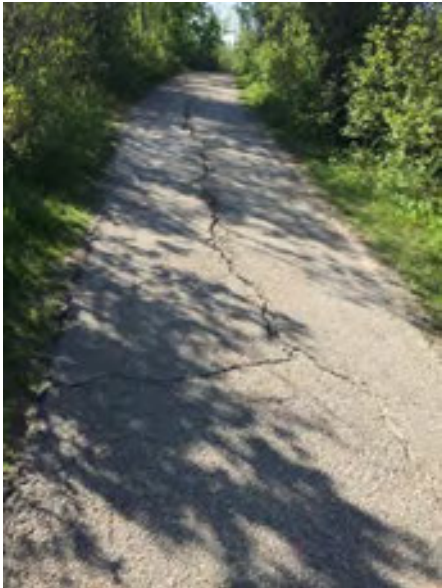
25. Pathway tension cracks between wetland and river, below 84 Avenue.

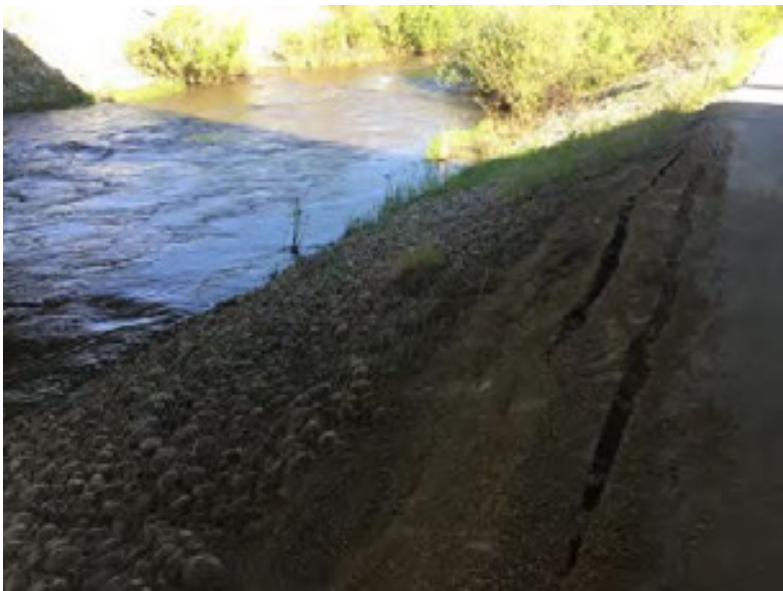
29. 84 Avenue bridge pathway tension cracking at sloughing gabion mattress.

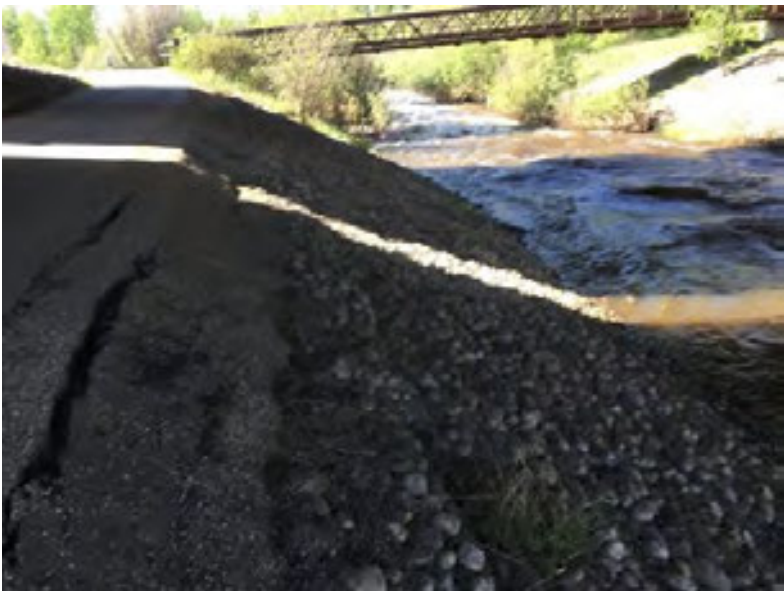
30. 84 Avenue bridge pathway tension cracking at sloughing gabion mattress.

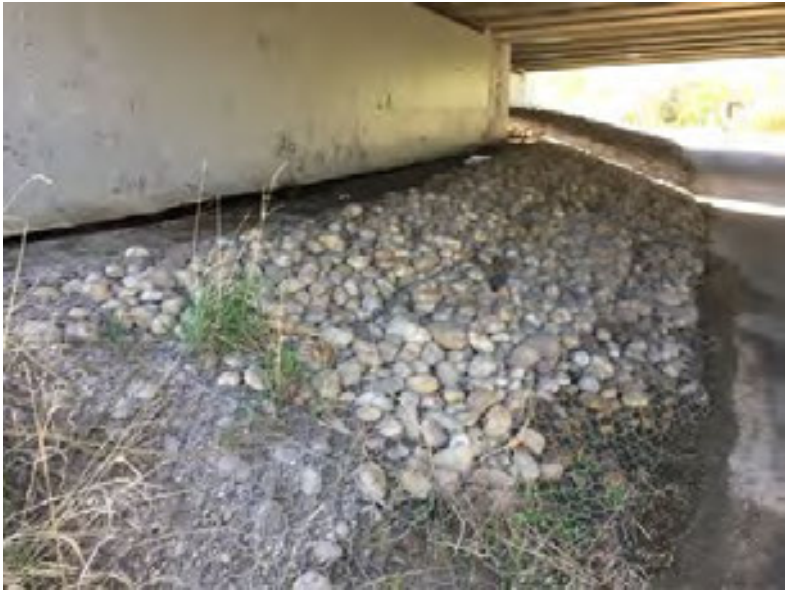
31. 84 Avenue bridge left abutment gap at sloughing gabion mattress.

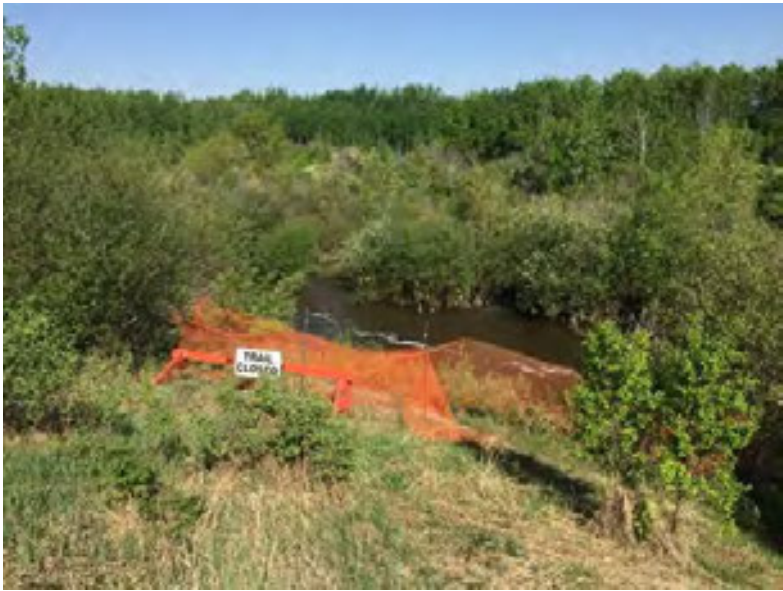
35. Trail closure near 89 Avenue.

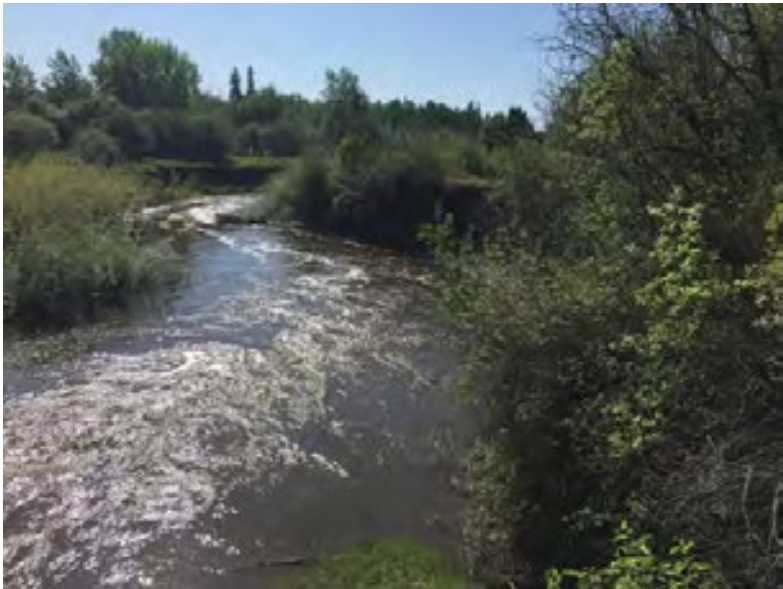
41. Bank erosion downstream of old rail bridge.

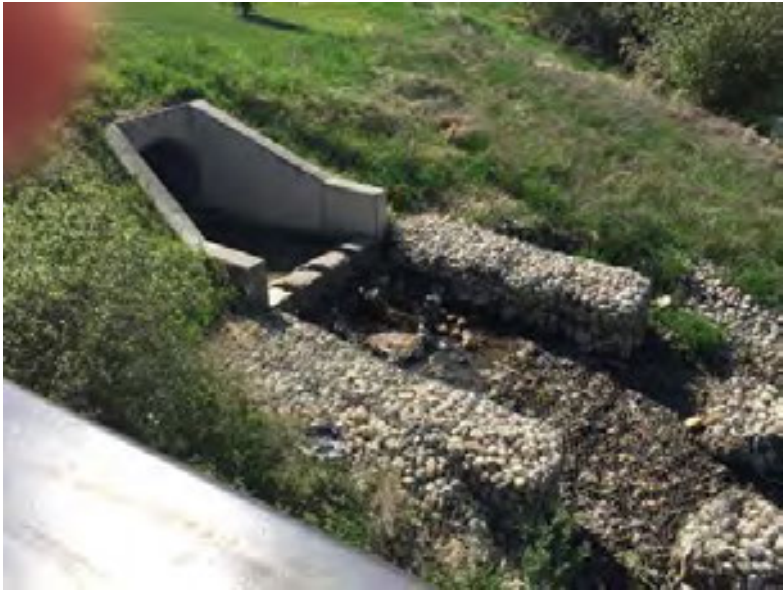
44. Outfall 22, gabion damage.

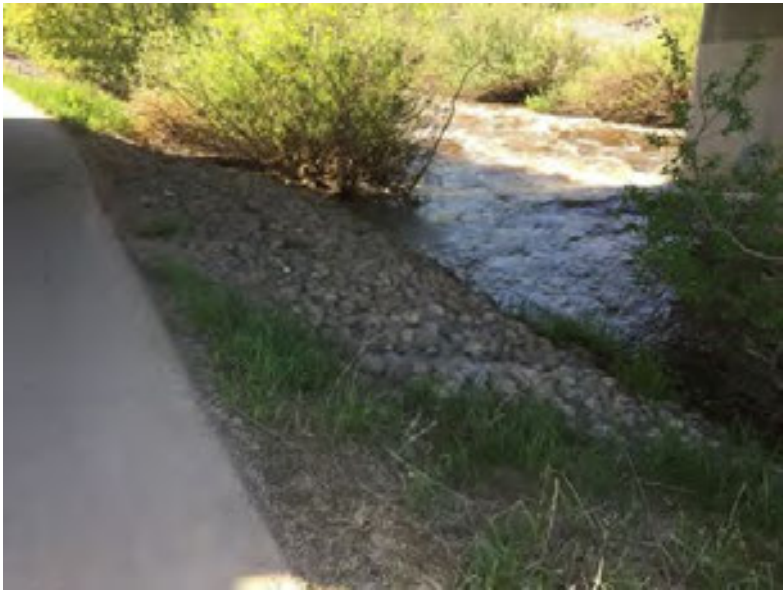
47. 99 Avenue bridge pier gabion conditions.

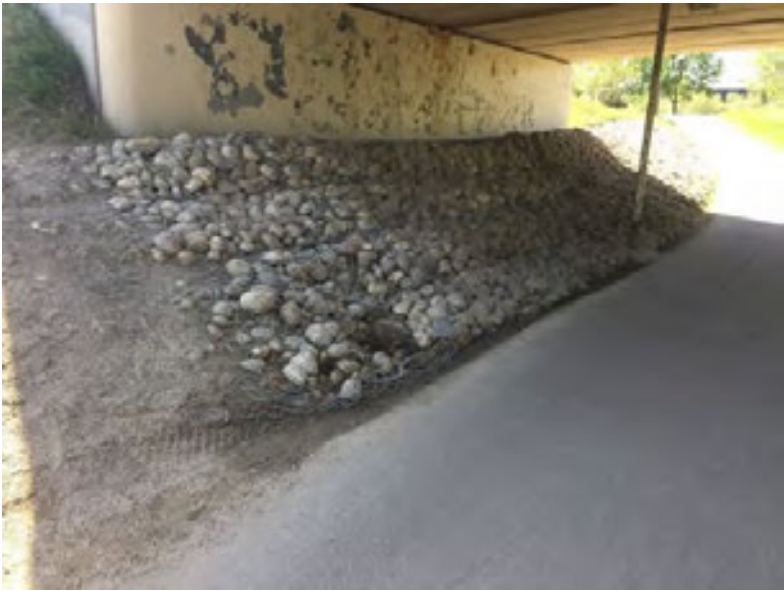
48. 99 Avenue bridge gabion mattress conditions at left bridge abutment (east side).

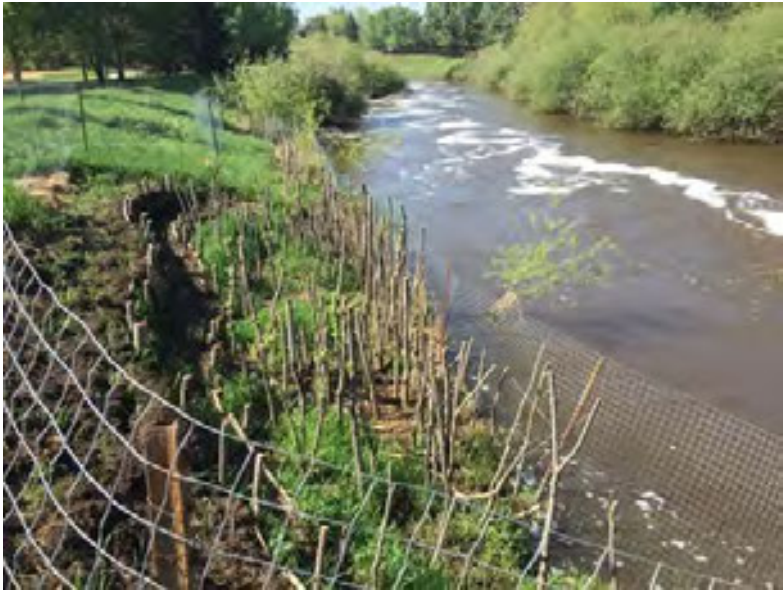
56. Bioengineering bank protection along pathway below dam.

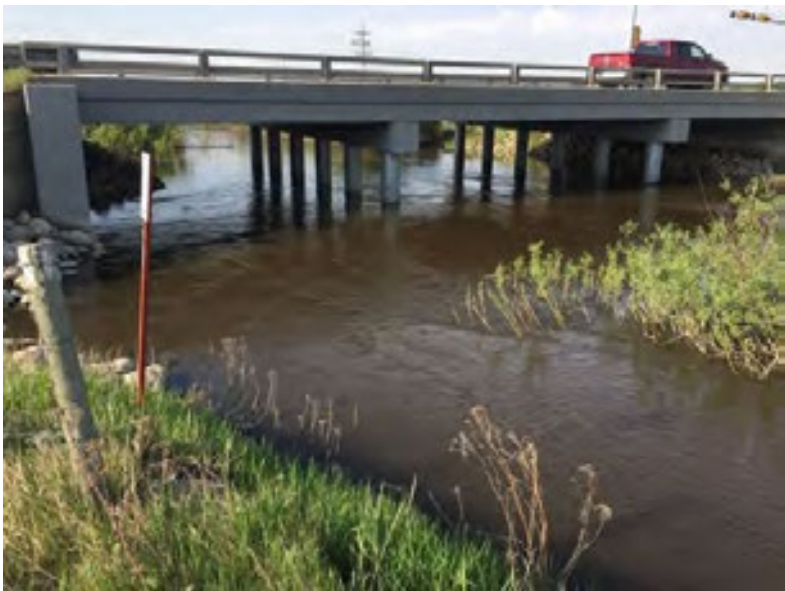
82. 132 Avenue bridge missing erosion protection under bridge, left bank.

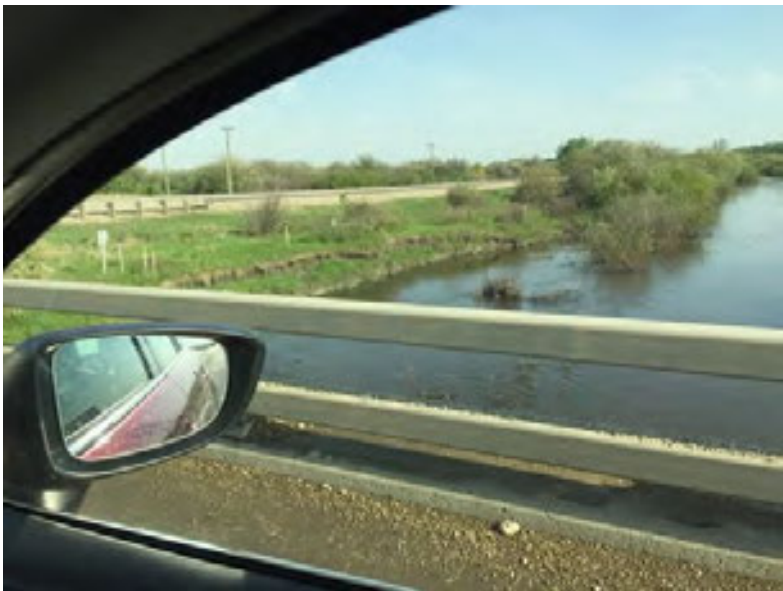
83. Bank failure upstream of 132 Avenue bridge.
