2020 Inundation Study and Dam Safety Review Final Report

Bear River Control Structure

City of Grande Prairie

July 16, 2021

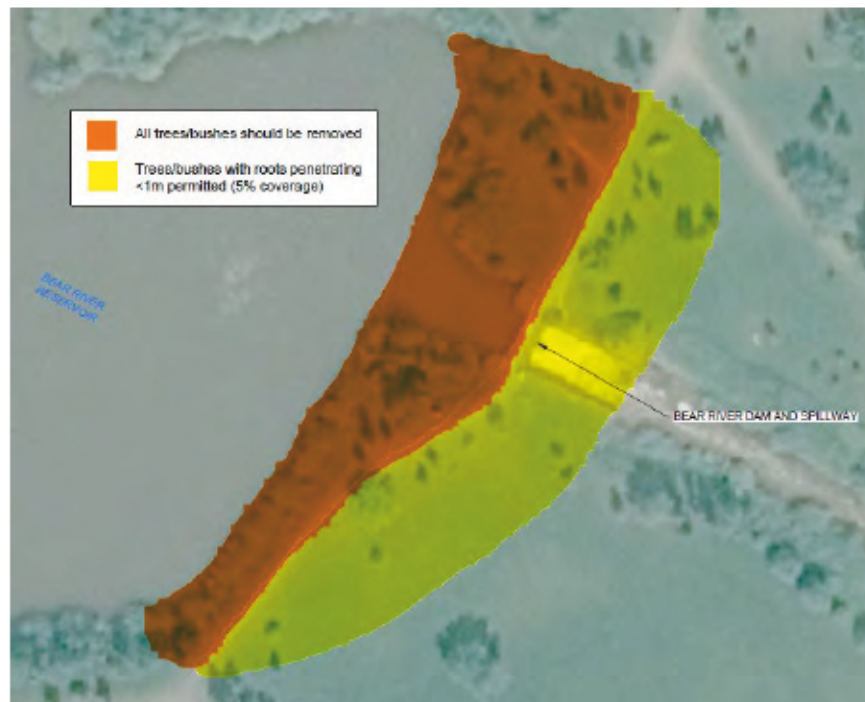
Figure 4.1 Locations for Tree/Bush Removal

- › There are a number of trees and bushes growing on the upstream slopes, crest, and downstream slopes of the dam. The trees (particularly the large deciduous trees) and bushes on the dam should be removed at some point in the next few years. **Figure 4.1** shows the areas where the trees and bushes should be removed. All trees and bushes should be cleared from the area highlighted in orange. Trees and bushes with root structures that penetrate less than 1 m into the dam are permitted in the area highlighted in yellow, with coverage of less than 5% of the total area recommended.

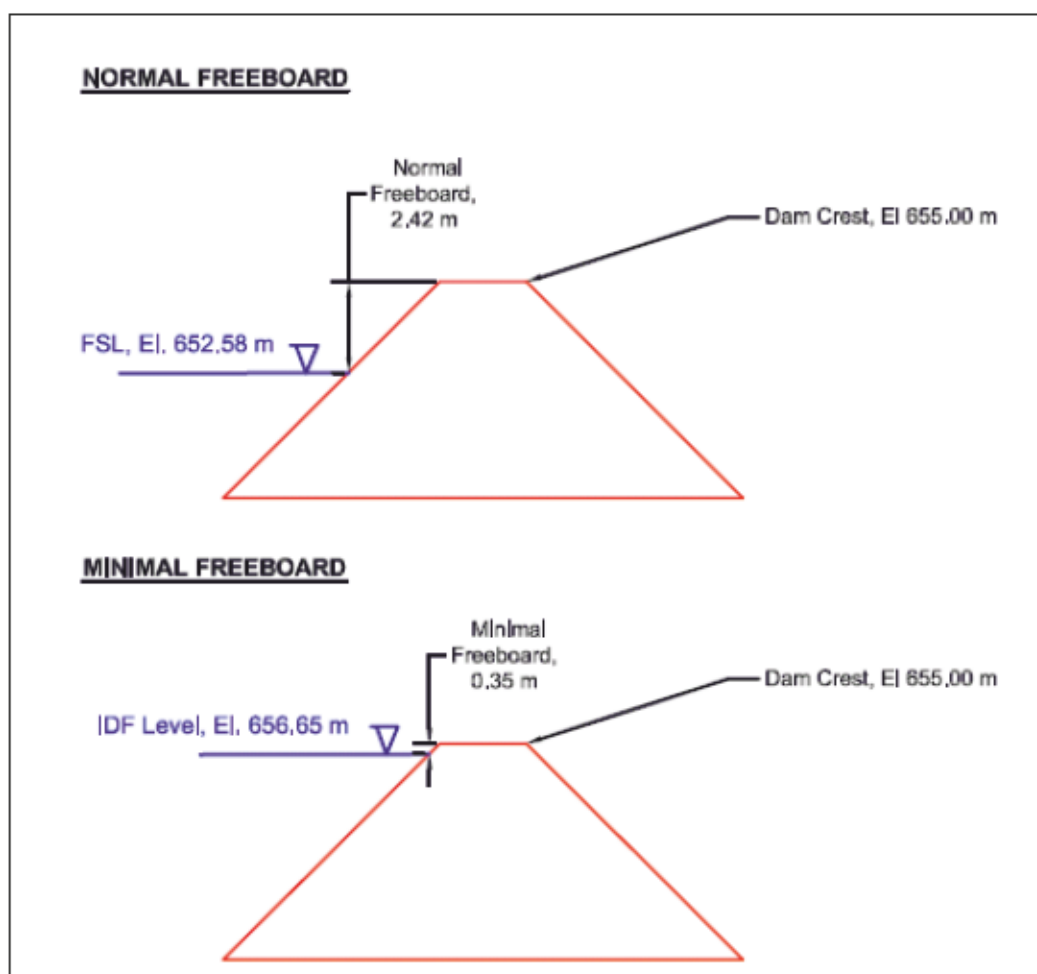
Figure 7.1 Normal and Minimum Freeboard

Available freeboard estimated based on wave run-up elevations for normal and minimum conditions are summarized in **Table 7.2**. While the IDF can be routed through the spillway without causing an overtopping of the structure, the available (minimum) freeboard of 0.35 m is not sufficient to avoid wave overtopping under a 1:10-year wind. An additional 0.28 m additional freeboard is necessary to avoid overtopping by 95% of waves generated during this critical scenario, for a total of 0.63 m. The normal freeboard for the reservoir at FSL is adequate.

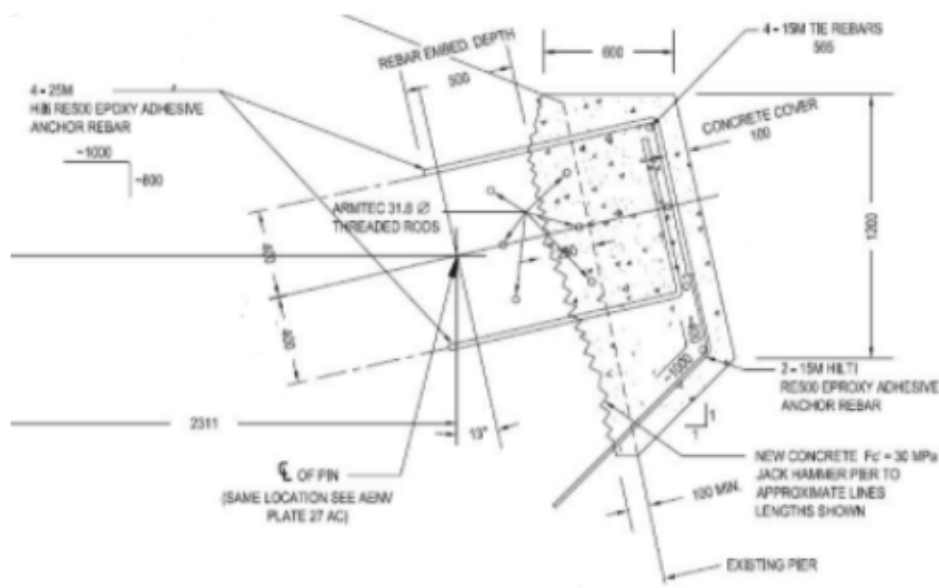
Figure 9.6 Middle Trunnion Concrete Block (Sameng 2010)

In the original design of radial gate trunnion support at the middle pier, the trunnion pin was placed through the pier and trunnion loads were transferred to the upstream bottom end of the pier by using an anchor block along with inclined anchors. When the gates were replaced in 2010, the arms of the new gates were slightly longer, and the trunnion location was downstream of the original location. The new trunnions were attached to the side of the pier, which was locally extended and reinforced on the downstream side. The relevant documents made available to SNC-Lavalin as part of this mandate - Bear River Spillway Radial Gate Replacement As-Constructed Report – provide some details of the pier extension/trunnion block and one drawing (from Sameng) also shows the size and reinforcement details for the new trunnion block. Design calculations or criteria used for transferring the new trunnion loads to the pier are, however, not available. The Sameng drawing shows that the new concrete block was attached to the middle pier using 4-25M and 2-15M HILTI RE500 epoxy adhesive anchor rebars with embedment depth of 500 mm, as shown in **Figure 9.6**.

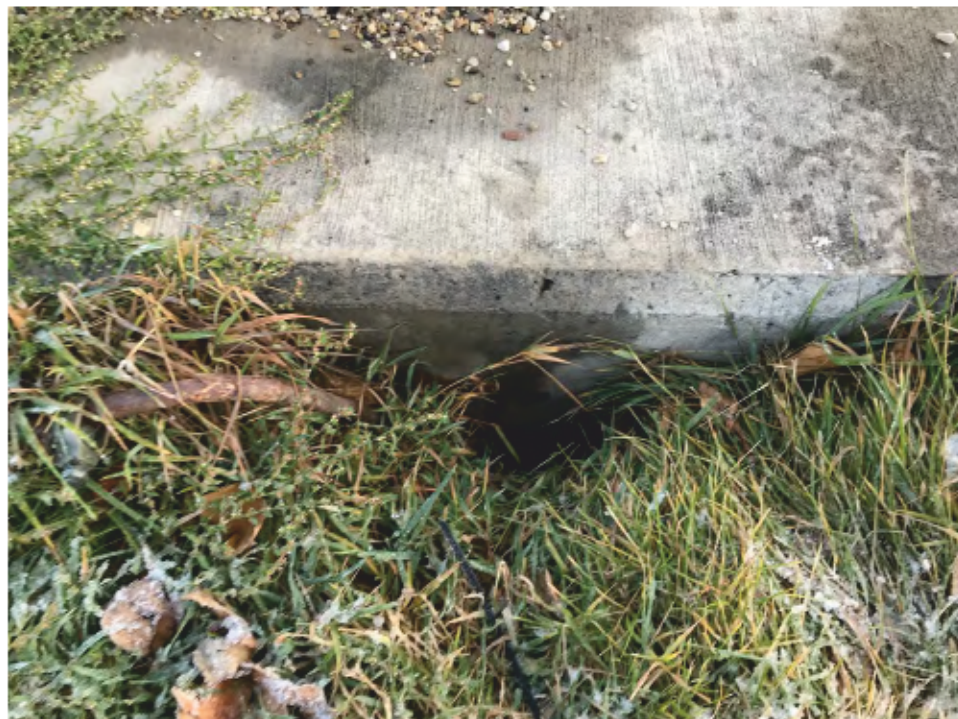
Photo 4: Animal burrow on dam crest, adjacent to spillway

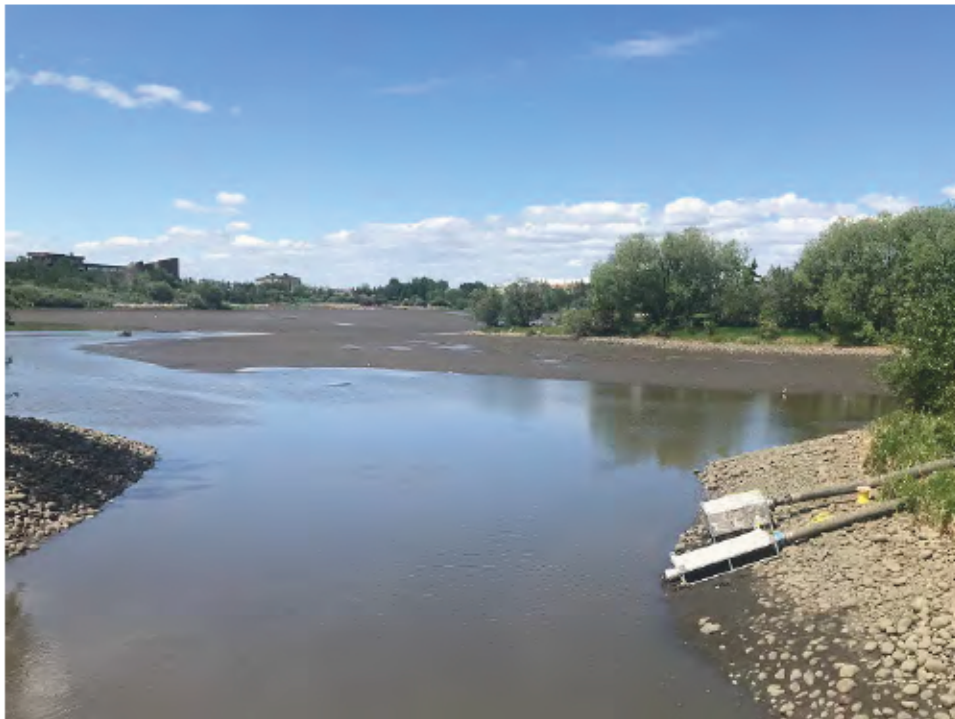
Photo 18: Reservoir filled with sediment

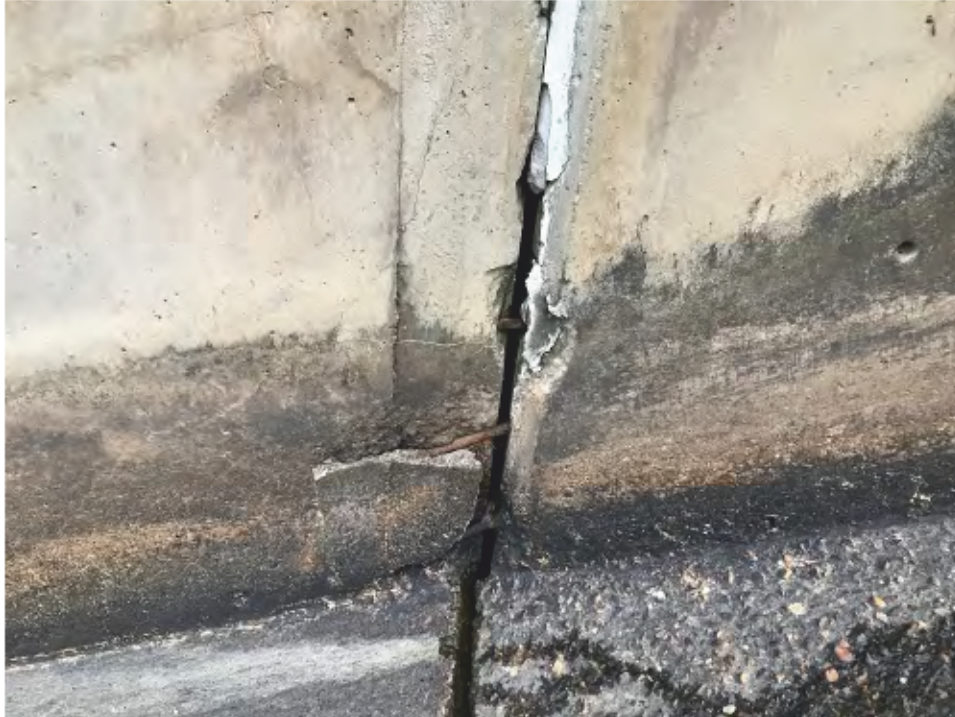
The chute walls were in satisfactory condition with no major deterioration or cracking. Most of the chute wall joints are in satisfactory condition. There are significant cracks in the second joint down the spillway on both the south and north sides of the spillway that should be repaired as the rebar is exposed.

Photo 33: Concrete spillway chute, joint crack in south wall

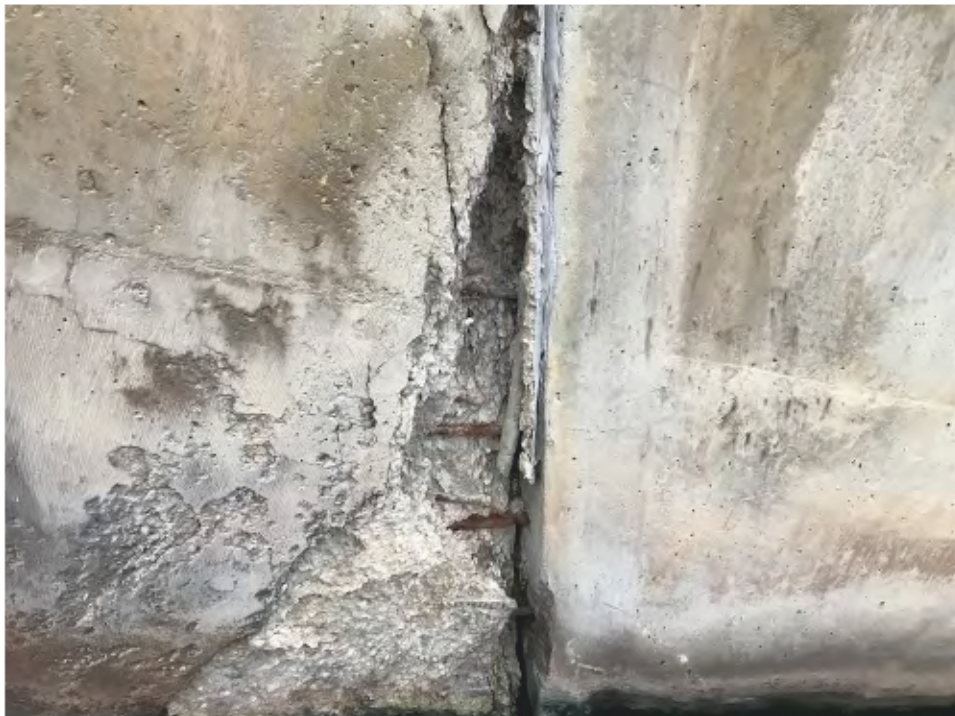
Photo 34: Concrete spillway chute, joint crack in north wall

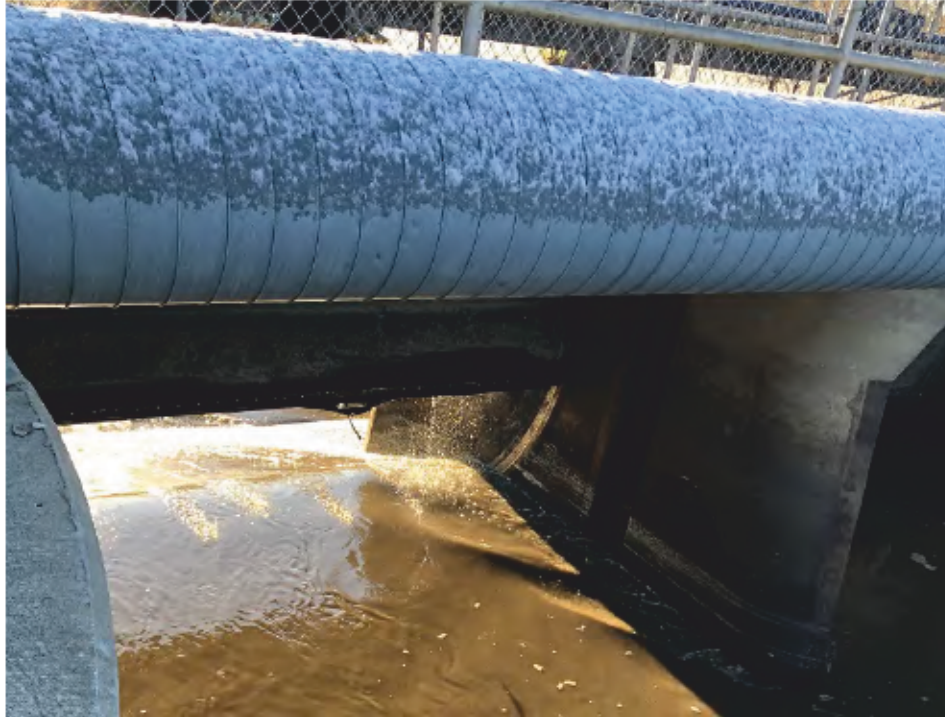
Photo 41: Damaged Base Seal North Gate
