# 2009 BEAR CREEK CORRIDOR OUTFALL INSPECTION REPORT

BEAR CREEK CORRIDOR  
GRANDE PRAIRIE, ALBERTA

PARKLAND GEOTECHNICAL LTD.

MARCH 16, 2010

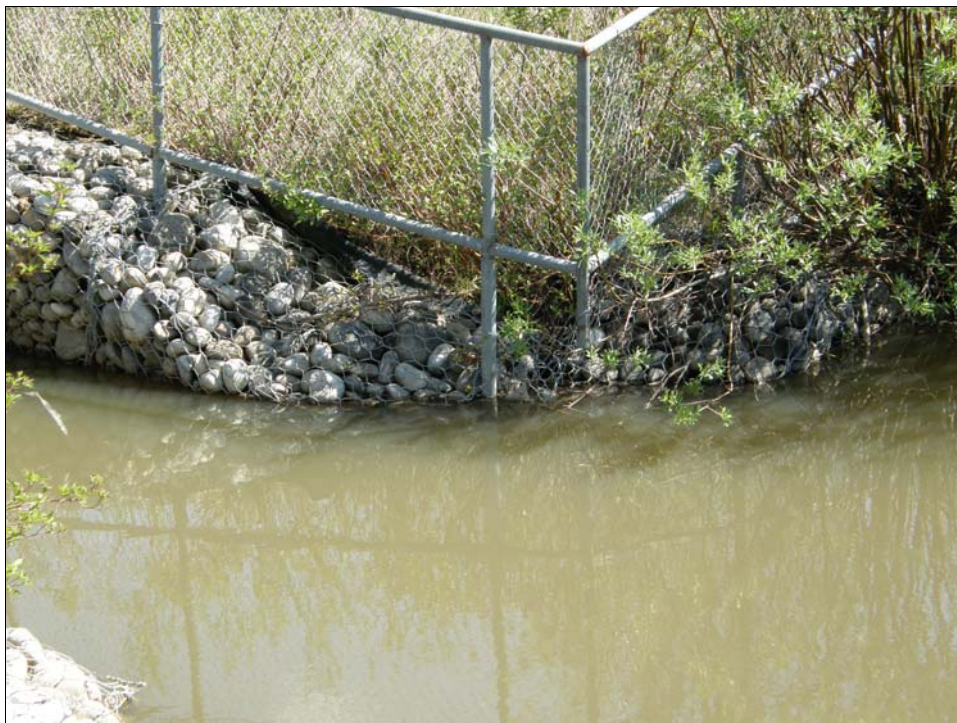
**Photograph 2: Gabion damage due to settlement, likely from erosion of base/foundation soils. May appear exaggerated if gabion initially constructed at angle.**

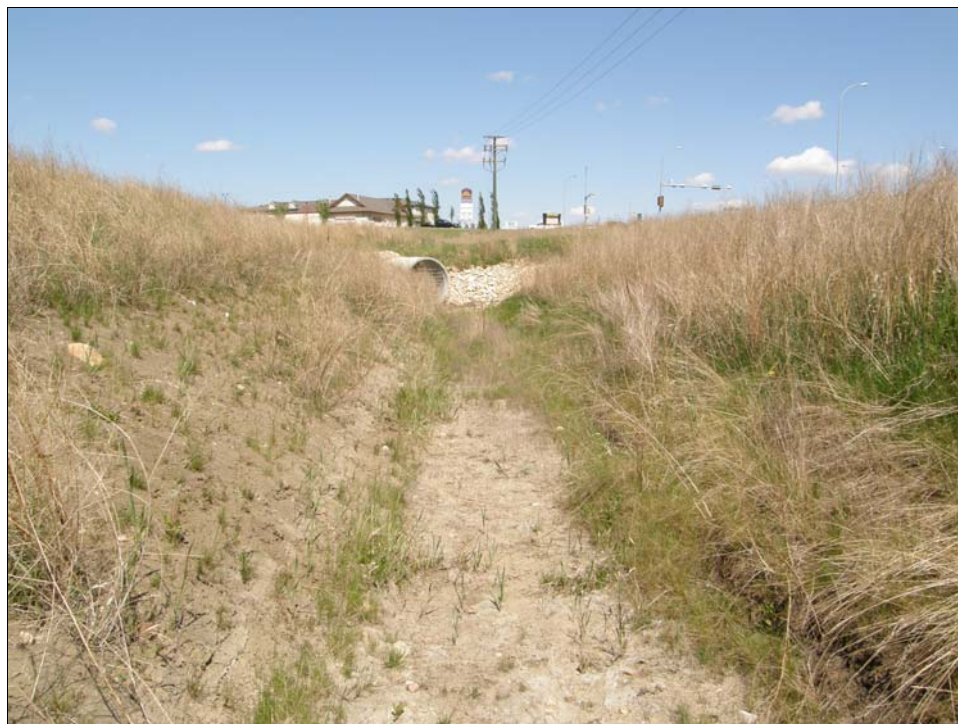
Sewer in good condition but lack of topsoil is hindering grass growth. Topsoil should have an erosion control blanket covering. Need to determine design flows to design erosion protection measures.

**Photograph 3: Sparse vegetation and minor erosion in drainage channel.**

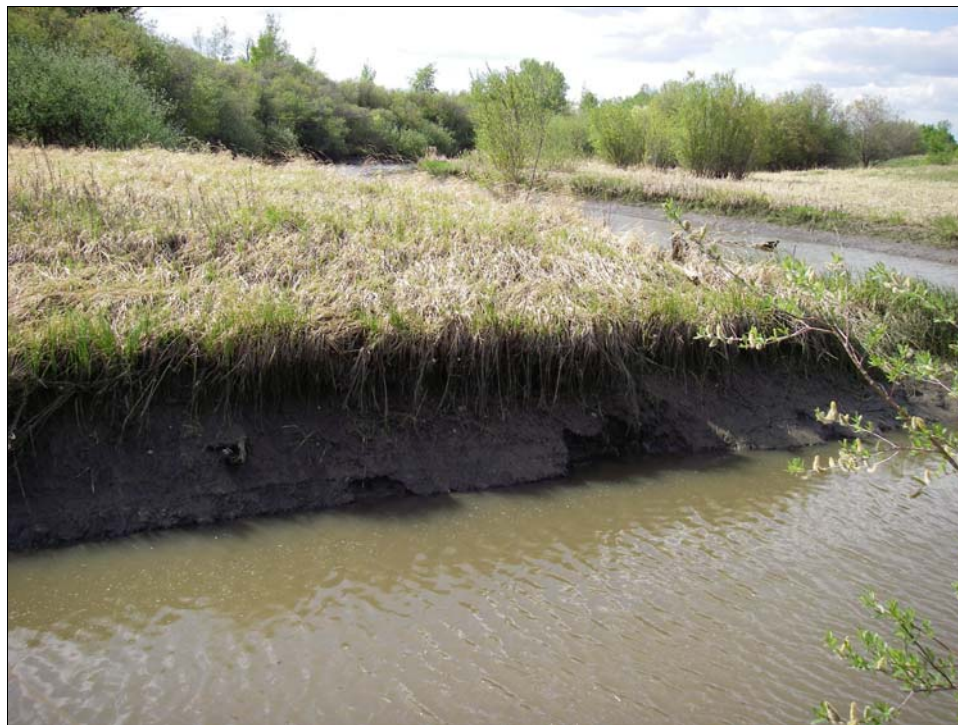
**Photograph 3: Erosion caused from outfall flow.**

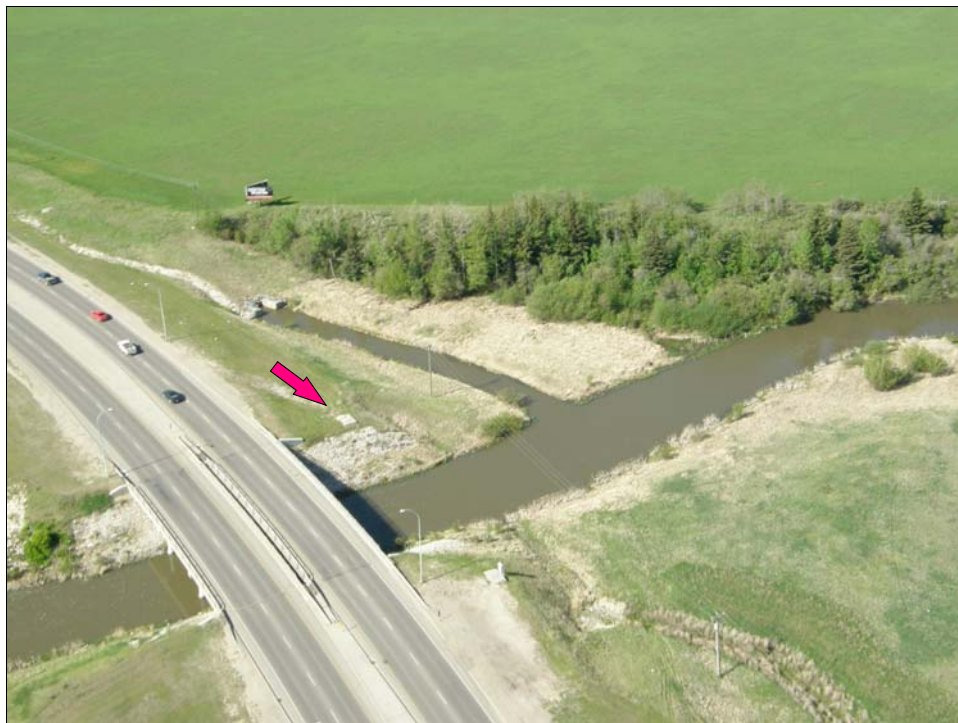
The outfall pipe could not be located but vegetation was present with the pipe should be located. The City drawings show that the outfall is located within the river - therefore the actual location should be found and updated on the City GIS.

**Photograph 1: The estimated location of Outfall #4 is shown located west of the bypass bridge.**

Cost to uncover the pipe, clear accumulated debris and adjust rip-rap is estimate to be less than \$1000.

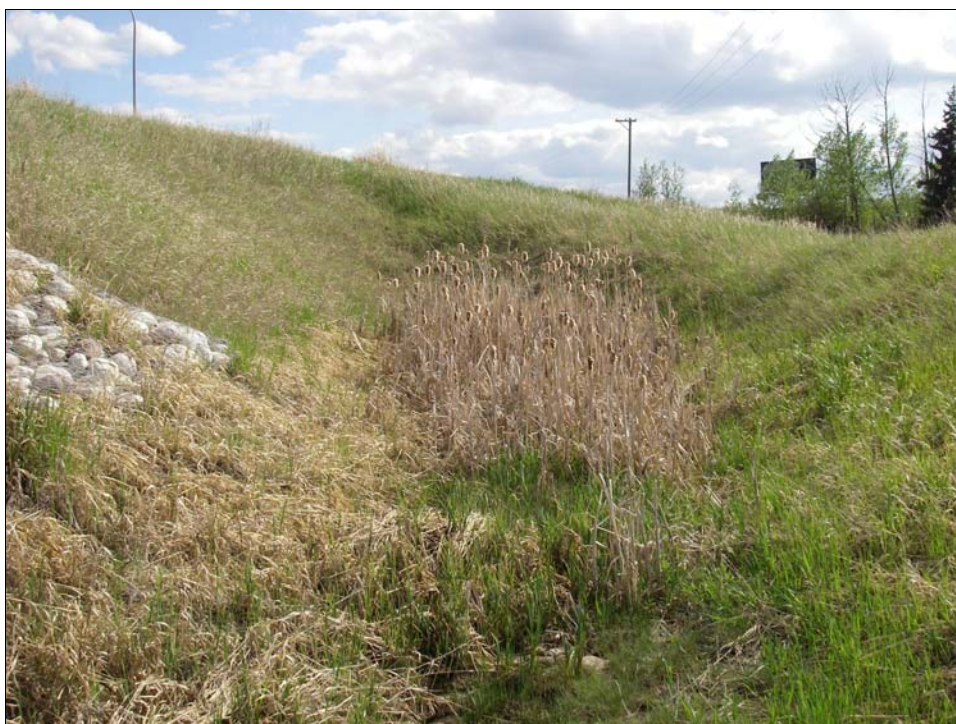
**Photograph 2: Likely location of Outfall #4 with overgrown vegetation.**

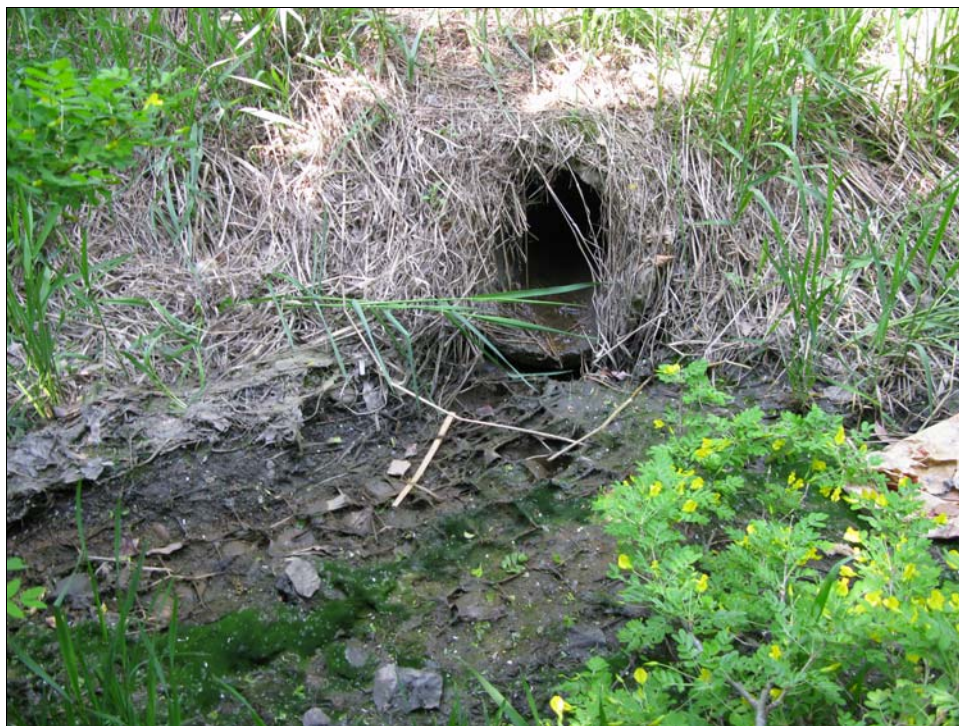
**Photograph 1: Outfall #6 with gabion mat. Sparse vegetation growth immediately downstream of outfall.**

Planting vegetation from the outfall to the Reservoir would help minimize sedimentation and minimize erosion. Existing gabion mat in fair condition and would not need replacement if a thick vegetation mat can be established.

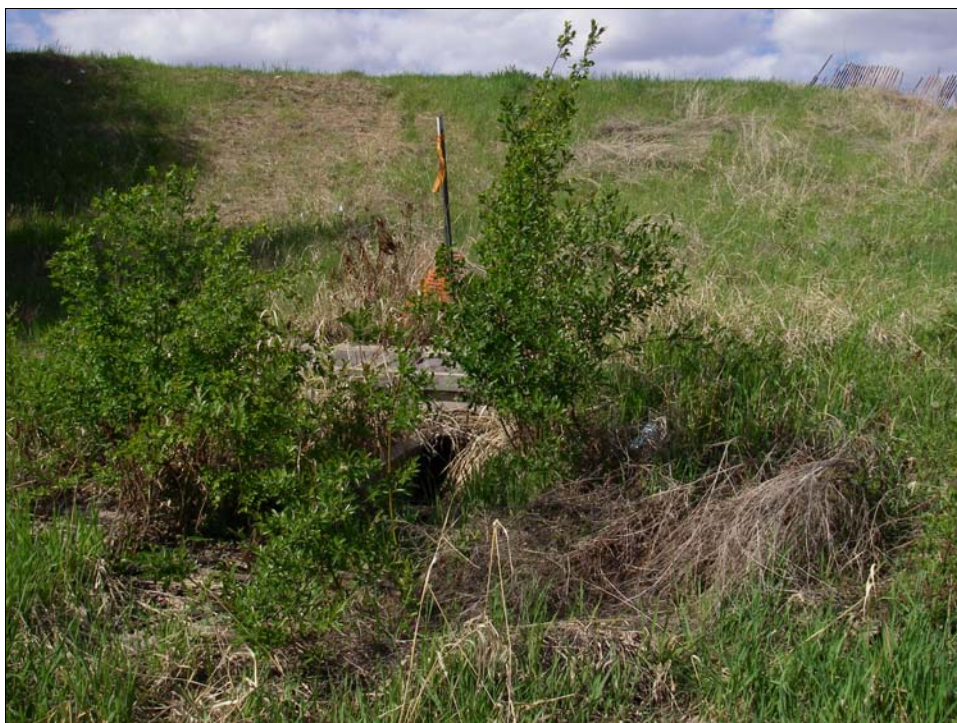
The dense vegetation around the outfall is choking off growth. Hand thinning and possible re-planting of grass may be required. Total maintenance costs are estimated to be less than \$600.

**Photograph 2: Outfall #7 with excess vegetation.**

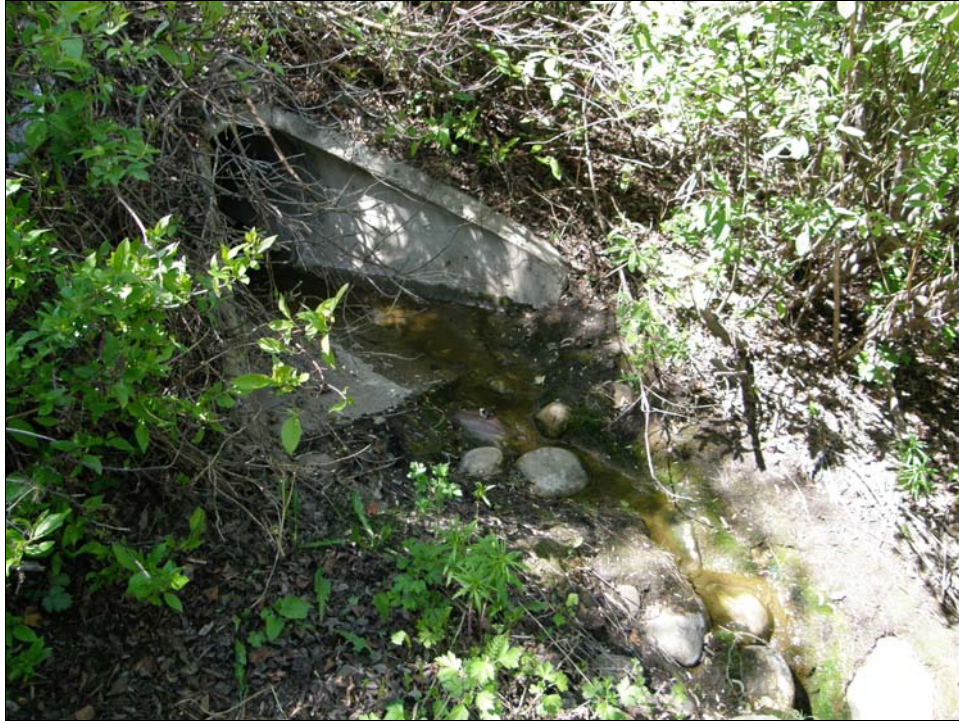
**Photograph 1: Outfall #9 with minor erosion.**

The placement of additional rip-rap could be delayed as the amount of erosion is currently minimal and the outfall has is over 30 years old.

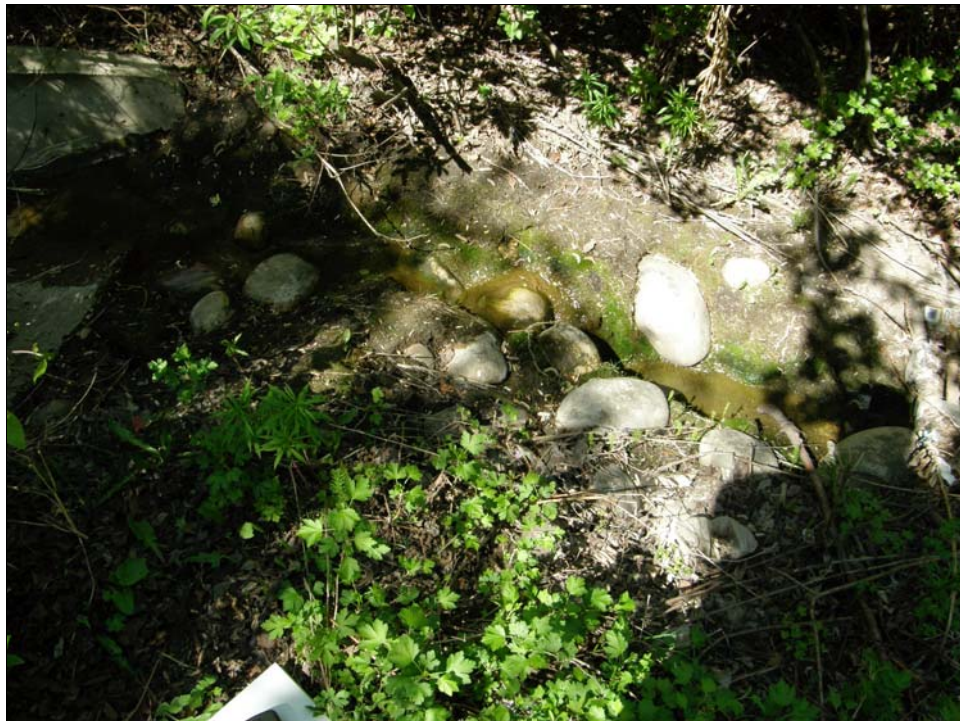
**Photograph 2: Minor erosion in channel.**

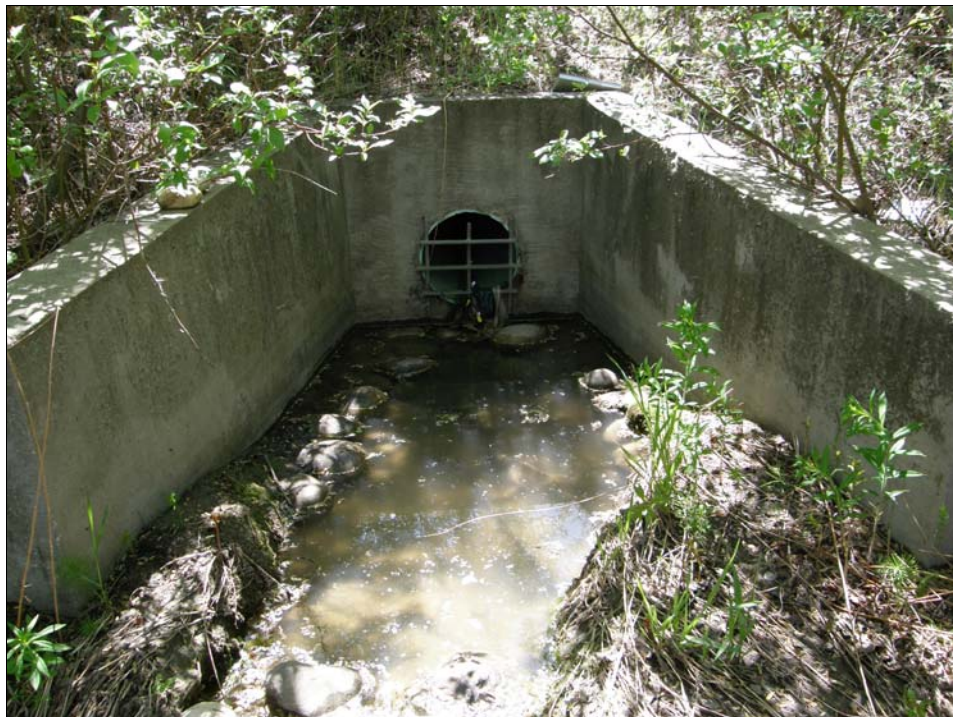
**Photograph 2: Silt is building up in the rip-rap apron area and may be starting to block or restrict flow.**

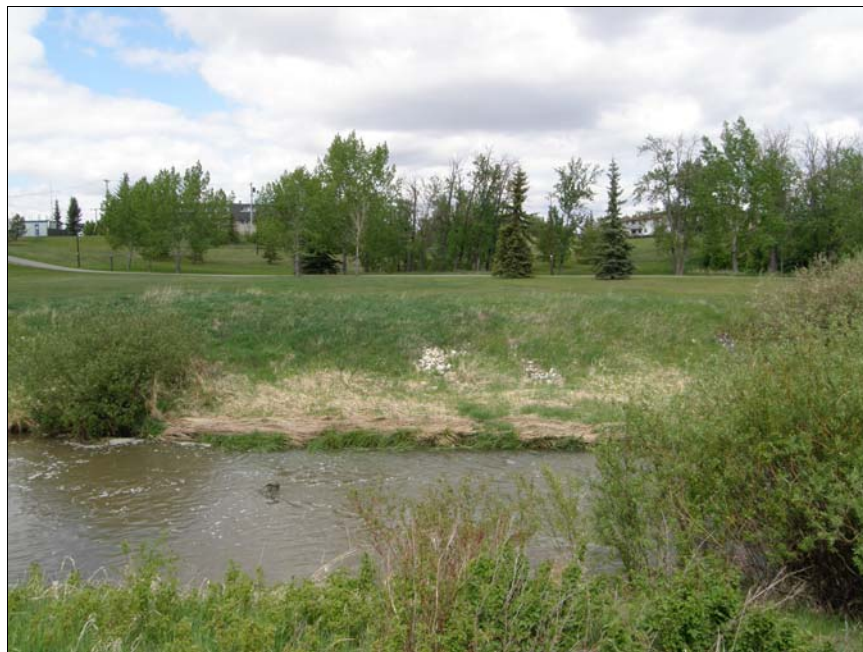
**Photograph 2: showing Outfall 12 and surrounding embankment. Water velocity is high due to proximity to the weir but no significant erosion was noted along the banks.**

Pipe should be uncovered as the pipe cannot be visually located. Hand positioning of rip-rap required and is expected to cost less than \$500.

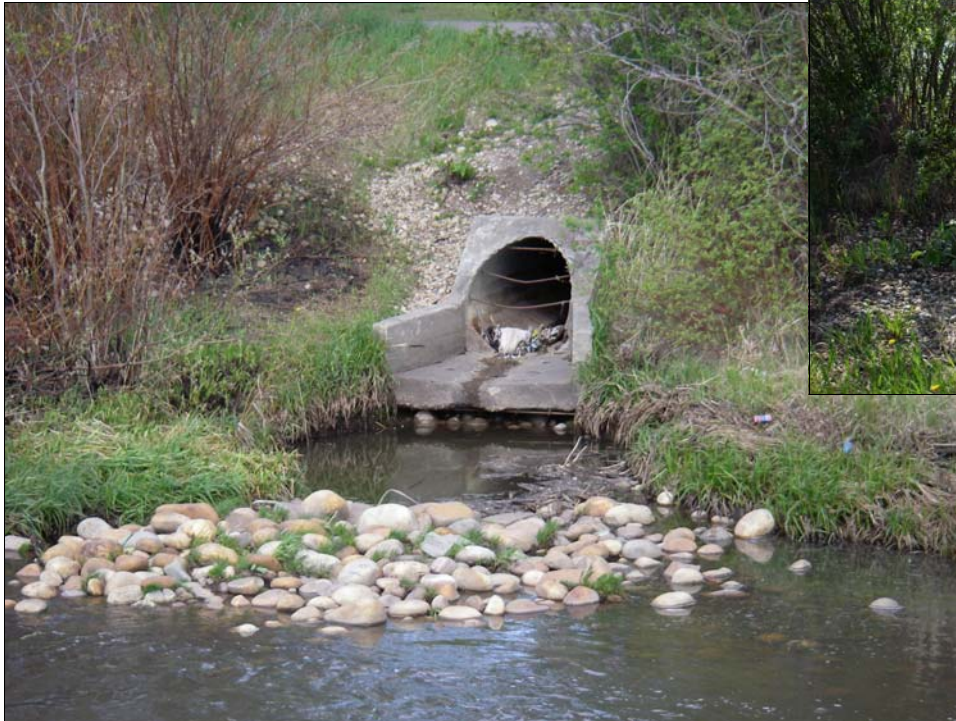
**Photographs 1 and 2: Outfall #13 with garbage present within pipe. Water is flowing below the pipe due to corrosion of pipe invert and is likely contributing to the scour below the apron.**

The cost of the remedial work is presented in Table 7 (Appendix B), and is estimated to cost about \$56,500.

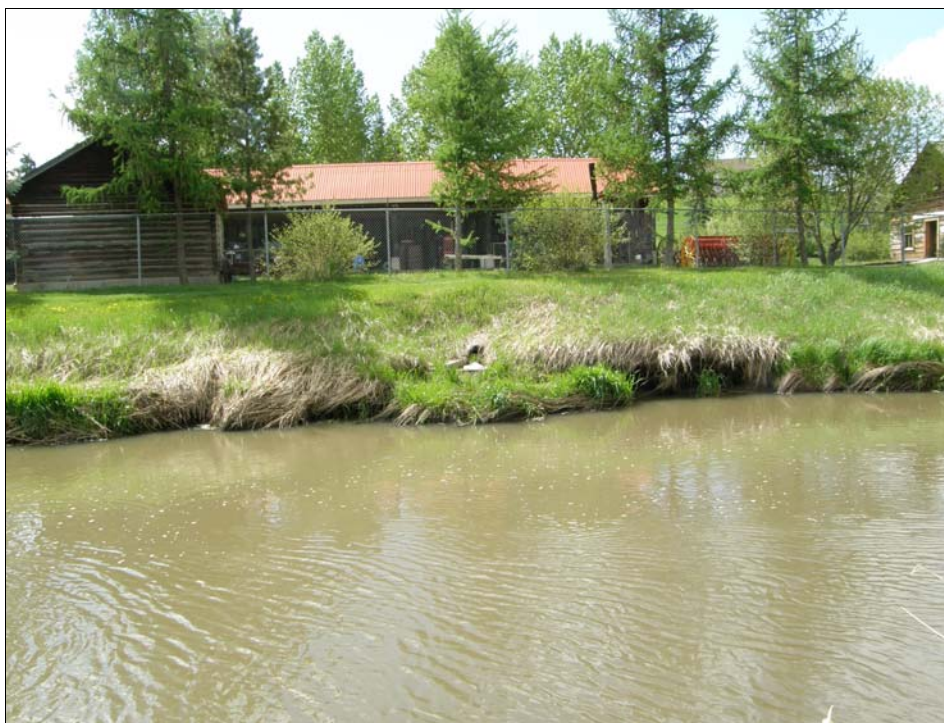
**Photograph 2: Outfall #15. The slump block is the very green vegetation located between the creek and the outfall structure.**

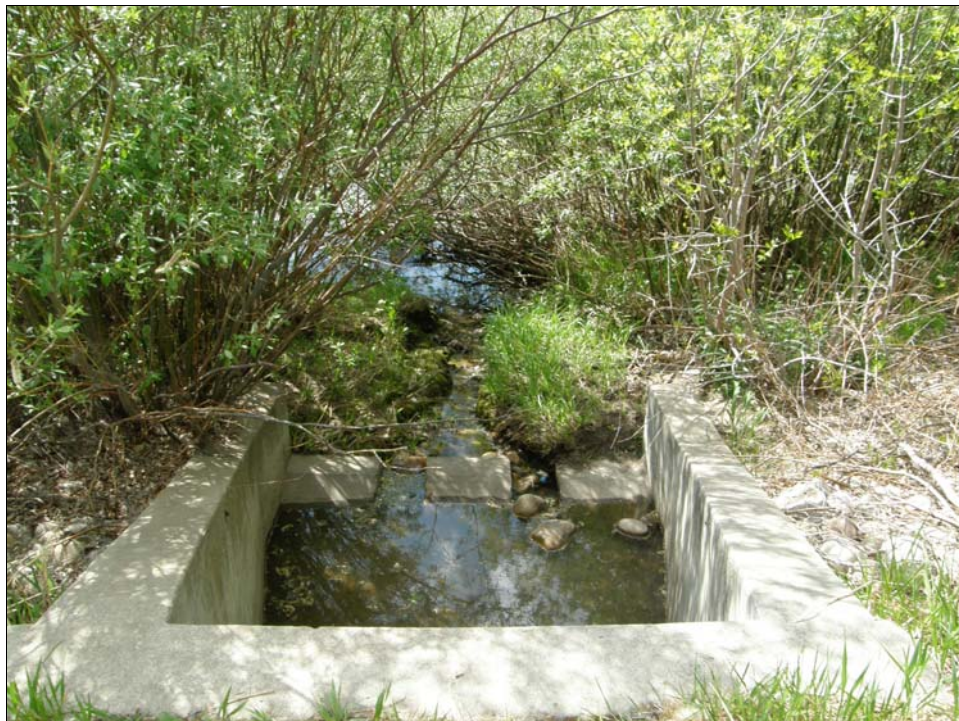
**Photograph 2: Minor erosion due to sewer flow.**

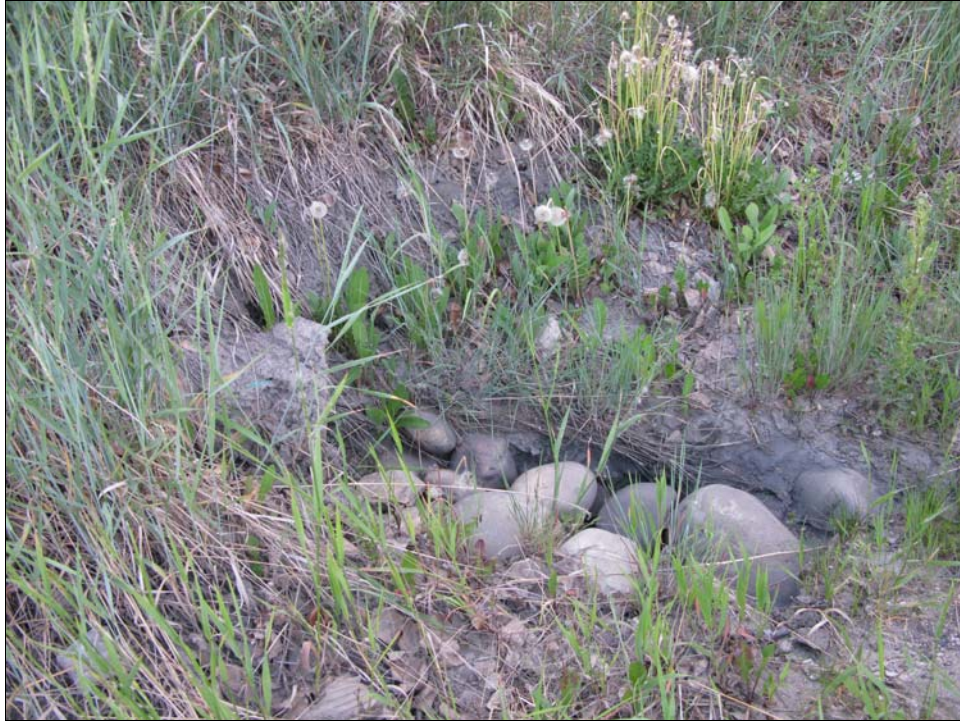
**Photograph 3: Minor erosion to the right of the pipe due to sewer flow.**

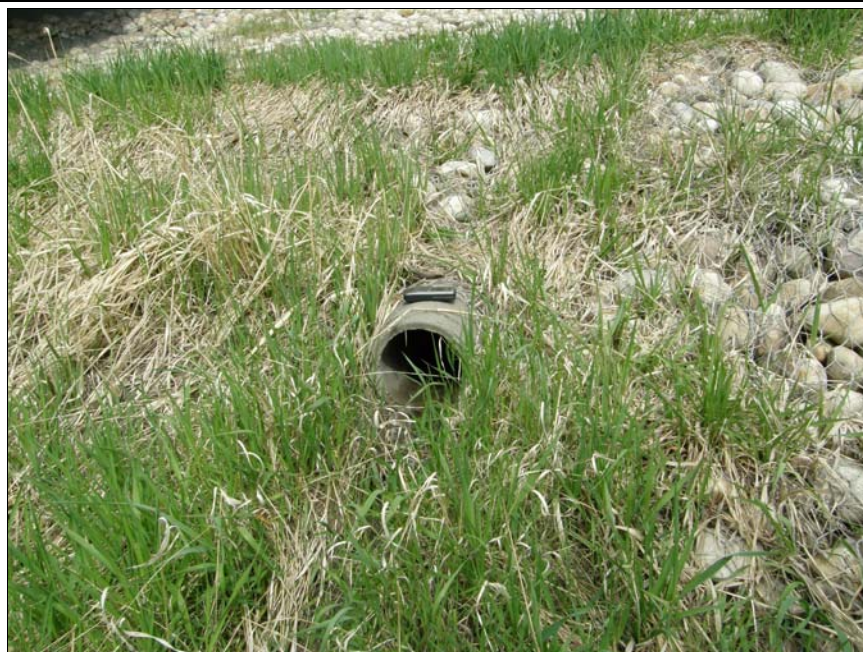
**Photograph 1: Looking up slope at Outfall #22. There is significant amount of rip rap on the slope adjacent and above the pipe, and on the slope above the bike path.**

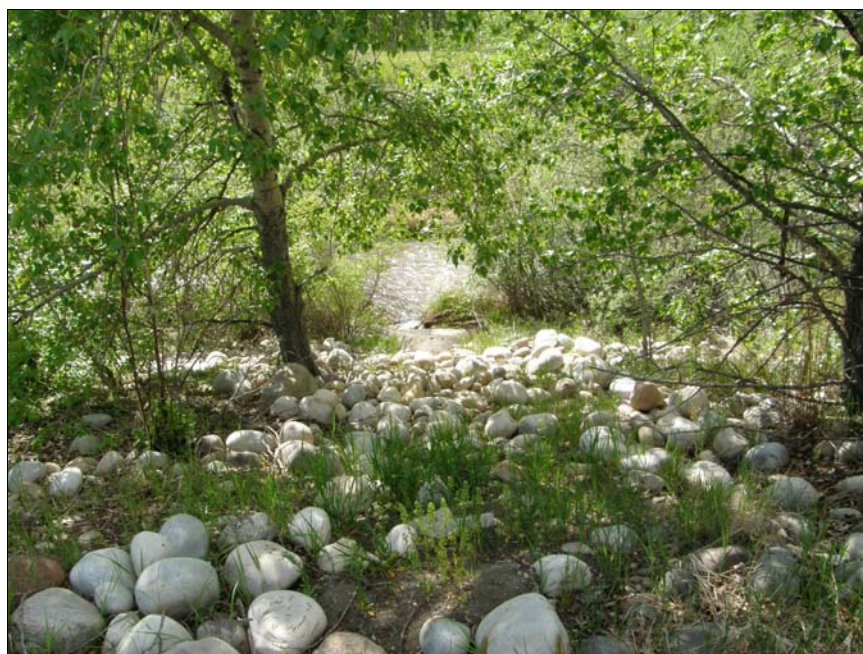
**Photograph 3: Taken from the bike path looking down towards the outfall structure. The area is covered with coarse rip-rap and weed growth.**

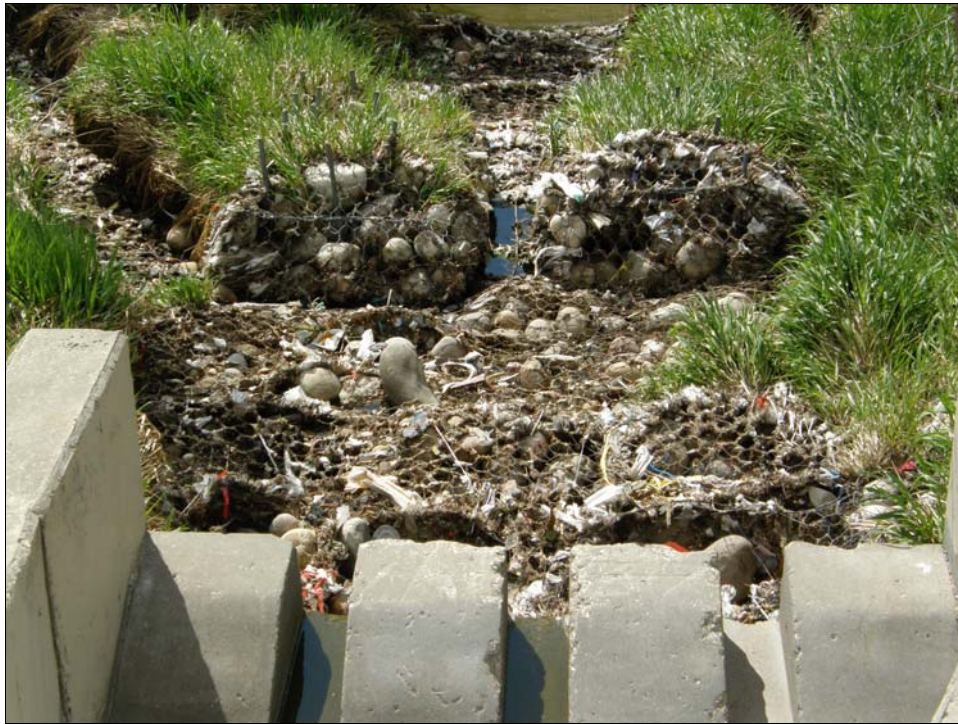
**Photograph 3: Looking downslope from the outfall showing the garbage in the gabions as well as the erosion channels.**

Periodic yearly inspection to monitor for erosion and garbage debris is recommended.

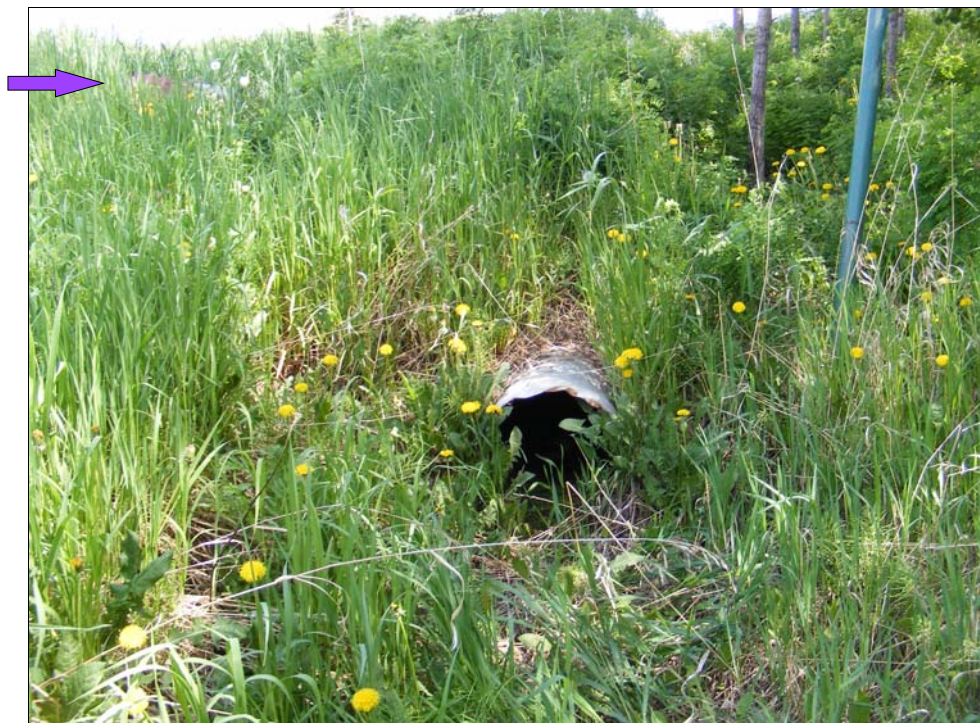
**Photograph 1: Detailed view of Outfall #26 with blue marker post adjacent to the pipe. A scrap piece of CSP culvert is located in the top left of photograph (see arrow).**

Removal of the old CSP culvert lying in the grass above the outfall is recommended.

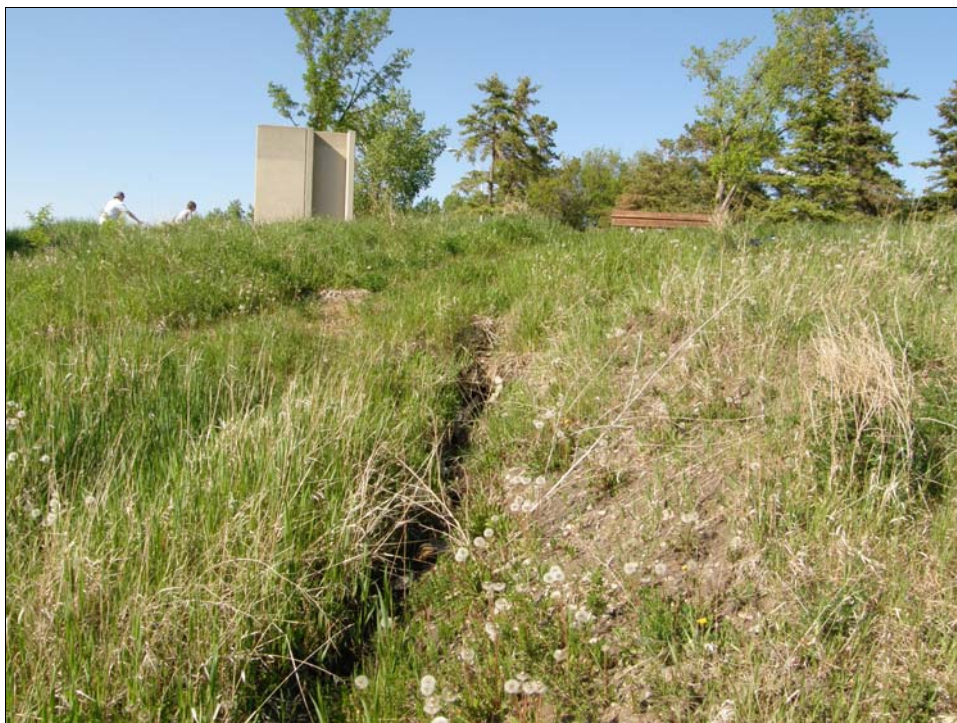
**Photograph 1: Outfall #29 and eroded trench.**

The estimated cost for remediation is \$10,500 and is outlined in Table 14 (Appendix B).

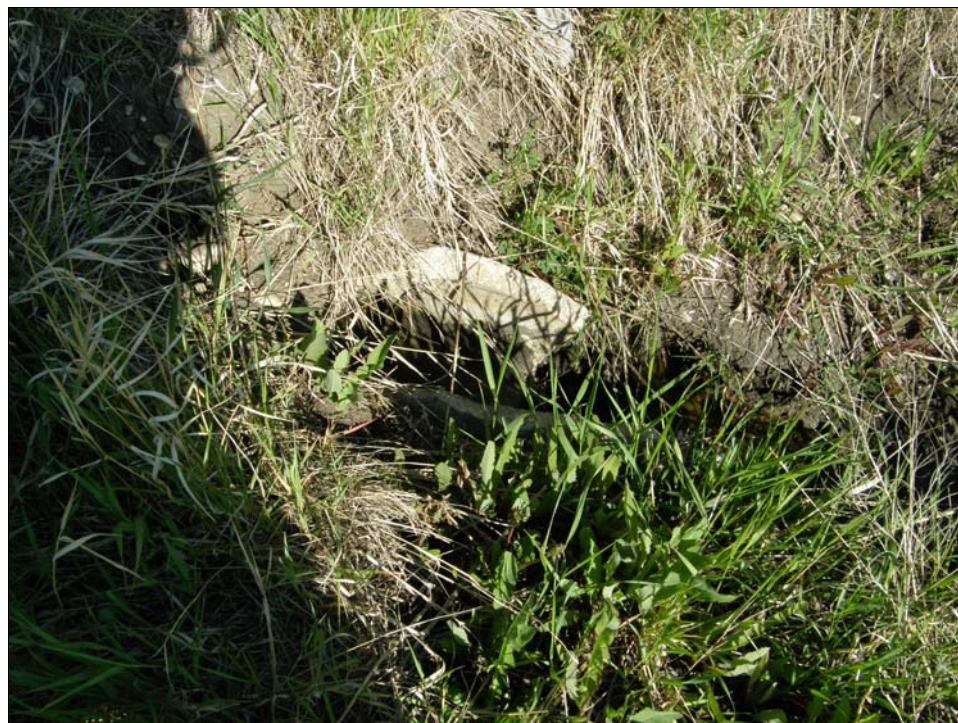
**Photograph 2: Cracked concrete pipe.**

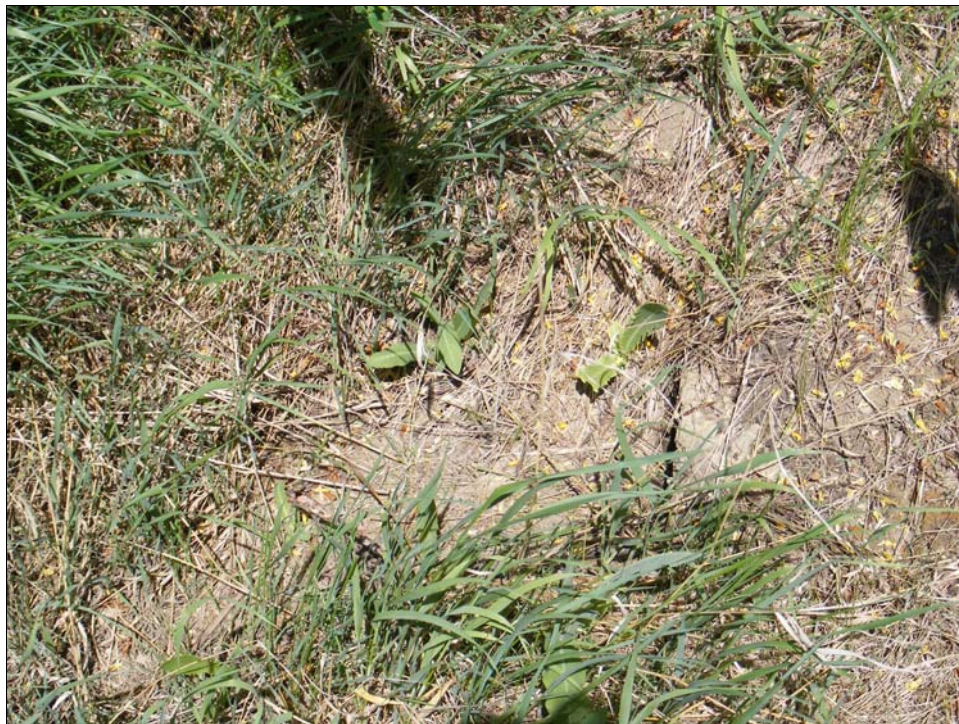
**Photograph 2: Minor soil erosion.**

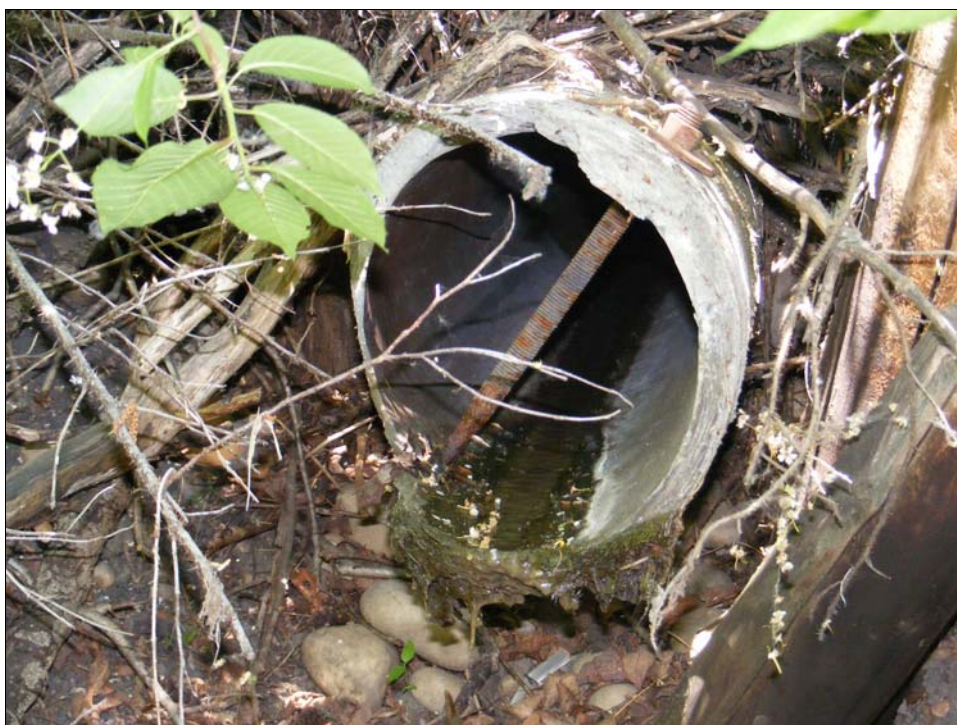
**Photograph 1: Outfall #33 showing cracked end with wooden support post at right that appears to be present as a marker post or possibly support during original construction.**

Consideration may be given to combining Outfall 32 and 33 as both require remedial work and are located in close proximity.

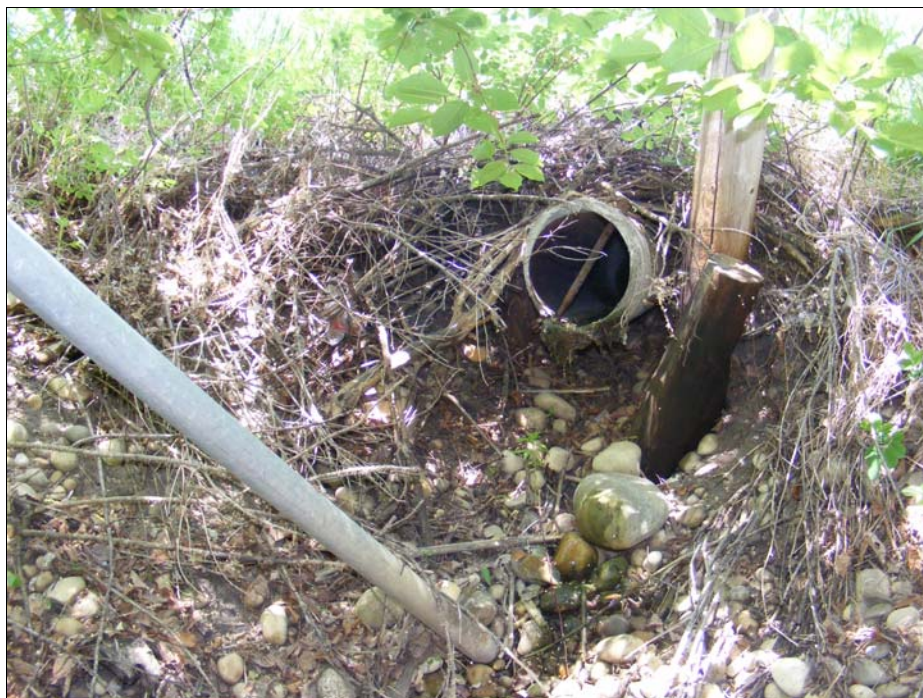
**Photograph 2: Vegetation debris and soil erosion. The lack of sunlight will limit the ability to establish additional vegetation but the erosion is not significant.**

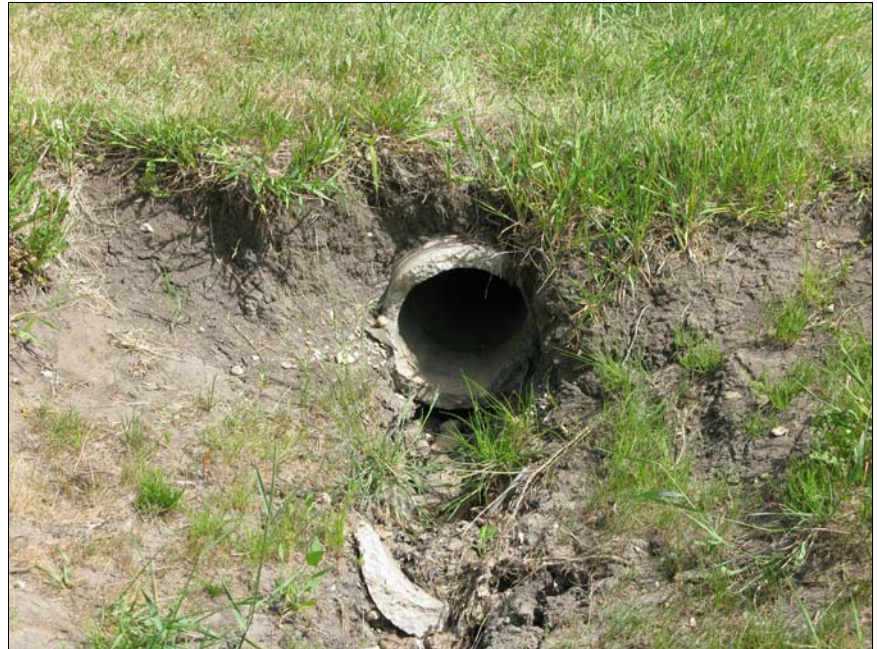
**Photographs 1 and 2: Outfall #36 showing soil erosion and lack of vegetation below the outfall, as well as cracked pipe.**

Tension cracks near the top of slope should be surveyed and backfilled. Yearly monitoring of the outfall and slope is recommended. Although the slope is not very steep, the presence of tension cracks suggest possible movement that should be monitored. A slope failure is unlikely to damage the roadway or houses further east but stabilization may be required.

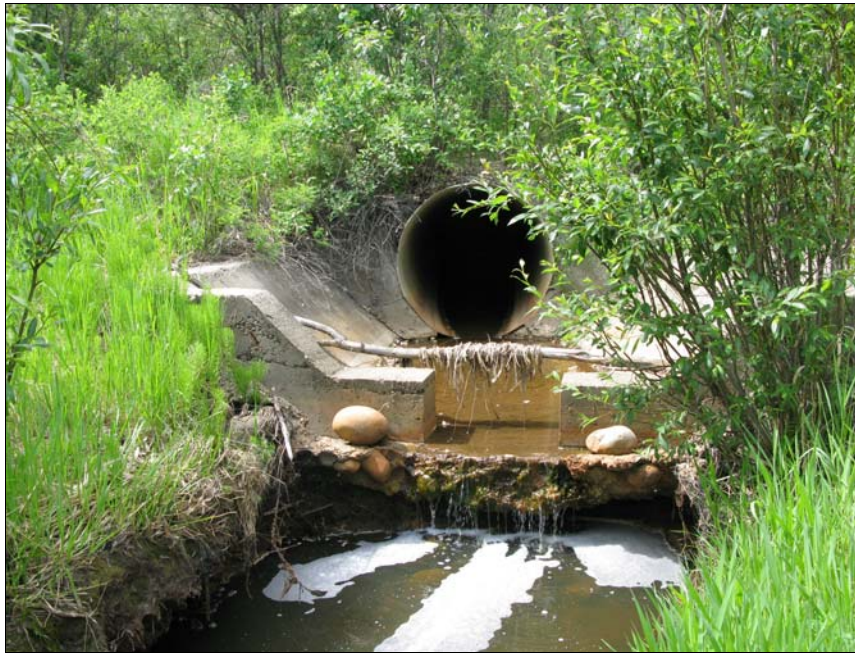
**Photographs 1 & 2: Outfall #37 and eroded soil/rip rap.**

The estimated remedial cost is \$7,300 and is presented in Table 19 (Appendix B).

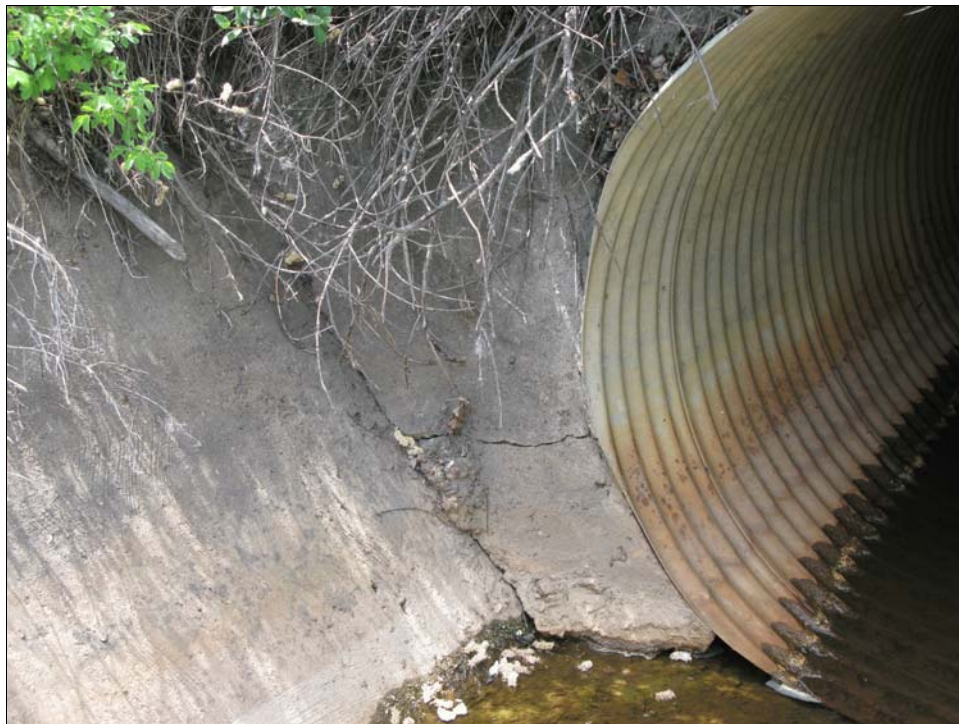
**Photograph 2: Cracked concrete apron surrounding CSP pipe.**

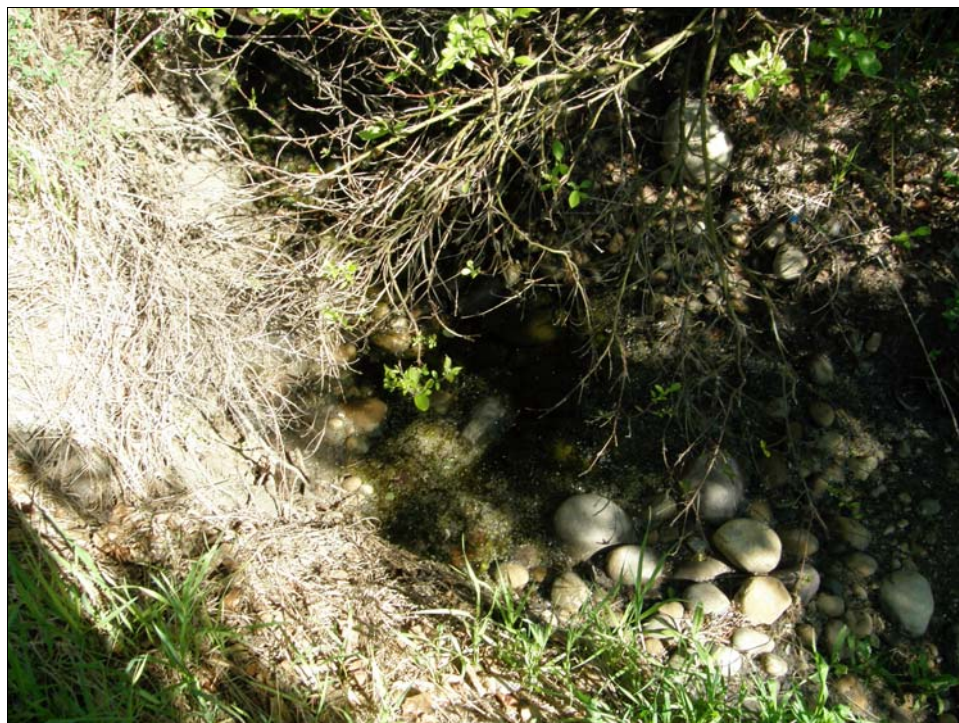
**Photograph 2: Outfall #38 showing rip-rap and depression where pipe should be located.**

Cleaning and uncovering of the outfall is estimated to cost approximately \$2000.

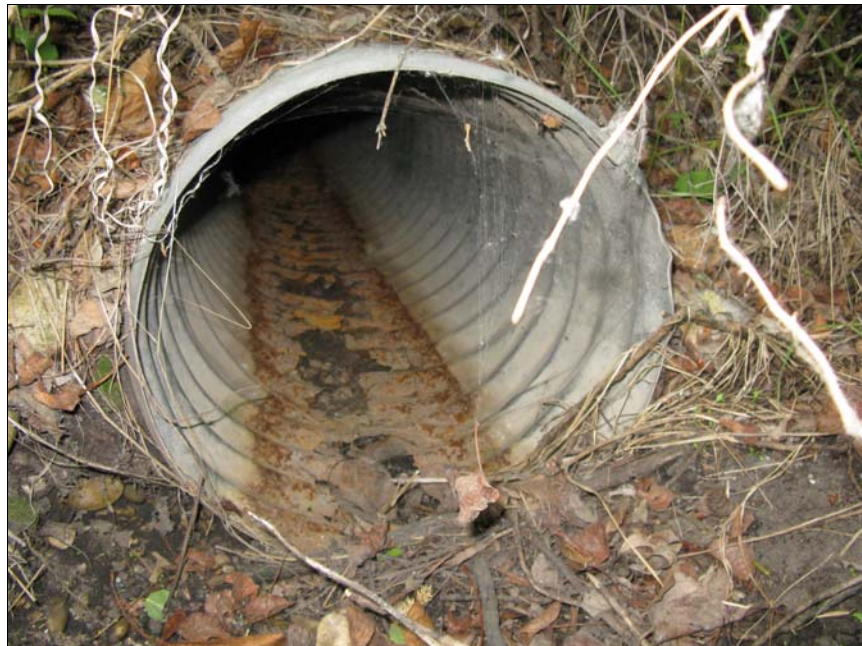
**Photograph 3: Rusted out pipe.**

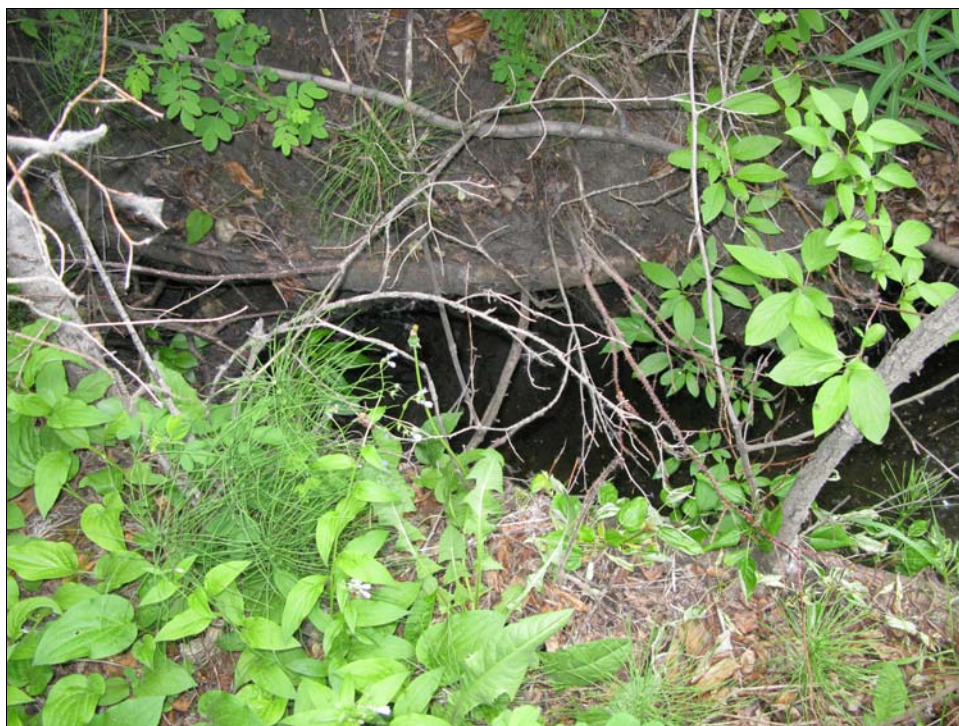
**Photograph 4: Eroded rip rap and trench.**

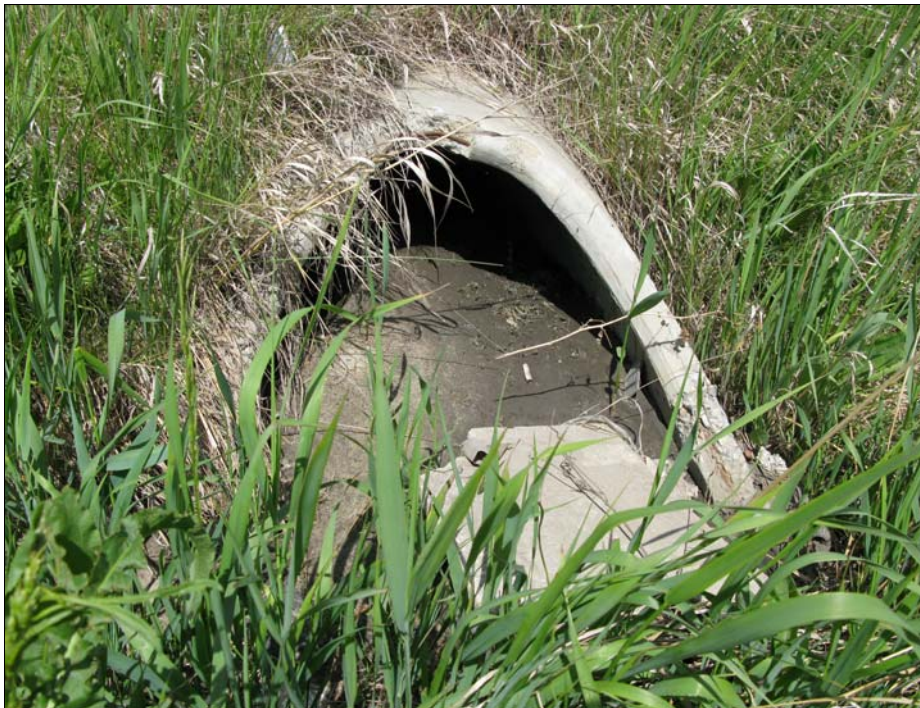
**Photograph 2: Broken concrete structure and soil debris.**

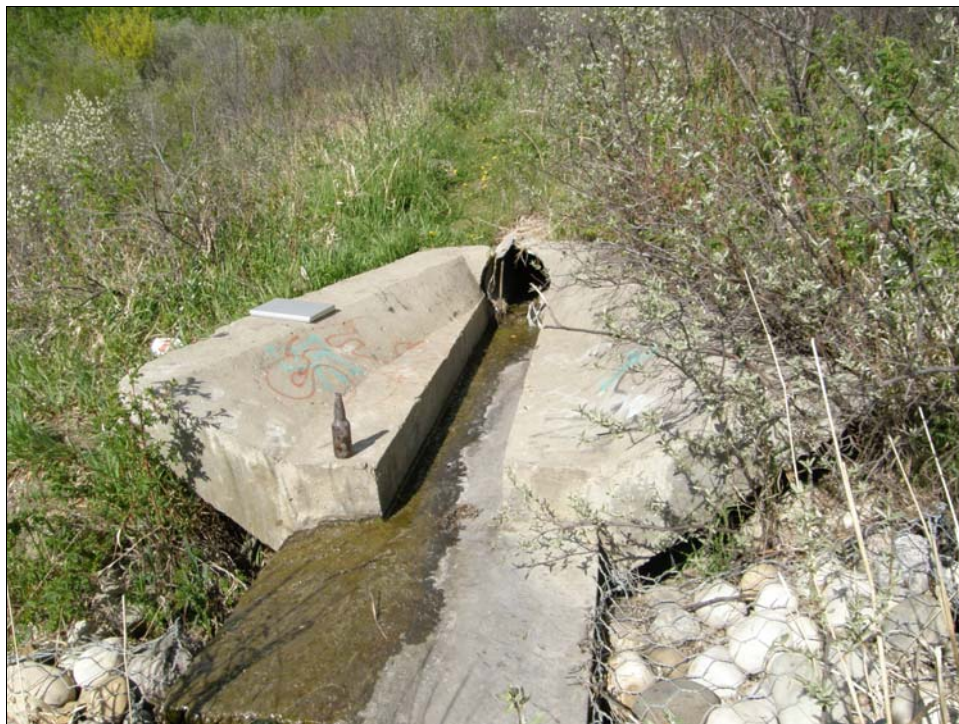
**Photograph 1: Outfall #41 showing voids below the apron sides. The water flow clearly shows that the apron is leaning towards the west (to the creek).**

Rehabilitation of this outfall is proposed that would include armoring of the creek bank, reconstruction of the gabions and erosion protection measures, re-installing the concrete apron and re-installing vegetation. An estimated cost of \$126,000 is presented in Table 22 (Appendix B).
