# 2009 BEAR CREEK CORRIDOR OUTFALL INSPECTION REPORT

BEAR CREEK CORRIDOR  
GRANDE PRAIRIE, ALBERTA

PARKLAND GEOTECHNICAL LTD.

MARCH 16, 2010

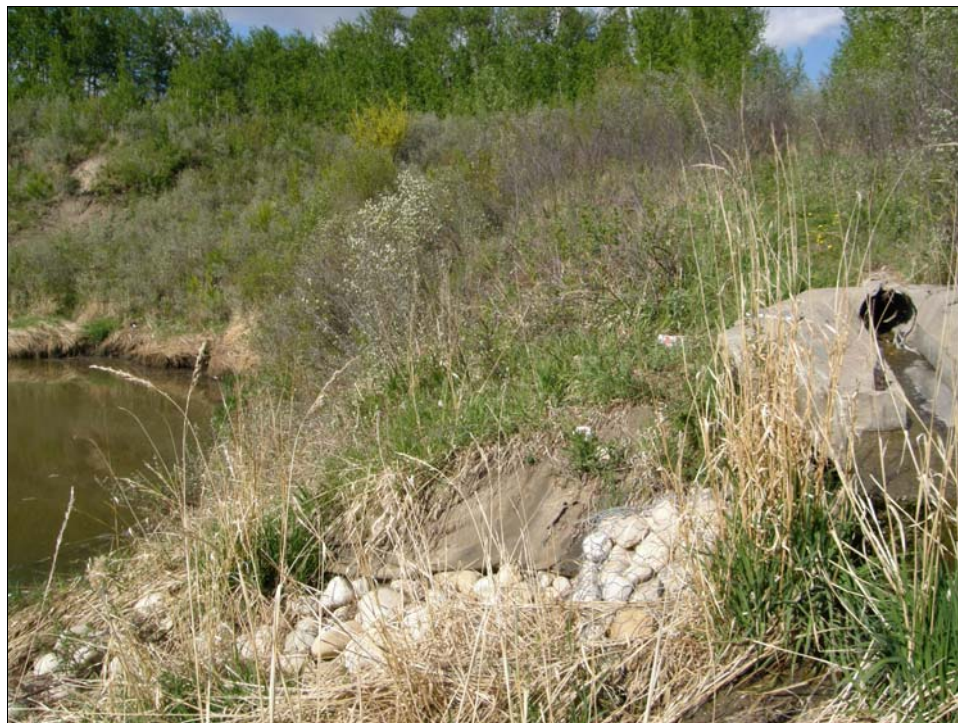
**Photograph 2: Soil erosion have caused the rip rap to settle.**

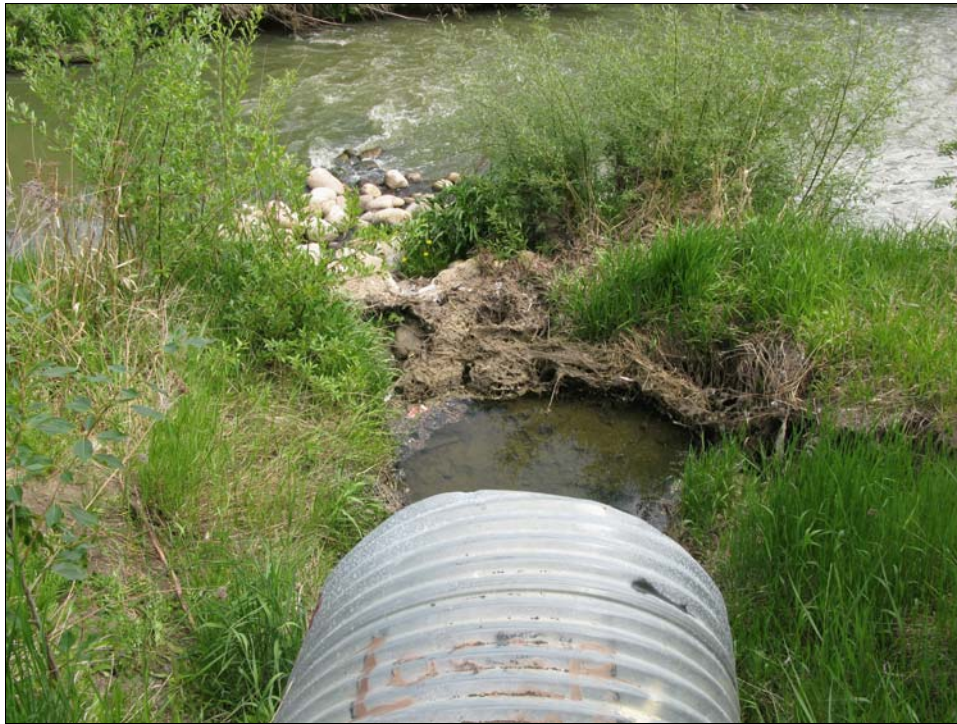
**Photograph 3: Soil erosion to the side of the outfall and below.**

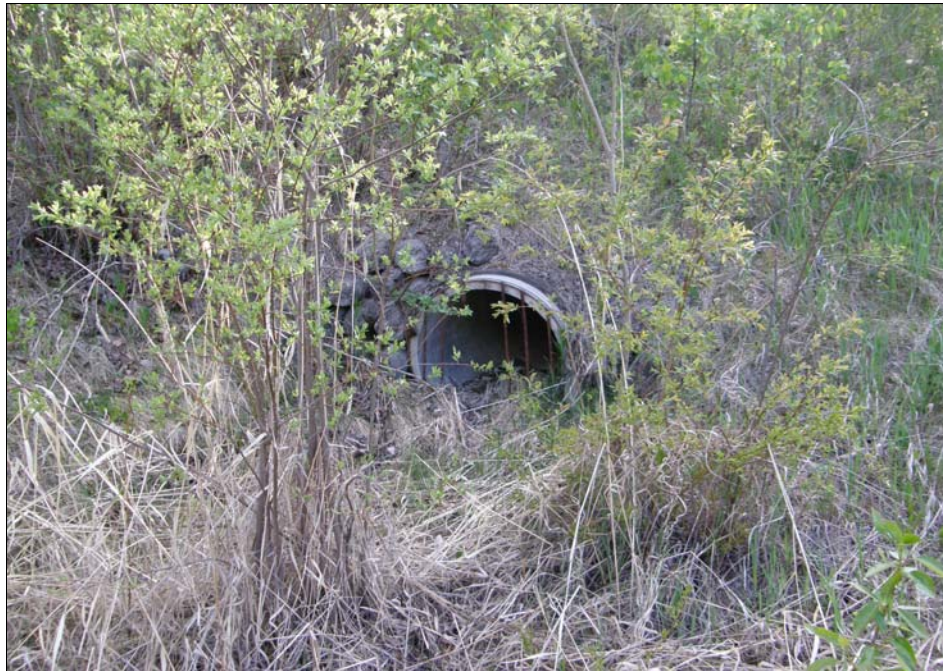
**Photograph 1: Outfall #45 is abandoned and becoming overgrown. The outfall is in good condition and does not present a safety hazard.**

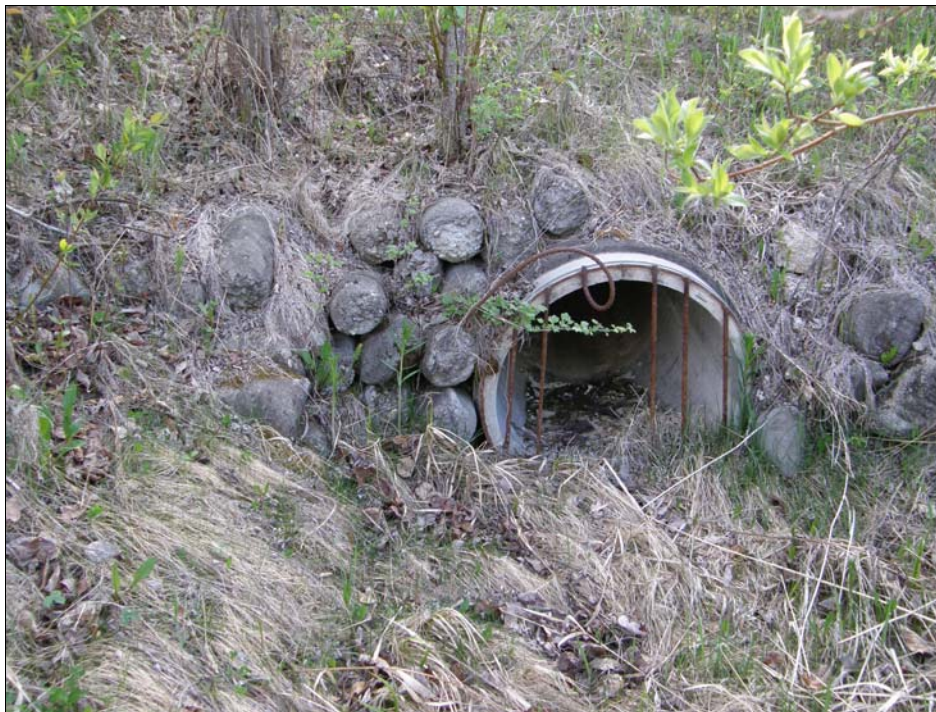
**Photograph 2: The abandoned outfall is in good condition, with only minor vandalism damage to the re-bar grate. Minor repairs may be necessary to repair the grate for security and safety concerns.**

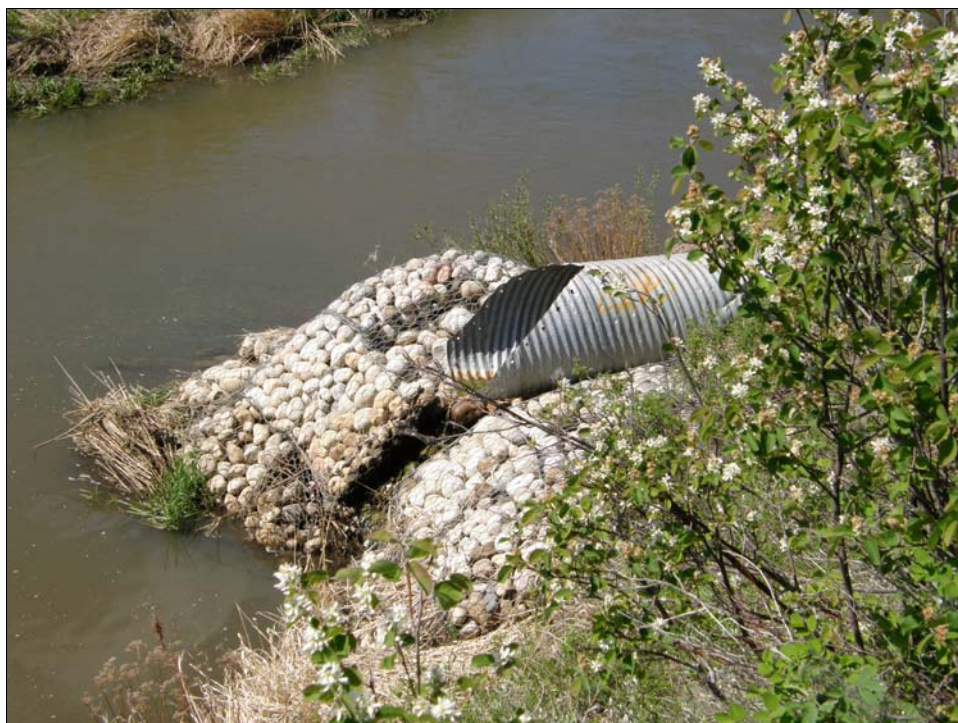
The cost for the repair of Outfall 46 is currently being investigated by ParklandGEO as part of a detailed geotechnical study, but it is expected that the costs will be between \$1 and \$2 Million. Outfall 24 will require in excess of \$50,000, while all others will cost between \$5,000 and \$45,000 to remediate. Excluding outfall 46 costs, the total Priority 1 remedial/maintenance costs are estimated to be \$155,700.

**Photograph 2: Outfall and gabions in good condition but evidence of settlement due to erosion of the soil below the structure.**

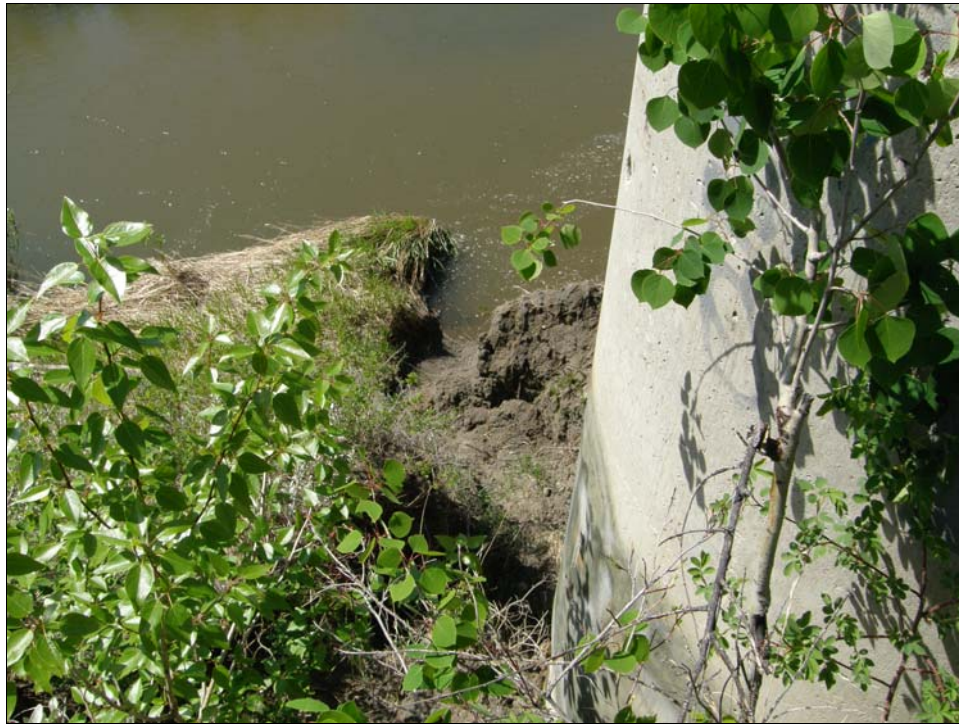
**Photograph 3: Soil erosion below the concrete drop structure.**

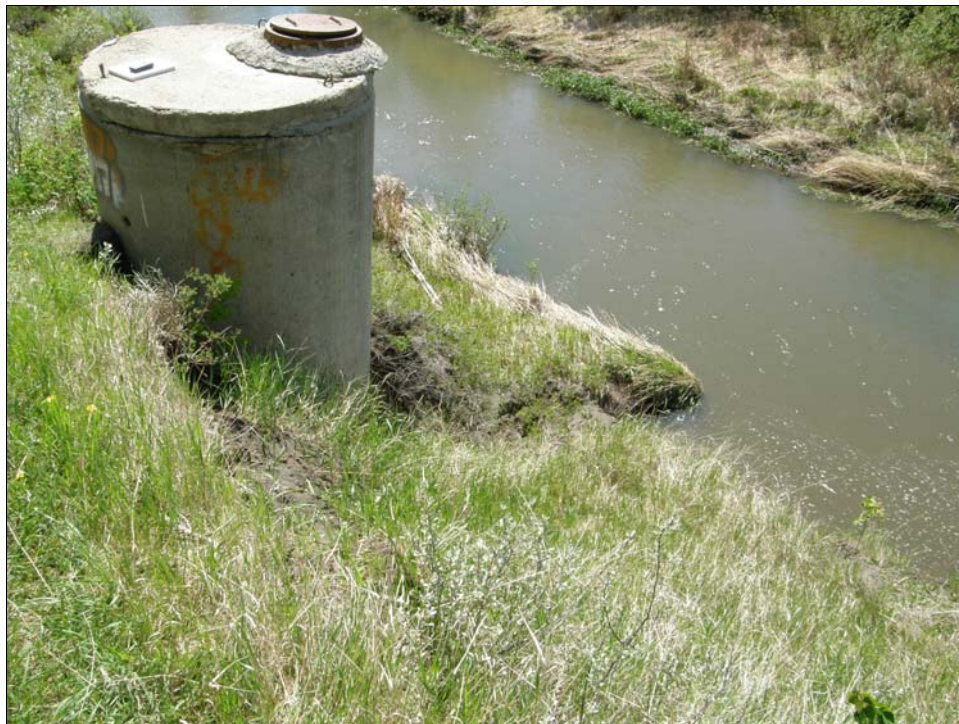
**Photograph 4: River flow causing soil erosion.**

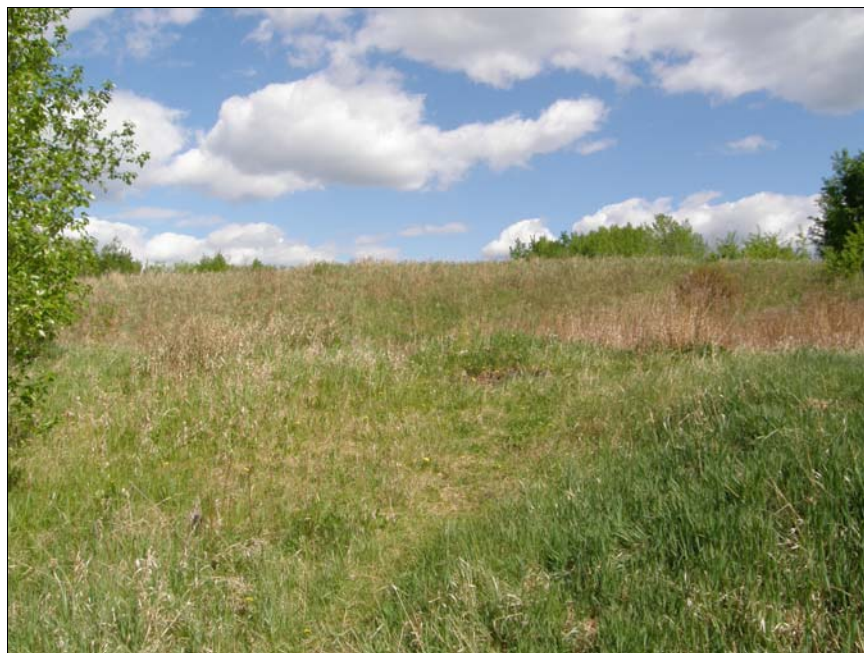
**Photograph 2: Looking upslope towards 100 Street. The slope appears stable and no other evidence of the former outfall was found.**

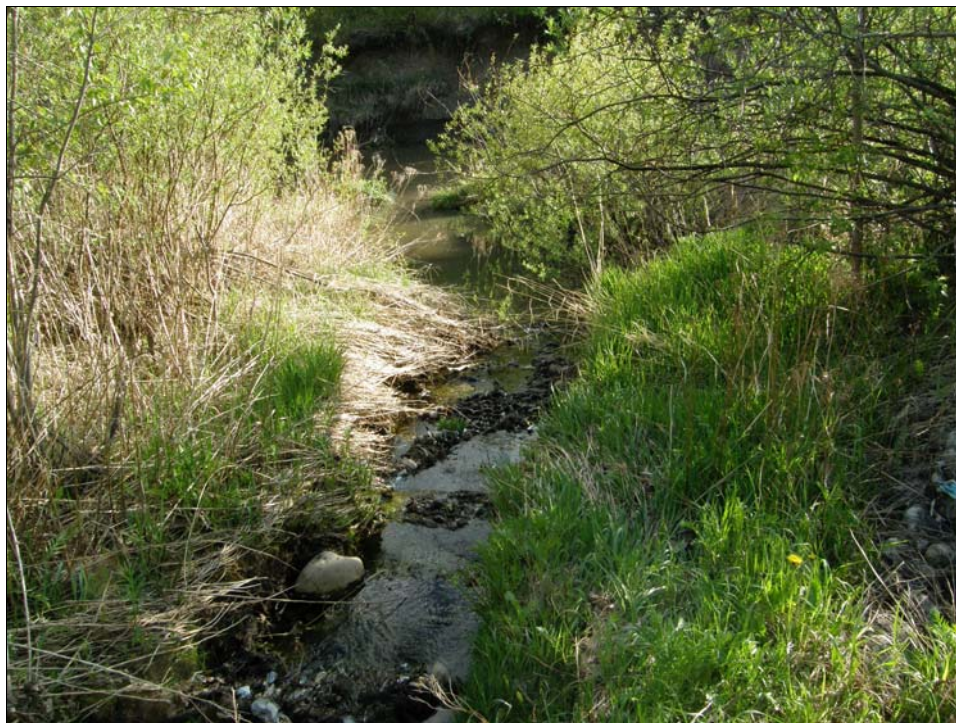
**Photograph 2: Erosion channel.**

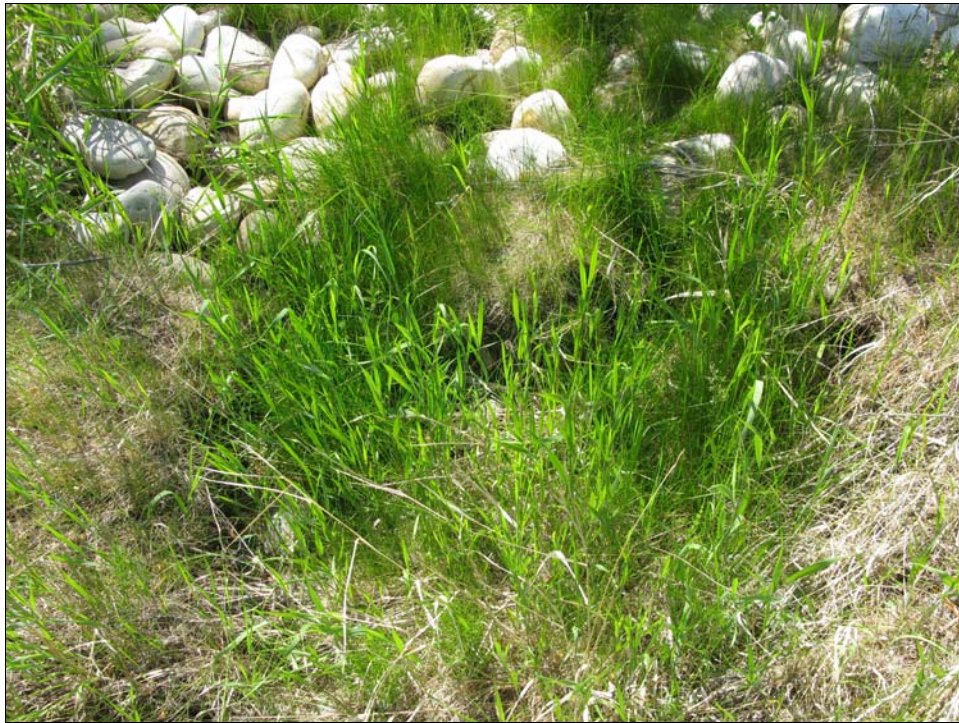
**Photograph 1: Outfall #50 with soil erosion and vegetation growth.**

The estimated repair costs are \$12,000 and are presented in Table 26 (Appendix B).

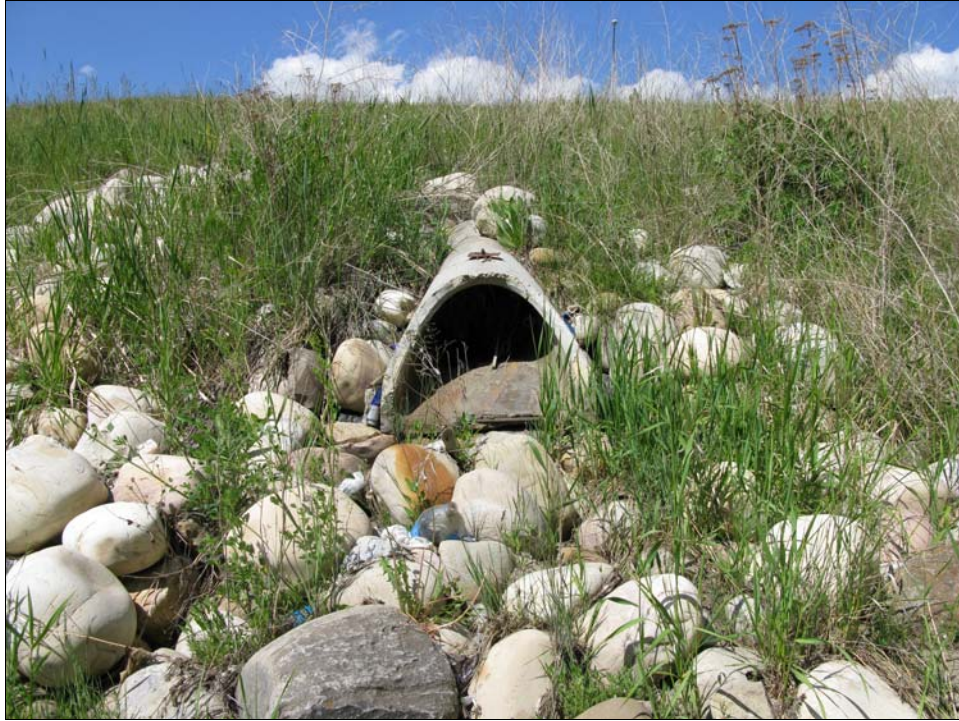
**Photograph 1: Looking north at Outfall #51. 68 Avenue is at the top of the photograph. Weed growth is prevalent within the rip-rap facing.**

The cost of remedial work is approximately \$3300, and is detailed in Table 27 (Appendix B).

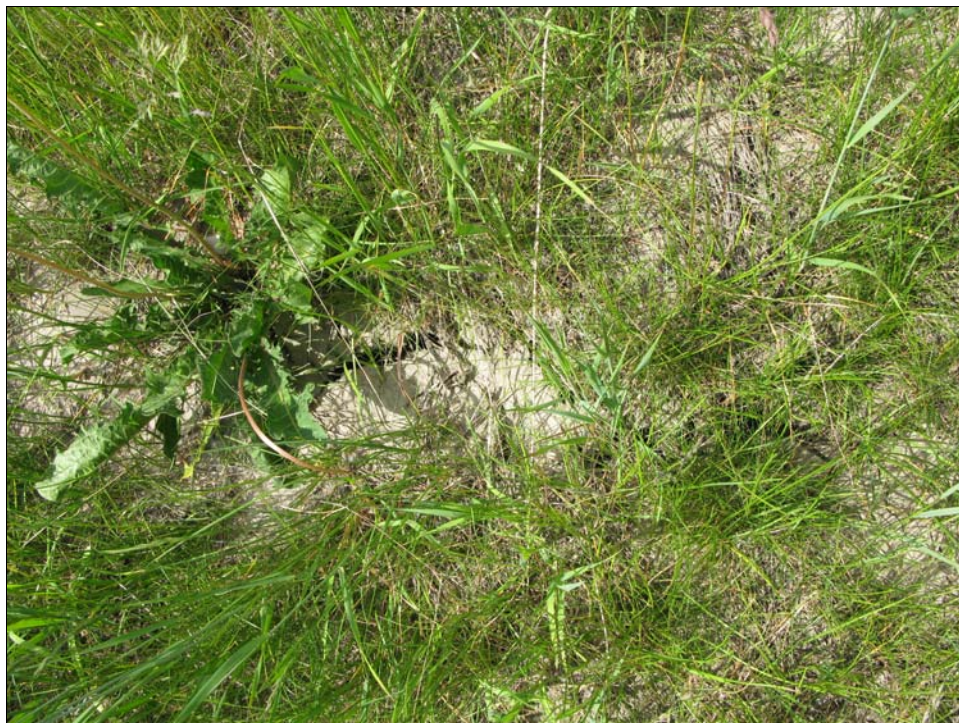
**Photograph 3: Soil erosion.**

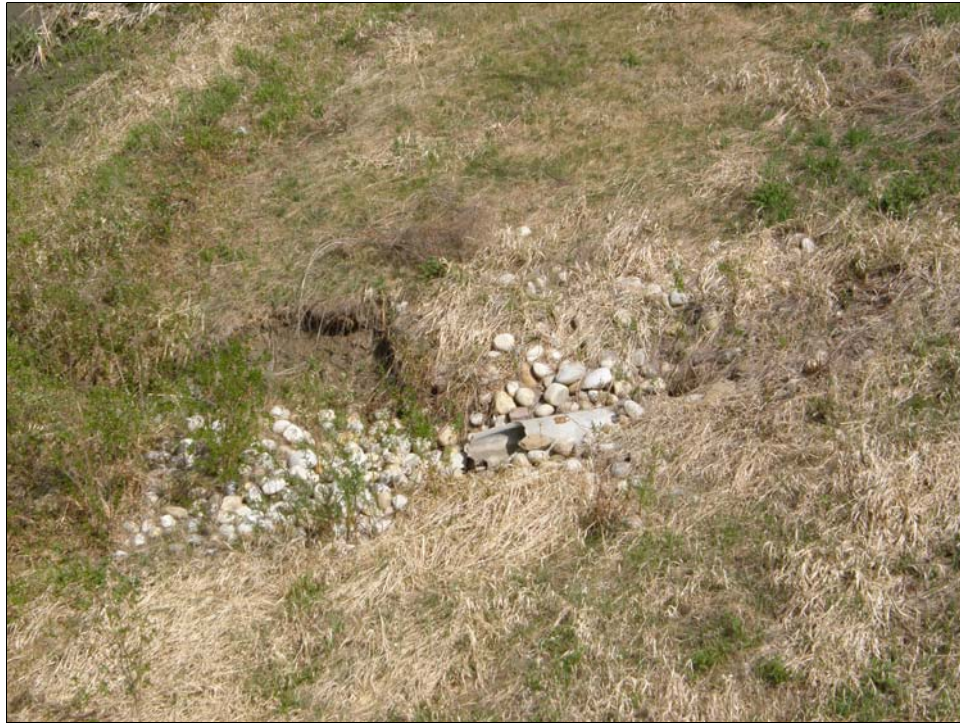
**Photograph 1: Outfall #53 with small slump to the north of the outfall.**

The estimate cost of installing matting and grass seed is less than \$1000.

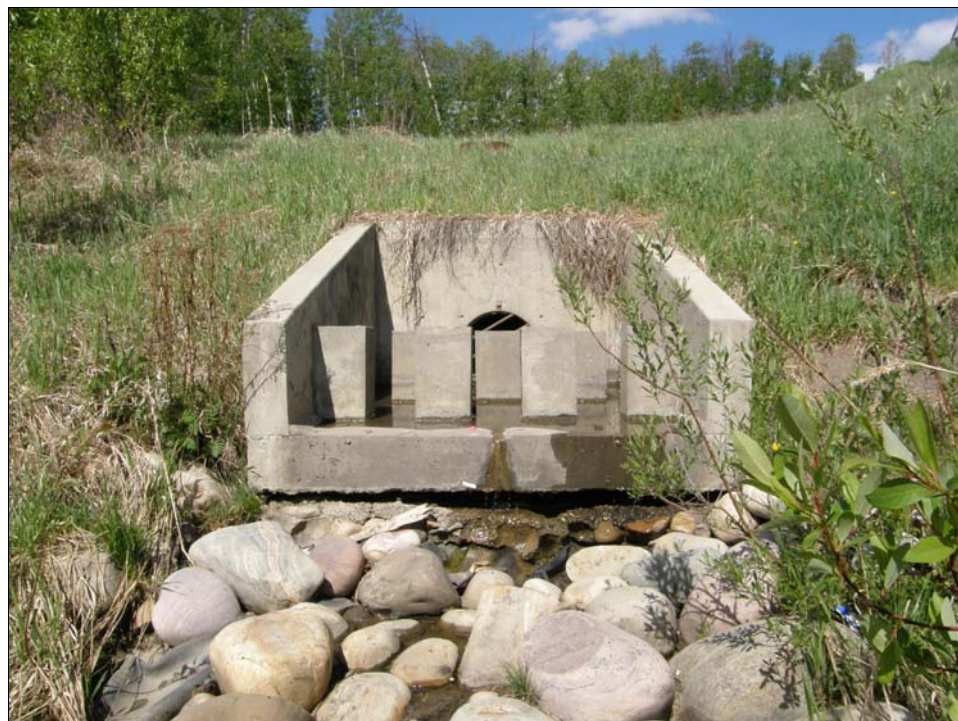
**Photograph 2: Outfall with minor erosion below the apron.**

We recommend that the outfall be inspected in 2010 and if gap below structure has not increased then use grout to fill void. If void is larger, redesign of the erosion control measures will be required.

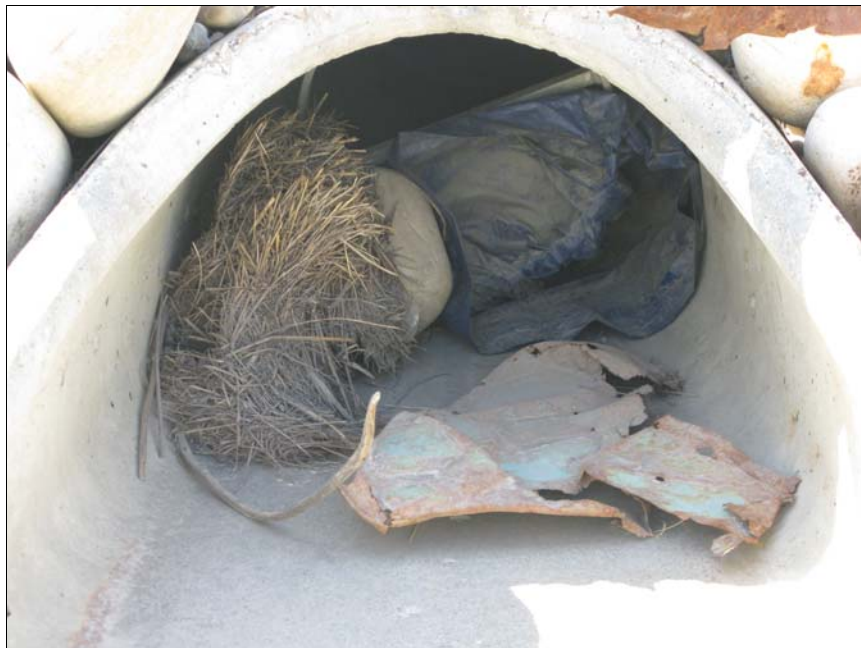
**Photograph 2: Plugged pipe due partly to vandalism.**
