2020 Inundation Study and Dam Safety Review Final Report

Bear River Control Structure

City of Grande Prairie

July 16, 2021

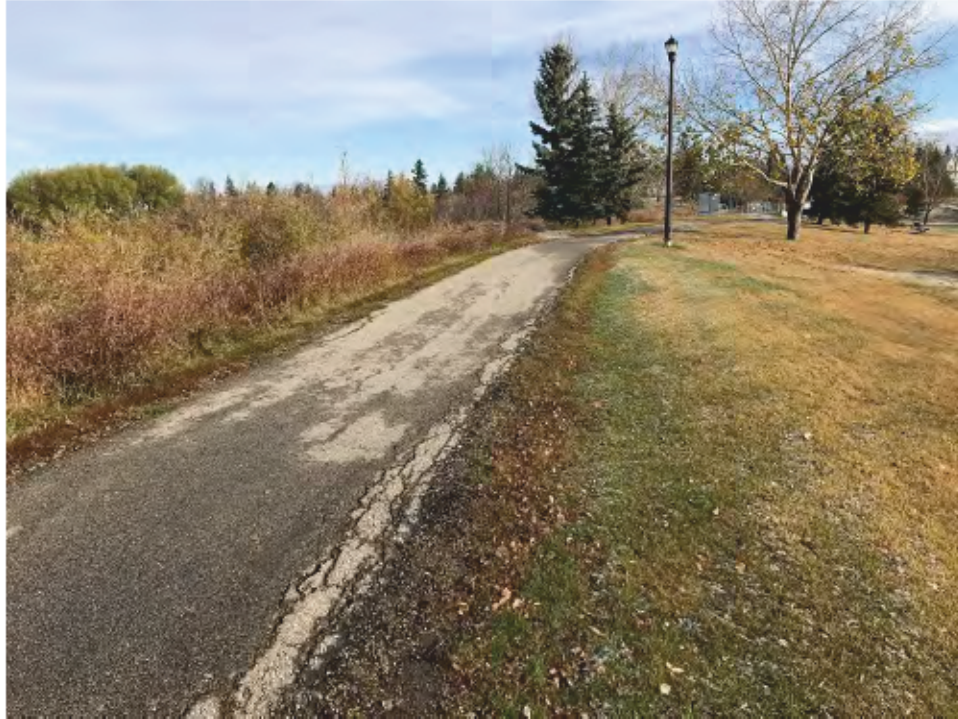
Photo 1: South crest area, facing northeast

Condition	Remarks/Description
Surface Cracking/Scarps	None observed in dam. Minor cracking in asphalt path (Photo 1).
Horizontal Alignment	No observed movement (Photo 2).
Settlement	None observed.
Depression/Sinkhole	None observed.
Surface Protection	Well vegetated with established park grasses that are routinely mowed.
Vegetation	Well vegetated with established park grasses that are routinely mowed. There are also several trees of varying size on the crest (Photo 3).
Animal Burrows	One observed at the joint between the dam crest and spillway concrete on the south side of the spillway (Photo 4).
Other	There is a buried sanitary sewer line that crosses the dam crest (Photo 5). The line is buried along most of the crest and is exposed where it crosses the spillway. There are also associated manholes and cathodic protection on either side of the spillway.

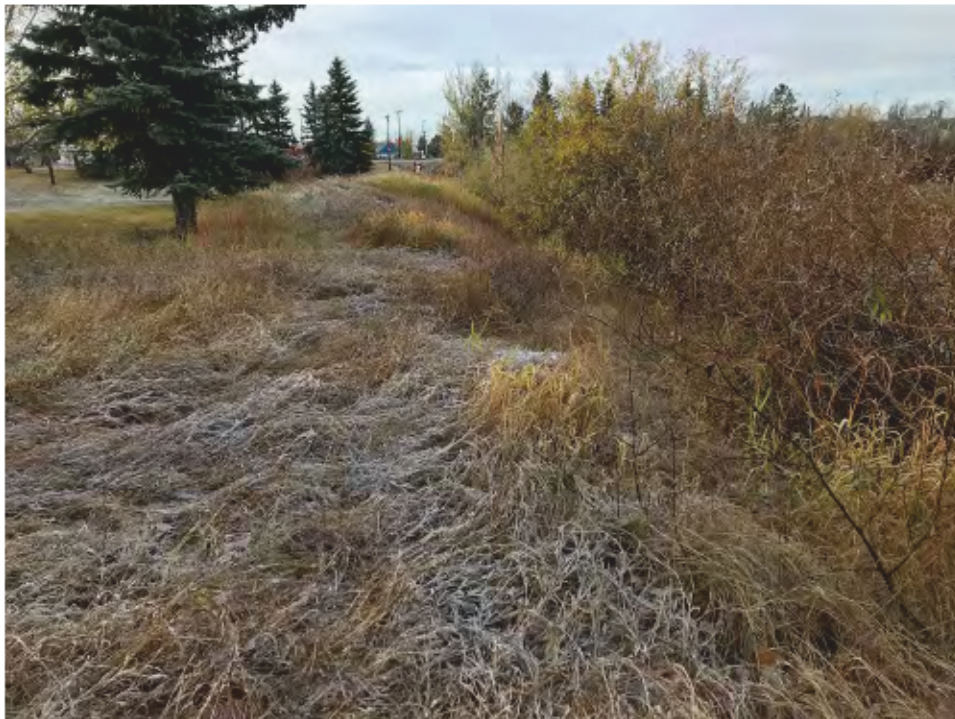
Photo 6: Upstream slope, south side, facing southwest

Condition	Remarks/Description
Slope Stability	Indications of instability were not observed during the inspection (Photo 6).
Slope Protection	Riprap extending up the slope, with vegetation within the upper riprap and on the upper slopes.
Upstream Riprap	The upstream riprap consists of well graded rounded cobbles and boulders between 100 mm and 300 mm in size (Photo 7). The riprap is in fair condition, though it is overgrown with vegetation in parts.
Erosion	None observed.
Depression/Sinkhole	None observed.
Vegetation	Well vegetated with a mixture of trees, native grasses, bushes, and shrubs (Photo 8).
Animal Burrows	None observed.
Other	n/a

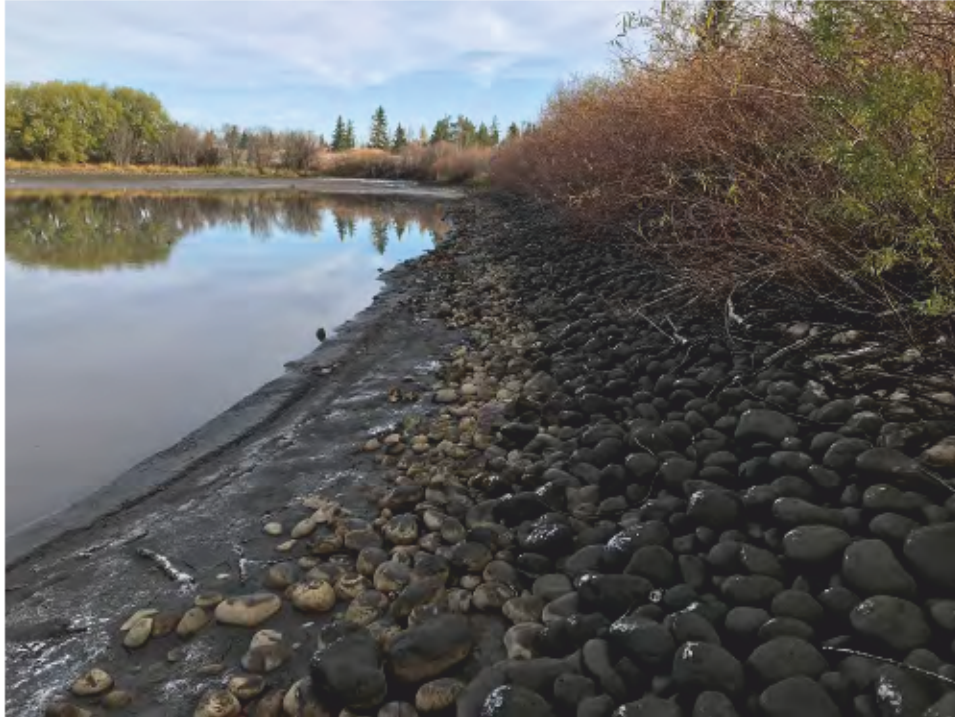
Photo 7: Riprap on upstream dam slope

The upstream slope of the dam is protected by riprap above and below the water surface, consisting of well-graded rounded cobbles and boulders between 100 mm and 300 mm in diameter. The riprap is in fair condition, through it is overgrown with vegetation in parts and is starting to show signs of weathering. Above the riprap, the upstream slope is vegetated with a mixture of trees, native grasses, bushes, and shrubs.

- › The upstream slope and approach riprap are in fair condition but may not meet current design standards. It is also overgrown in parts. Although vegetation is providing protection, there is a risk of the loss of protection should the vegetation be destroyed (e.g., by disease or fire).

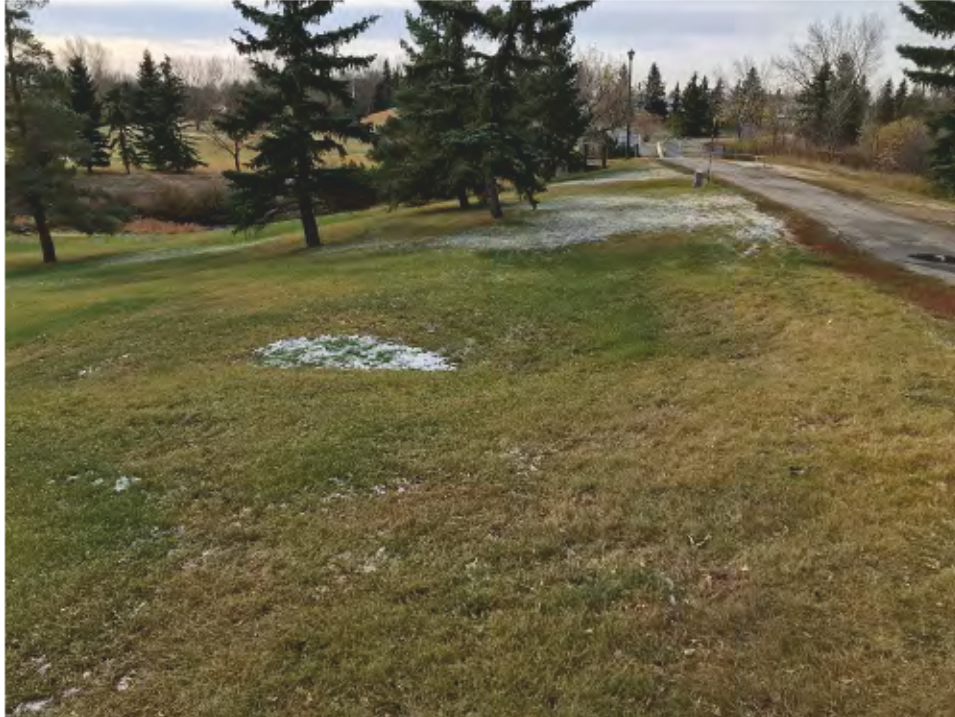
Photo 13: Depressions on the north side of the downstream slope

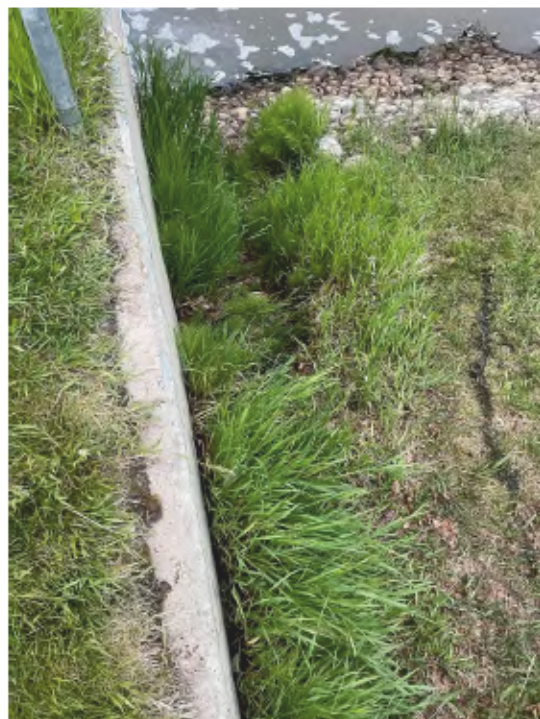
Photo 22: Erosion channel above riprap along downstream wing wall

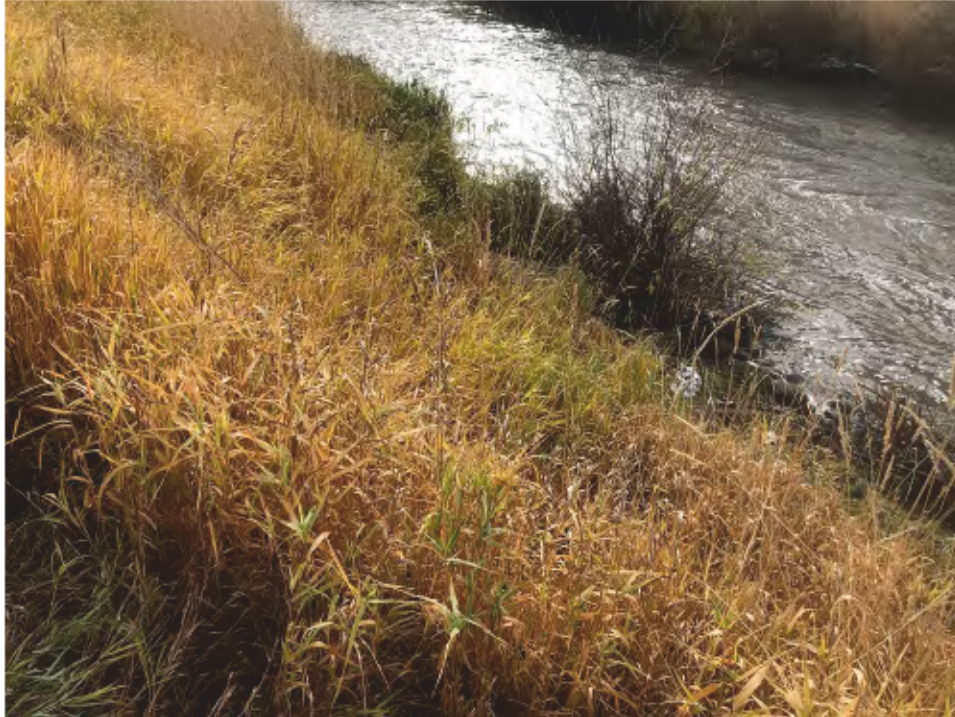
Photo 23: Sloughed area on north side of downstream bank (view impeded by grasses)

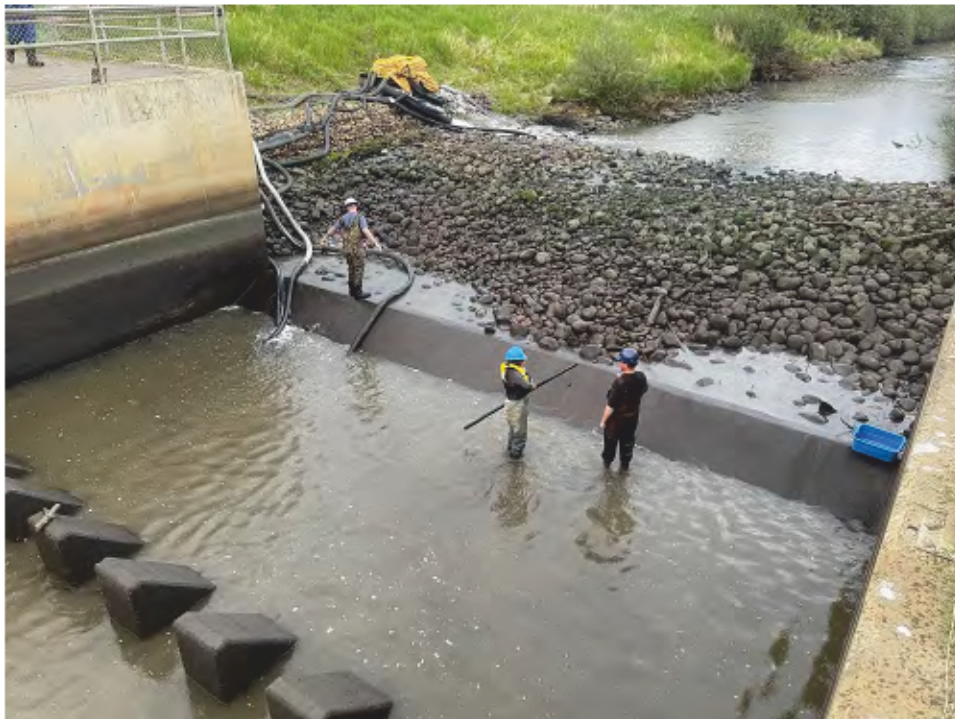
Photo 24: Displaced cobbles deposited downstream of the stilling basin

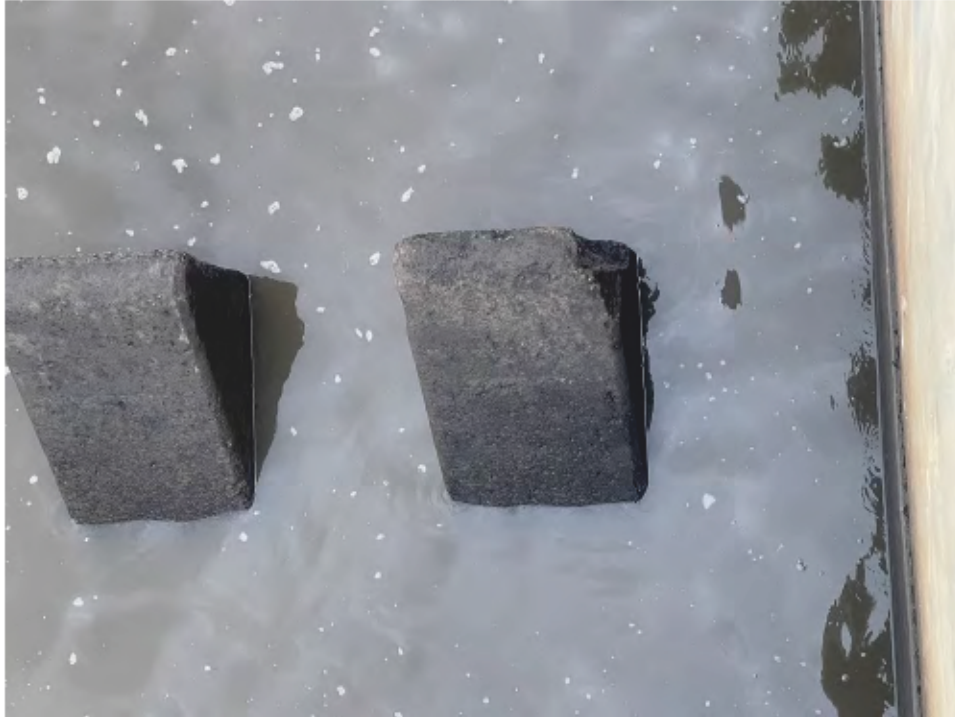
Photo 35: Chipped energy dissipation baffle

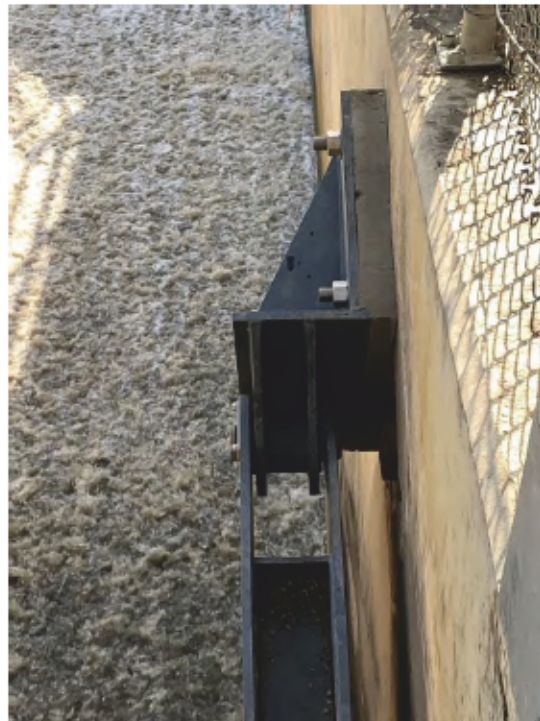
Condition	Observation: Sketch, Measure, Photograph, Locate (SMPL)
Gate Structure – Pivot Bracket and Gates c/w Gate Arms	<p>Pivot Bracket Connection:</p> <ul style="list-style-type: none"> › South Gate & North Gate; The bracket connection plates, concrete connection bolts and pivot bracket grout at connection points were in good condition with no signs of damage <p>Pivot Pins:</p> <ul style="list-style-type: none"> › South Gate & North Gate; pivot pins were in good condition with minor surface corrosion. <p>Pivot Point:</p> <ul style="list-style-type: none"> › South Gate & North Gate; a clear movement gap was noted between the pivot bracket and gate arm at connection points; the alignment was true at both connection points. No point of contact between the brackets and gate arms was evident during the gate test; no paint damage or corrosion to suggest contact was noted. Refer to Photo 36. <p>Gate Arms:</p> <ul style="list-style-type: none"> › South Gate; South Arm; Tree branch was caught on the gate arm, located away from the arm pivot point, the arm was in good condition. › South Gate; North Arm; the gate arm was free of debris and in good condition. › North Gate; South Arm; the gate arm was free of debris and in good condition. › North Gate; North Arm; the gate arm was free of debris and in good condition. <p>Downstream Face of Gate & Top of Gate:</p> <ul style="list-style-type: none"> › South Gate; debris was collected along the south side of the gate top, around the south cable and within the pockets/horizontal girders on the downstream face of the gate. Refer to Photo 37. › North Gate; debris was collected along the gate top and around both cables. Moderate debris collected in the pockets/horizontal girders on the downstream face of the gate. Refer to Photo 38. <p>Gate Skin Plates:</p> <ul style="list-style-type: none"> › South Gate & North Gate; the skin plates were in good condition with no damage noted.

Photo 36: South Gate Pivot Point

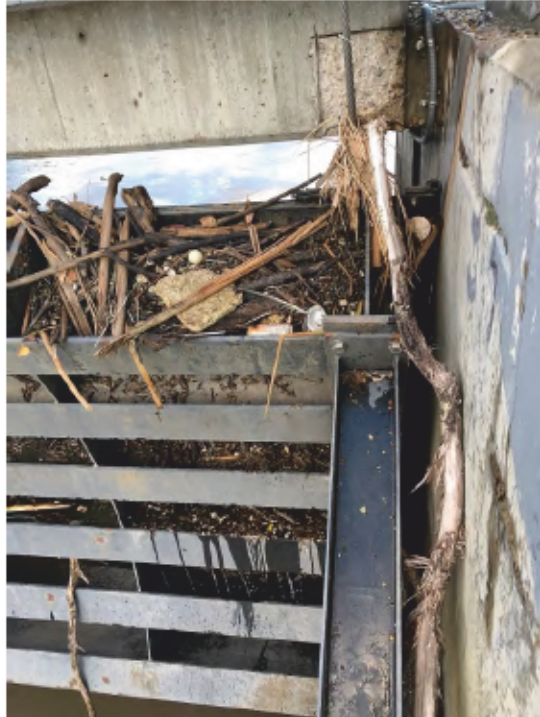
Photo 37: Debris South Gate

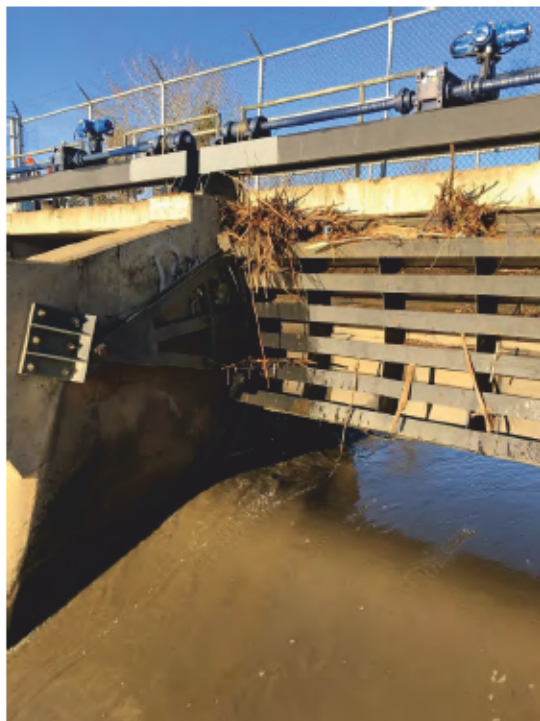
Photo 38: Debris North Gate

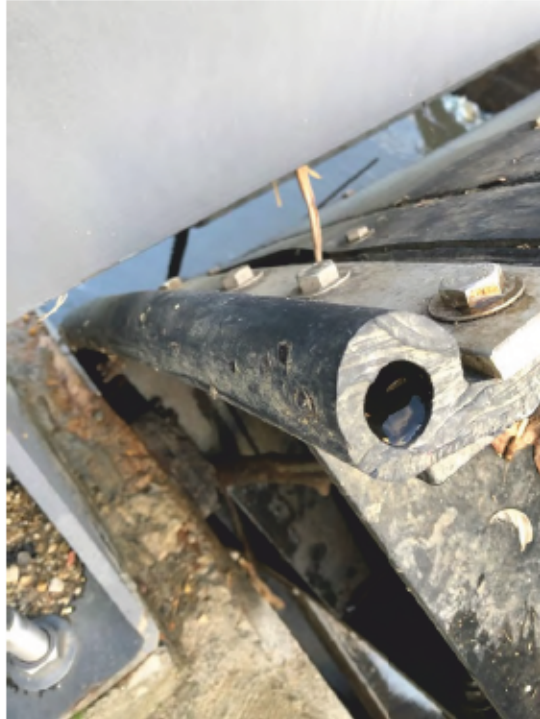
Condition	Observation: Sketch, Measure, Photograph, Locate (SMPL)
Rubber Seals and Seal Path	<p>Sealing:</p> <ul style="list-style-type: none"> › South Gate; very little flow/leakage when fully closed › North Gate; leakage noted from the middle section of the gate when fully closed. <p>Side J-seals:</p> <ul style="list-style-type: none"> › South Gate & North Gate; J-seals are in fairly good condition. Minor damage has been shown on the J seal from the debris on Photo 39. Little leakage noted. Refer to Photo 39 and Photo 40. However, Photo 37 shows a gap on the J seal close to the top of the gate for the south gate. <p>Side J-seal retainers;</p> <ul style="list-style-type: none"> › South Gate & North Gate; J-seal retainers were in good condition with no signs of damage or wear. <p>Side Seal Path/Plate;</p> <ul style="list-style-type: none"> › South Gate & North Gate; Seal paths/plates where in good condition with a smooth finish. <p>Bottom J-seals:</p> <ul style="list-style-type: none"> › South Gate; the bottom J-seals could only be viewed from a distance – no damage noted from this view point. › North Gate; the bottom J-seal is highly damaged in the middle section. Refer to Photo 41.

Photo 39: J-seal South Gate

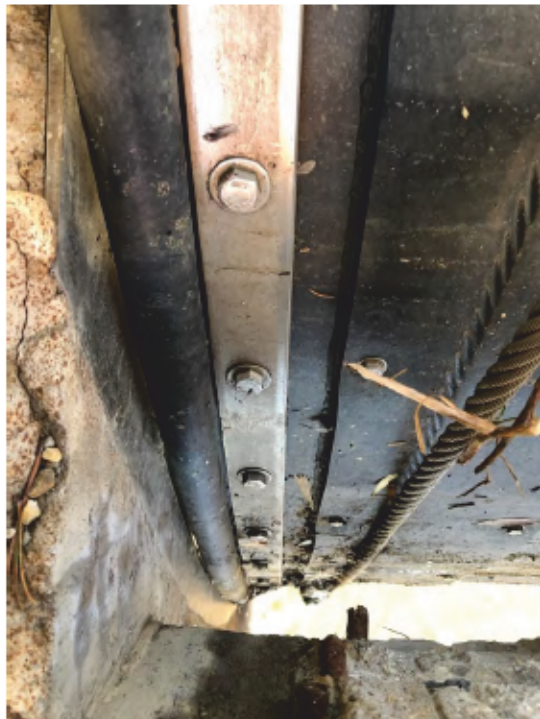
Photo 40: J-seal, Seal Retainer and Hoist Cable Belting North Gate

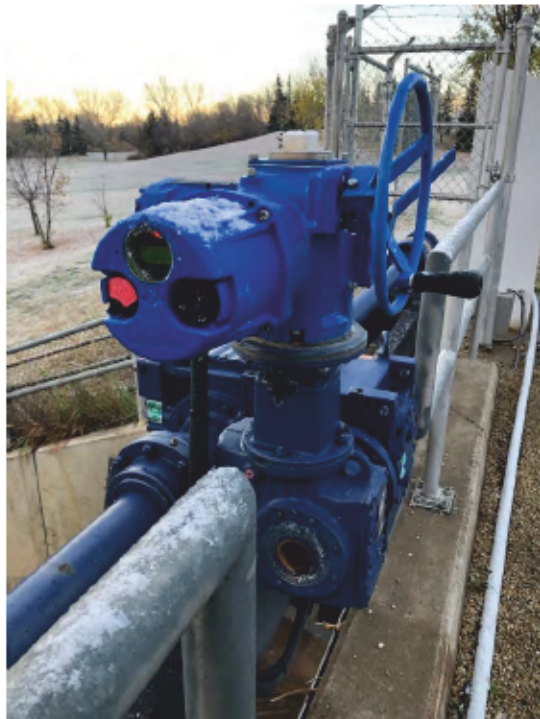
Condition	Observation: Sketch, Measure, Photograph, Locate (SMPL)
Motor/Limitorque Actuator	<p>South Gate; the actuator was in good condition visually, with no signs of damage. Staff noted that there is an intermittent faulty sensor on the motor control indicating overheating when the unit is powered up. The fault resets after a power cycle, alternatively the fault has often reset once the north gate has been actuated and the user returns to the south gate motor control. During the inspection the fault was not seen (during both local and remote testing of the actuator). No abnormal noises were noted during operation.</p> <p>North Gate; the actuator was in good condition visually, with no signs of damage. No abnormal noises were noted during operation.</p> <p>In the event of a power failure a drill pack and mobile generator is available (stored off the dam site).</p> <p>The manual handwheel is fitted permanently to both actuators; they are not locked out. Refer to Photo 44.</p>

Photo 44: South Gate Actuator with Handwheel

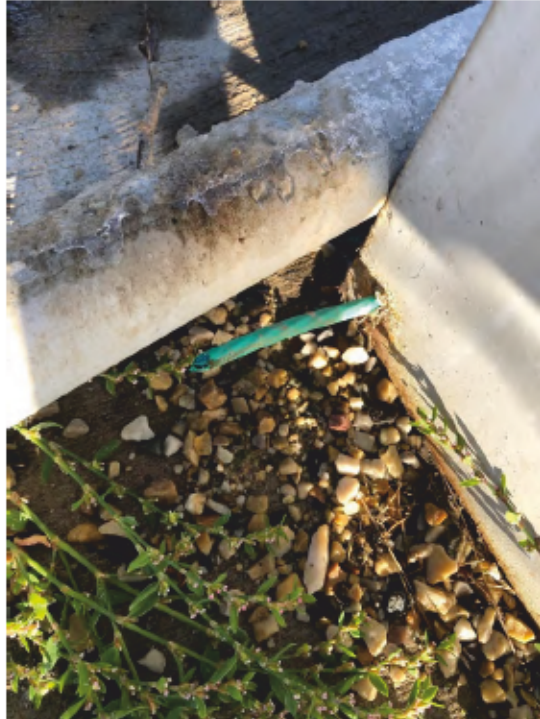
Photo 45: Disconnected Grounding Wire

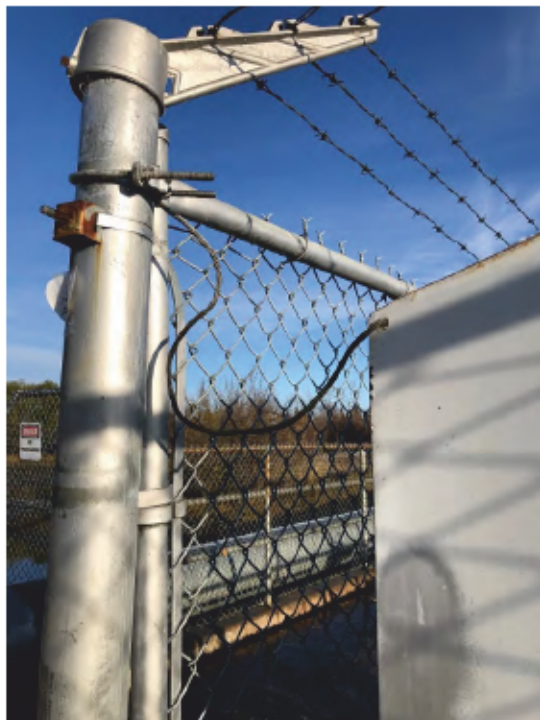
Photo 46: Fencing Bonding Cable

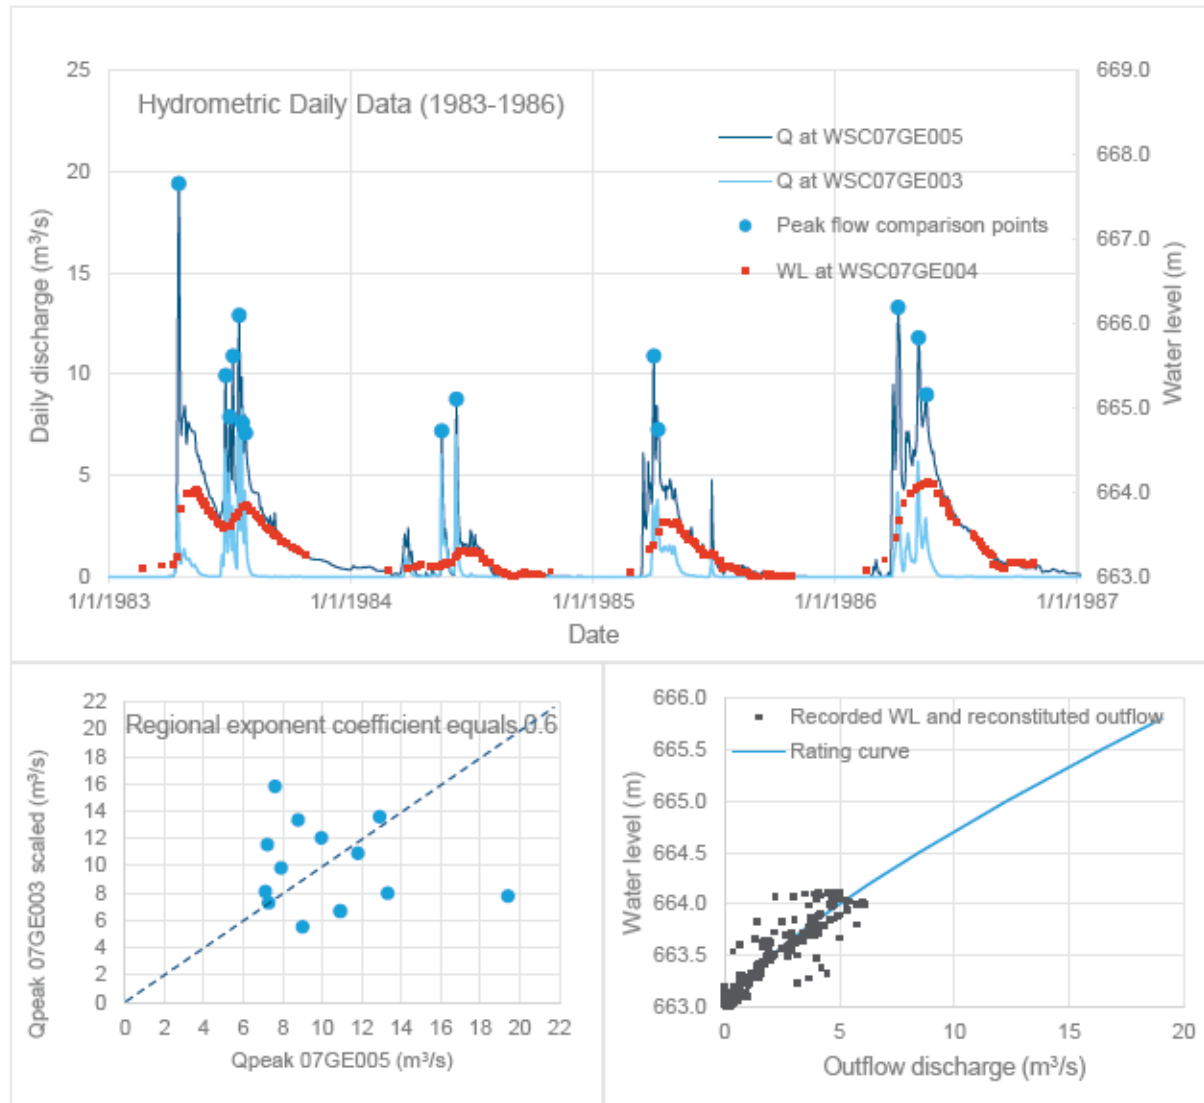
Figure III.4 Hydrometric Data and Bear Lake Rating Curve Assessment

1986. The hydrometric data and the results of the analyses are presented in **Figure III.4**. The reconstituted rating curve, which assumes conservatively that the discharge is free of backwater, indicated that the maximum discharge water level from the lake was of around 19 m³/s.

regional exponent coefficient of the equation was determined based on the recorded peak discharges at WSC 07GE005 and 07GE003 for the period 1983-1986 as shown in **Figure III.4**. A coefficient of 0.6 was found to produce the best transposition of peak discharges between watersheds (bottom left chart on **Figure III.4**).

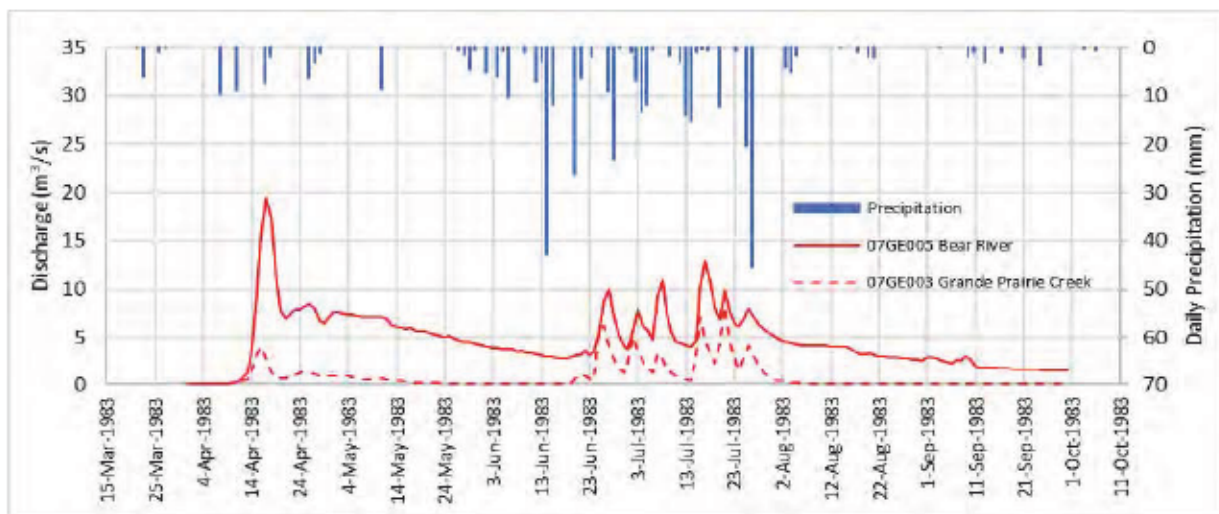
Figure III.5 1983 Bear River-Grande Prairie Creek Recorded Flow and Grande Prairie Airport Precipitation Data

Comparison of the available four years of flow data (1983 to 1986) between the Bear River at the Bear River Reservoir and the Grande Prairie Creek are shown in **Figures III.5** through **III.8**. As noted in the figures, the peak flows of the two stations match with a time difference of approximately one day. Moreover, the contribution of the Bear Lake outflows and the Grande Prairie Creek to the hydrograph at Bear River Reservoir are clearly identifiable. The difference of the two hydrographs, after scaling the flows recorded at WSC 07EG003 to the intermediate watershed down to the Bear River Reservoir, corresponds to the outflows of the Bear Lake.

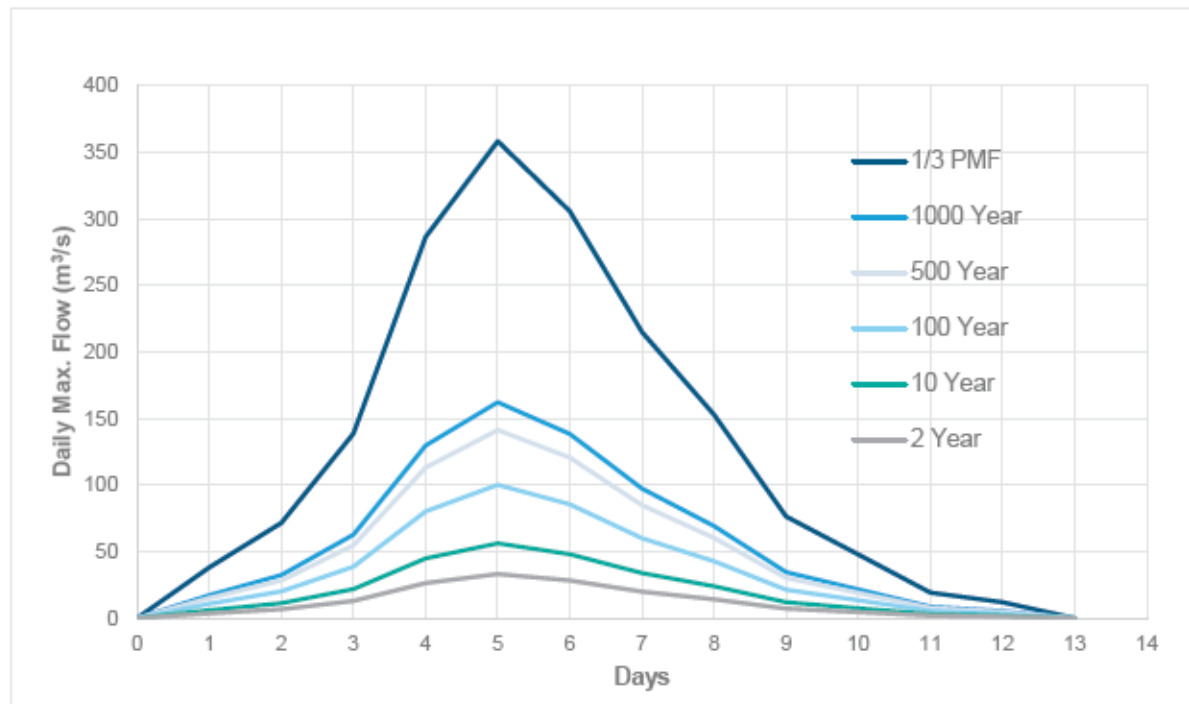
Figure III.9 Flood Hydrograph into Bear River Reservoir

The daily flows of the Bear River gauged data at Grande Prairie (1983 to 1986) were reviewed for the observed hydrographs. The review confirmed that the unit hydrograph considered in the 2014 DSR is representative of the observed hydrographs. This unit hydrograph from the 2014 DSR was used to scale up the various flood events for this study. **Figure III.9** presents the flood hydrograph into the Bear River Reservoir.

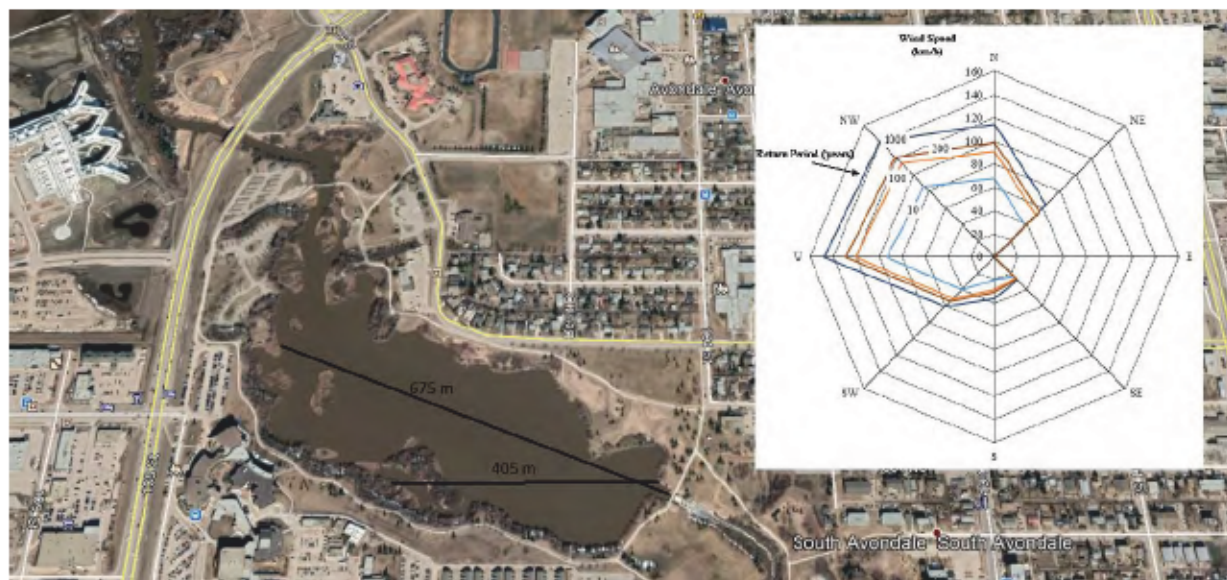
Figure V.1 Wind Rose and Fetch Length

The maximum wind speeds are expected to come from the West and Northwest. Therefore, the fetch length for the Bear River Reservoir was estimated to be about 405 m and 675 m, respectively, as shown in Figure V.1.
