# 2009 BEAR CREEK CORRIDOR OUTFALL INSPECTION REPORT

BEAR CREEK CORRIDOR  
GRANDE PRAIRIE, ALBERTA

PARKLAND GEOTECHNICAL LTD.

MARCH 16, 2010

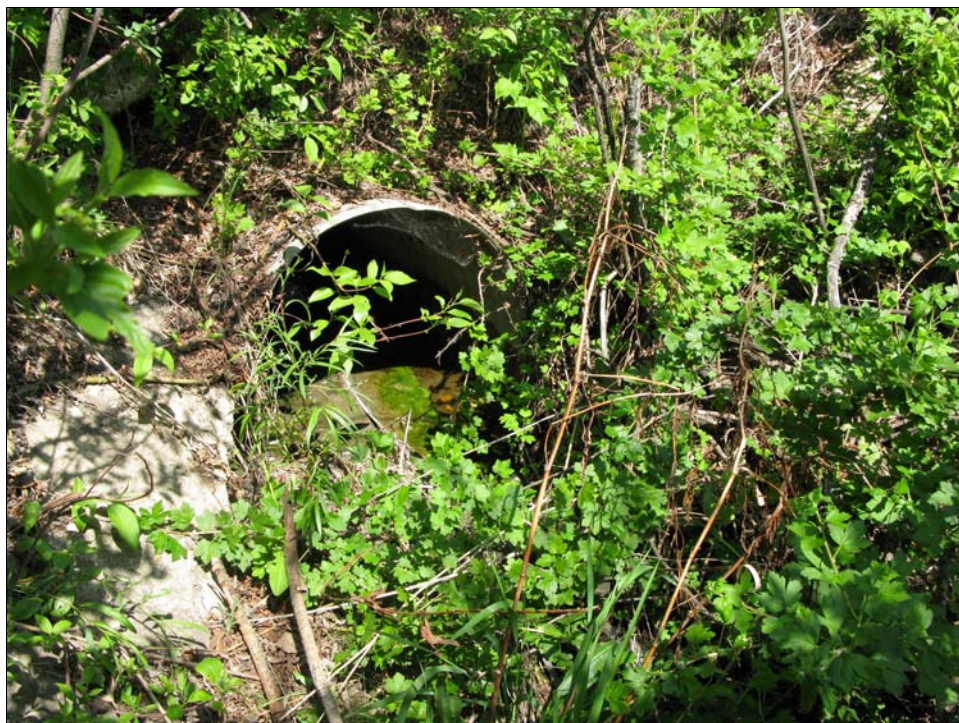
A concrete pipe and concrete debris is present near the outfall and it is unclear if this is an active pipe. A concrete vault is sitting above ground at this location.

**Photograph 1: Outfall #5 and thick vegetation.**

The estimated remedial cost is presented in Table 4 (Appendix B), and is expected to be about \$5000.

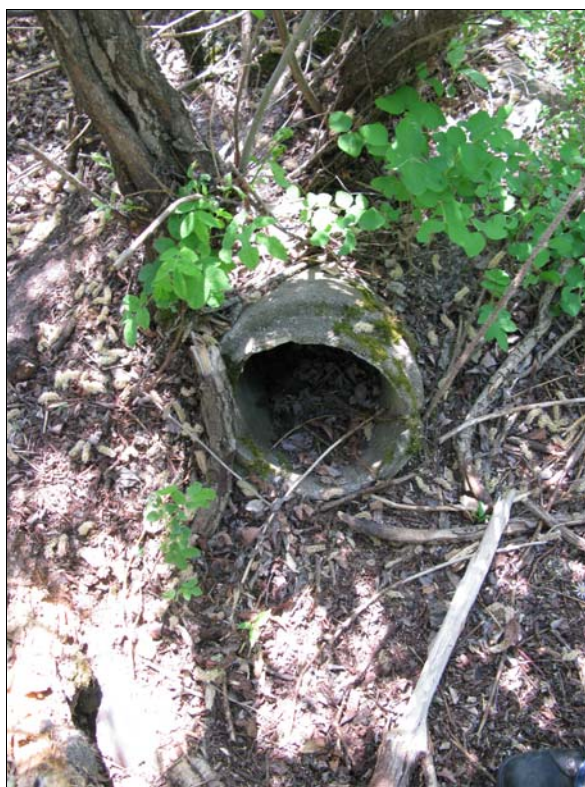
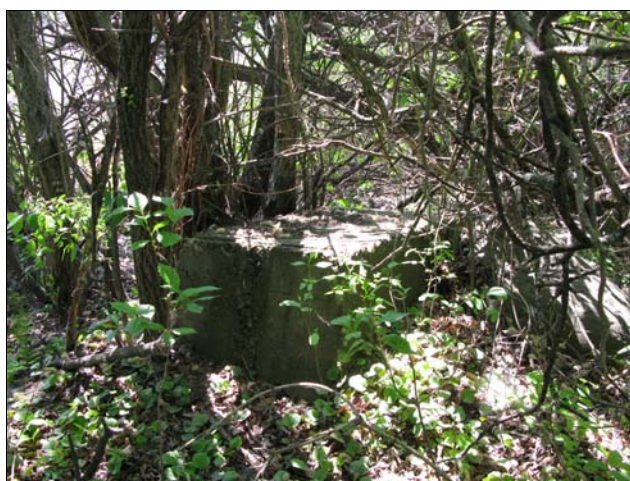
**Photographs 2 and 3: Showing buried concrete pipe of unknown purpose and a concrete vault both located in the trees near Outfall 5.**

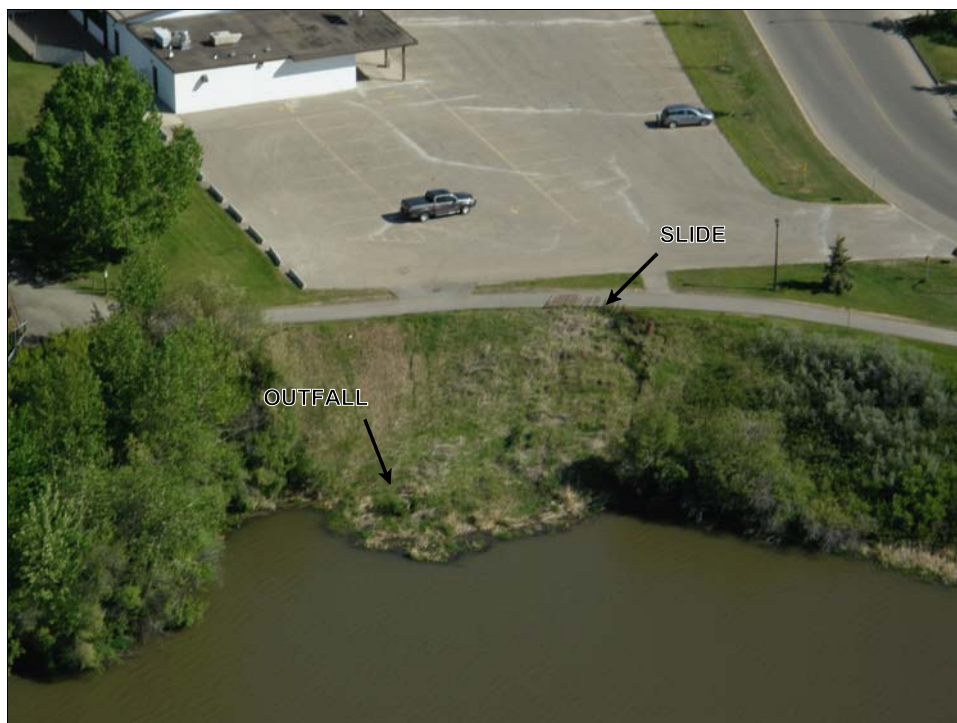
**Photograph 1: Outfall #7.**

Slope instability upslope of the outfall will cause distress to public pathway. Large slope movement will cause distress to outfall. Slope movement does not appear to be related to outfall. Recommendations for slope assessment provided in separate report.

The dense vegetation around the outfall is choking off growth. Hand thinning and possible re-planting of grass may be required. Total maintenance costs are estimated to be less than \$600.

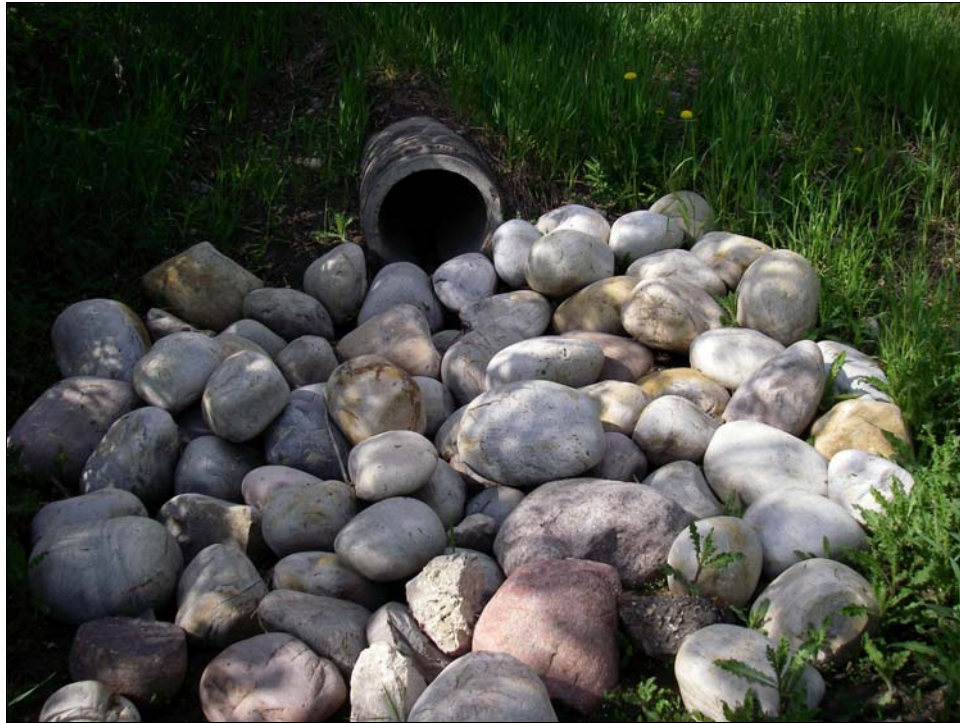
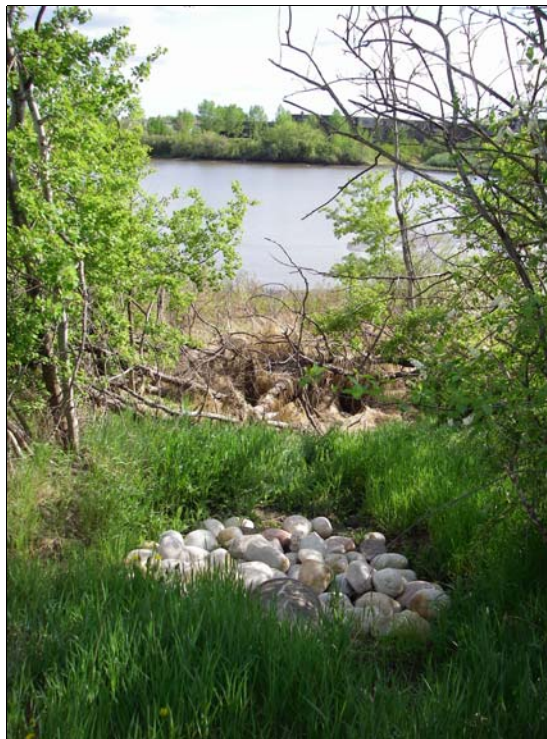
**Photograph 1: Outfall #8.**

**Photograph 2: Looking from the public path down to Outfall #8 and towards the Reservoir.**

Given the weed growth, spaying followed by re-seeding is recommended.

The cost of maintenance is estimated to be less \$2000, as presented in Table 6 (Appendix B).

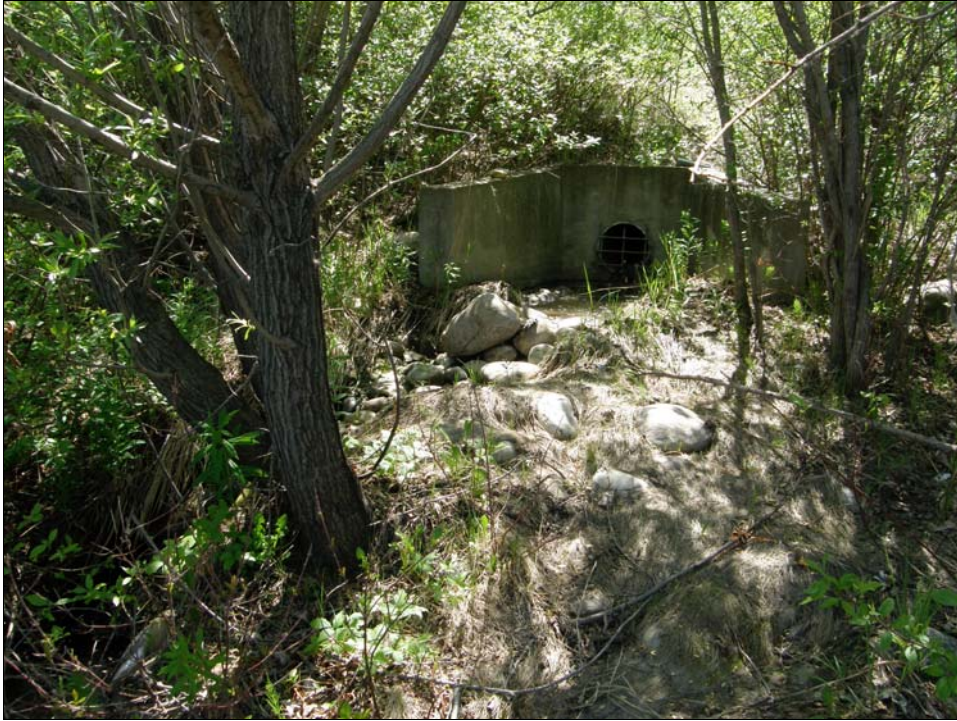
**Photograph 1: Outfall #10.**

The outfall apron is lined with rip-rap. Silt is building up with vegetation that should be cleared to improve the hydraulic performance. The cost for cleaning out the silt and vegetation is less than \$500.

A minor erosion gully is forming where the run off enters the reservoir. This should be monitored and erosion control matting installed if the erosion becomes worse.

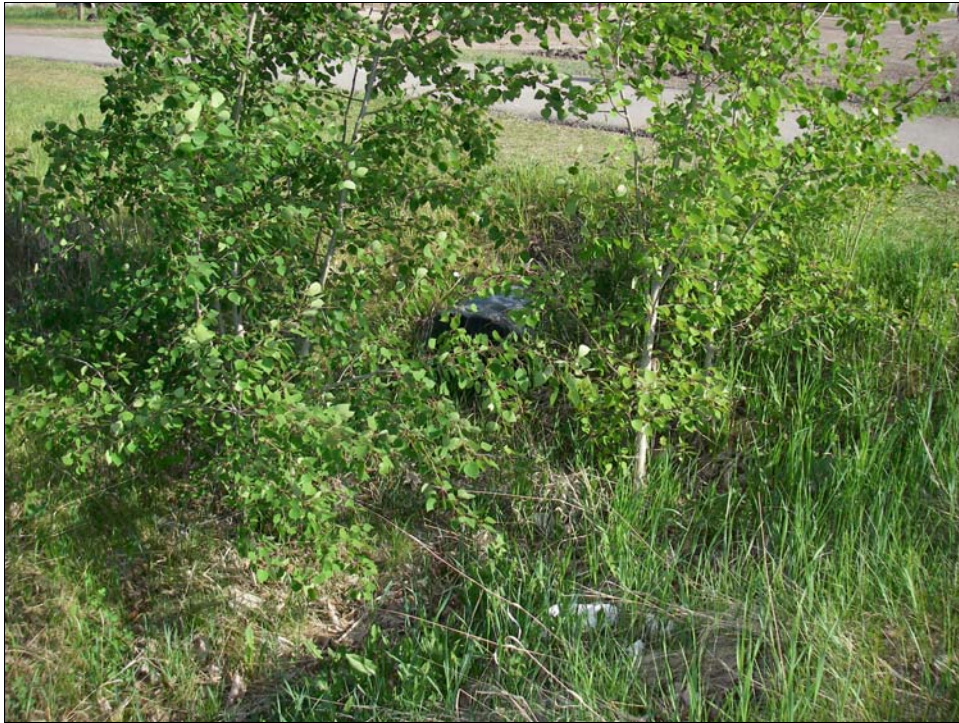
STORM SEWER OUTFALL SUMMARY			
Outfall No.	11	Drawing Ref.	Figure 2
Location (UTM)	0384674 6115758	Year	1982
Material	CSP	Diameter (mm)	595
Location Description	East of Outfall #10 and on the south side of the Reservoir		
Overall Condition		Comments	
Pipe Condition	Good		
Outfall Structure Condition	Good		
Gabions/Rip Rap Condition	Good		
Erosion by River	No		
Erosion by Sewer Flow	No		
Debris Present	Yes	-vegetation surrounding pipe	
Safety Hazard Identified	No		
Surrounding Slope	Stable		
Maintenance Required	Yes	-vegetation should be removed/thinned from pipe flow path	
Rehabilitation Required	No		
Access Restrictions	No		
Priority	2

**Photograph 1: Outfall #11 located east of the GPRC campus. A paved path is located immediately south of the outfall.**

Minor vegetation clearing/thinning recommended to ensure unrestricted flow. Only minor hand clearing required. The cost of clearing is estimated at less than \$500.

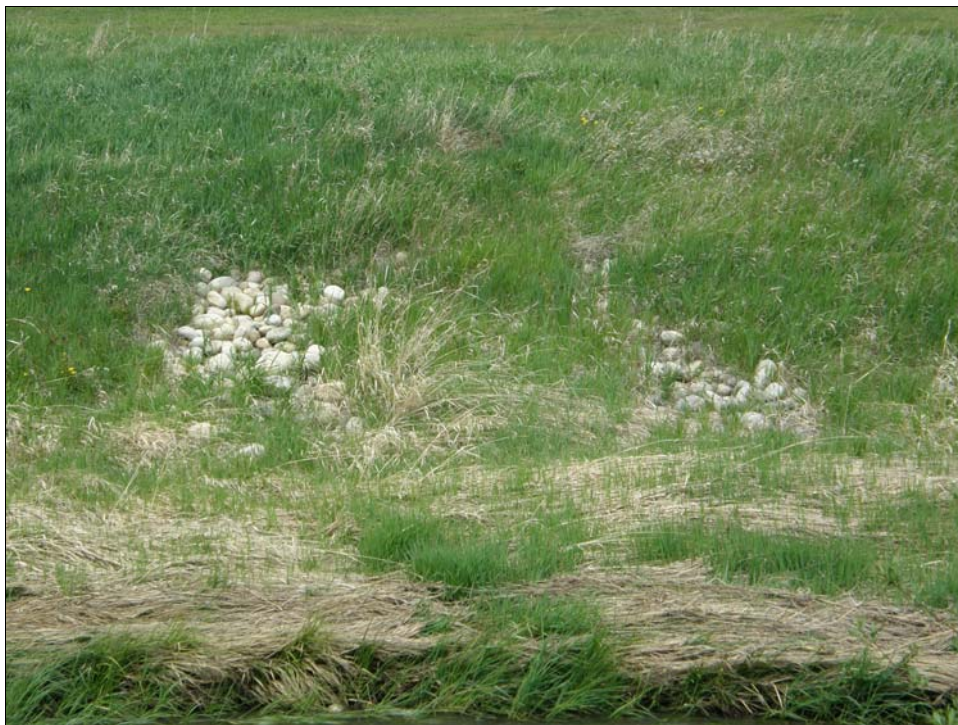
**Photograph 1: Expected location of Outfall #12.**

STORM SEWER OUTFALL SUMMARY			
Outfall No.	12	Drawing Ref.	Figure 3
Location (UTM)	0384895 6115821	Year	1977
Material	CONC	Diameter (mm)	450
Location Description	East of the Reservoir and south of 106 Ave.		
Overall Condition		Comments	
Pipe Condition	Unknown	-pipe covered by rip rap	
Outfall Structure Condition	Fair		
Gabions/Rip Rap Condition	Good		
Erosion by River	No		
Erosion by Sewer Flow	No		
Debris Present	Yes	-pipe covered by rip rap	
Safety Hazard Identified	No		
Surrounding Slope	Stable		
Maintenance Required	Yes	-rip rap should be removed to expose pipe	
Rehabilitation Required	No		
Access Restrictions	No		
Priority	2

Pipe should be uncovered as the pipe cannot be visually located. Hand positioning of rip-rap required and is expected to cost less than \$500.

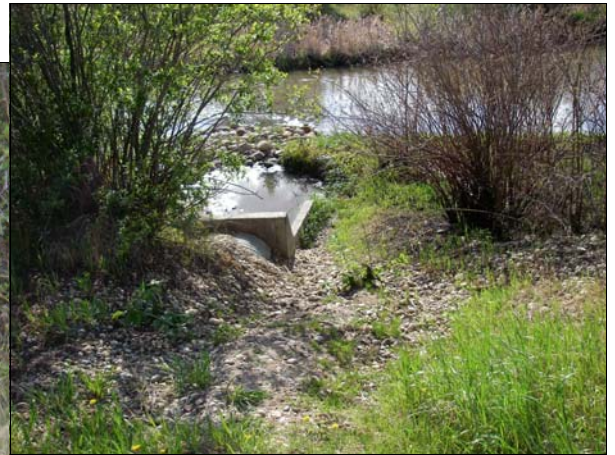
**Photographs 1 and 2: Outfall #13 with garbage present within pipe. Water is flowing below the pipe due to corrosion of pipe invert and is likely contributing to the scour below the apron.**

Complete replacement of the CSP pipe to the manhole structure located approximately 20 m to the north is required, but camera inspection of the lines upgradient from the last manhole is recommended. A liner may be considered rather than complete removal and replacement, provided the voids below the invert are grouted to provide adequate support.

The cost of the remedial work is presented in Table 7 (Appendix B), and is estimated to cost about \$56,500.

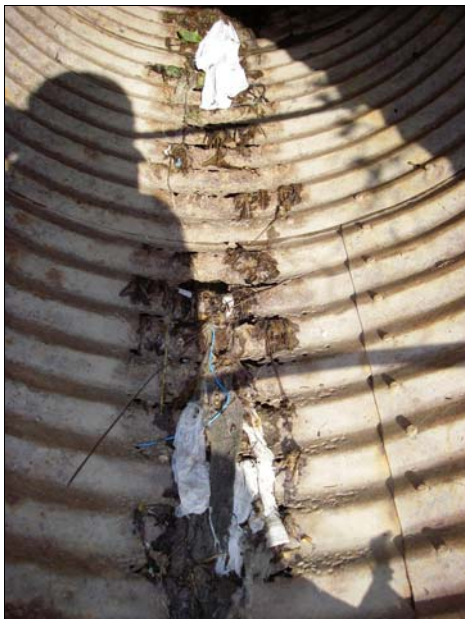
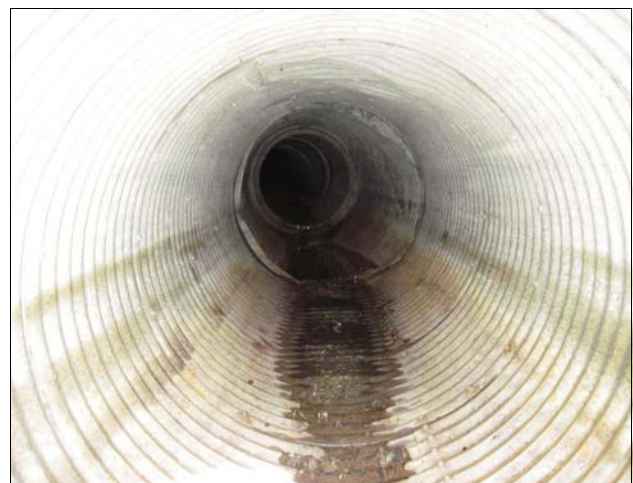
**Photographs 3 and 4: Corroded CSP. All water flow was occurring below the pipe within the bedding material. The pipe joints appear damaged and the pipe is not straight.**

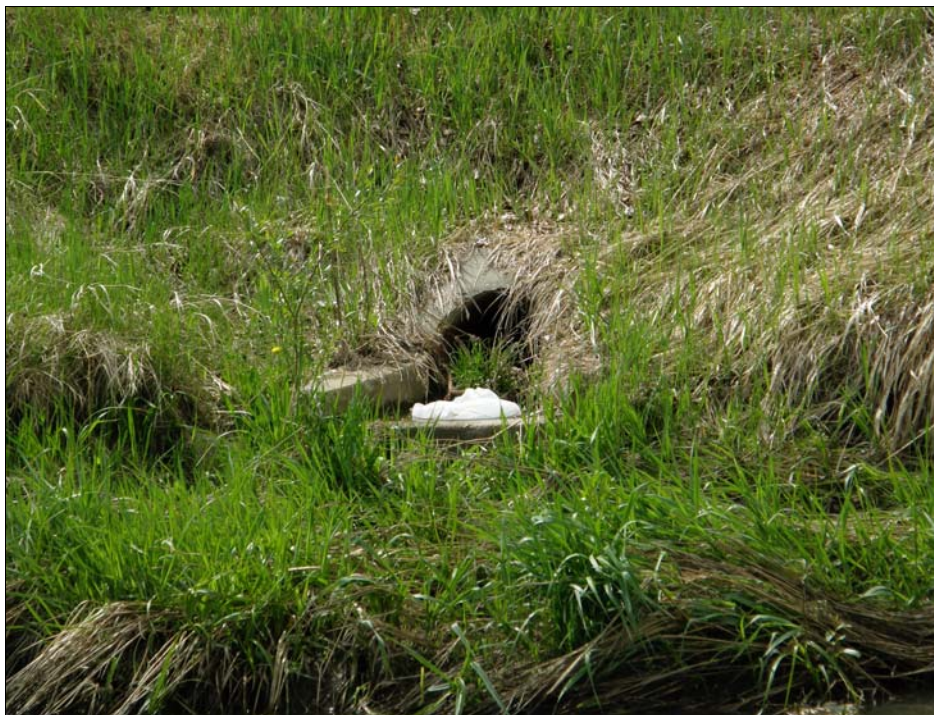
**Photograph 1: Outfall #15 showing garbage on the apron and the slump block in the foreground.**

Alternatively, a new line could be installed to divert sewer flow to Outfall 17 and this structure could be decommissioned. This would likely be more costly but would remove long term maintenance costs associated with this structure

The cost of the remedial work is presented in Table 8 (Appendix B), and is estimated to cost about \$40,000.

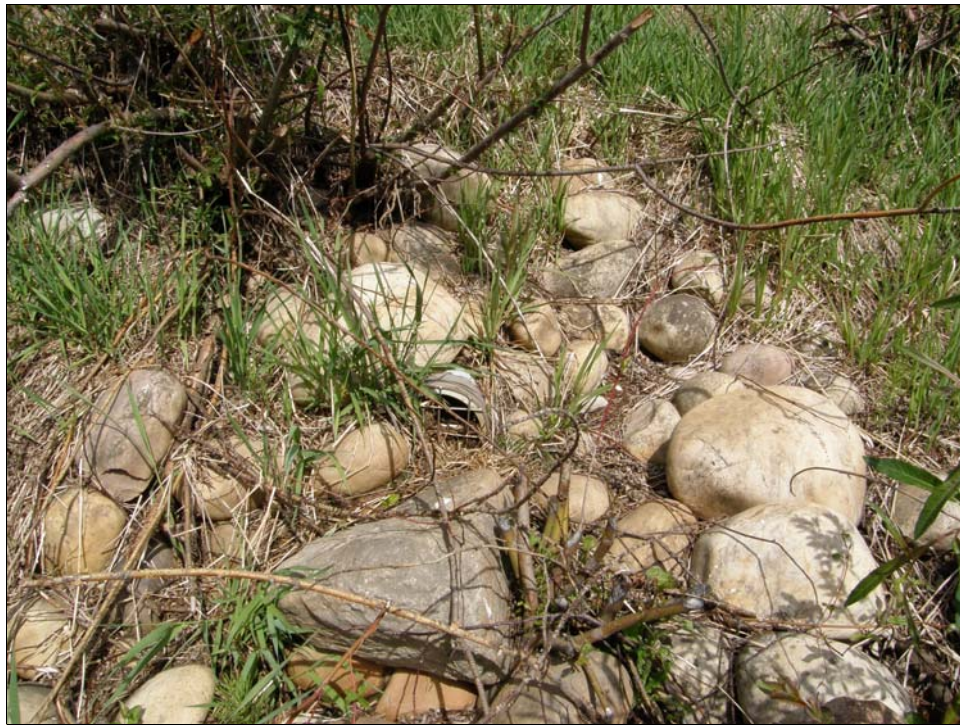
**Photograph 1: Outfall #16 showing partial pipe blockage and vegetation growth.**

Hand clearing of rip rap, organic matter and silt build-up from pipe and immediate outflow area required.

The estimated cost of thinning vegetation and hand adjustment of the rip-rap is less than \$500.

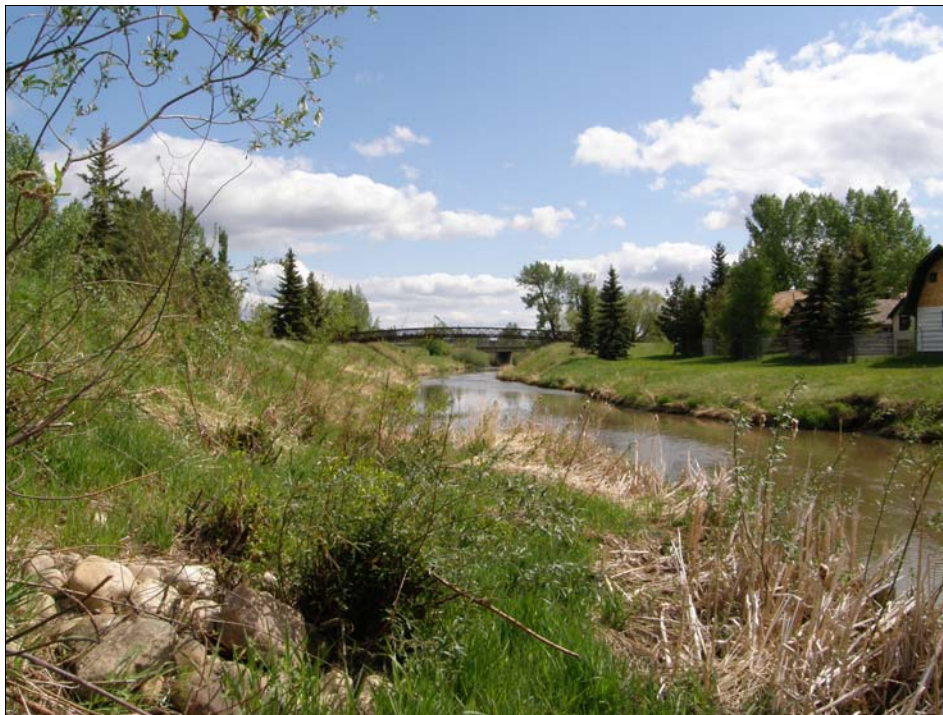
**Photograph 2: looking south along Bear Creek with the edge of the outfall rip-rap in the bottom left.**

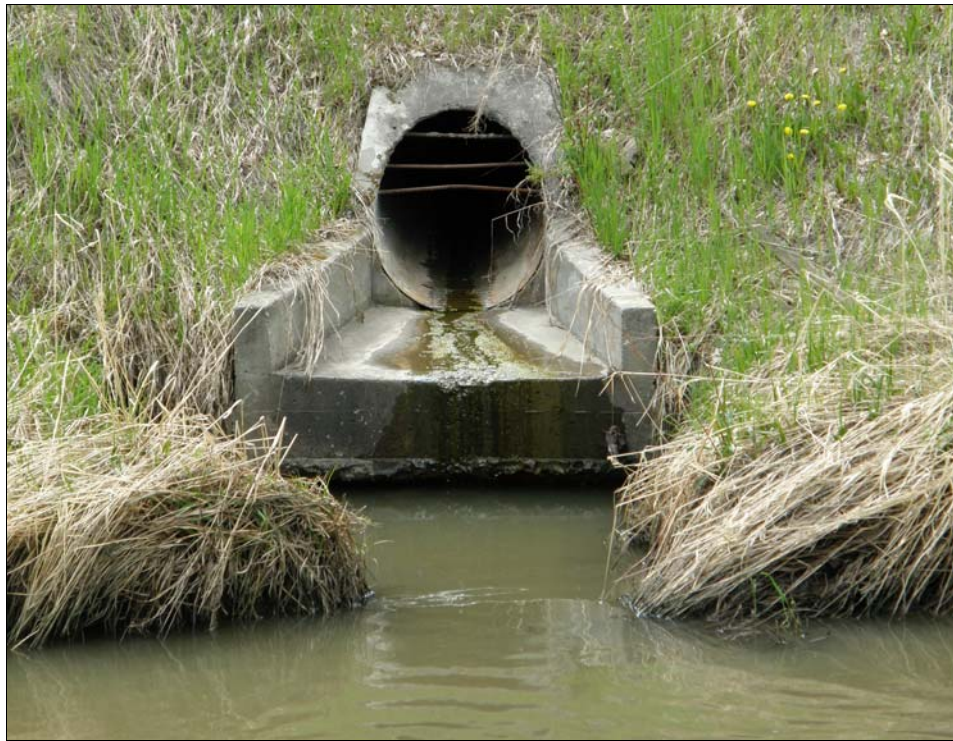
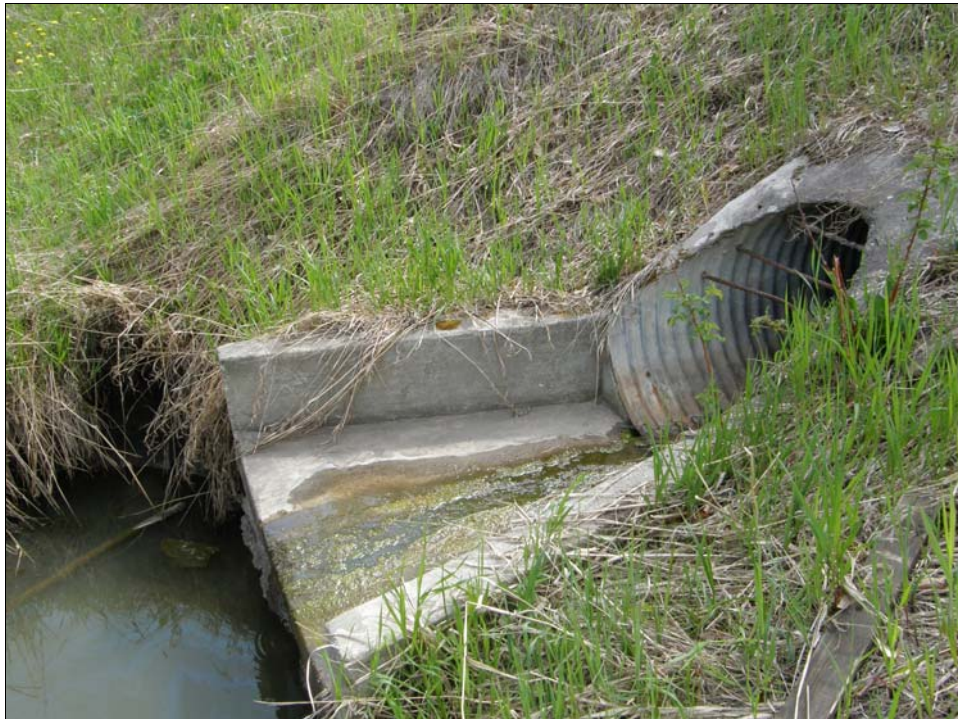
**Photograph 2: Outfall #17.**

STORM SEWER OUTFALL SUMMARY			
Outfall No.	17	Drawing Ref.	Figure 3
Location (UTM)	0384917 6115391	Year	1967
Material	CSP	Diameter (mm)	525
Location Description	West of Bear Creek and north of 101 Ave.		
Overall Condition		Comments	
Pipe Condition	Good		
Outfall Structure Condition	Fair		
Gabions/Rip Rap Condition	None		
Erosion by River	Yes		
Erosion by Sewer Flow	No		
Debris Present	No		
Safety Hazard Identified	No		
Surrounding Slope	Stable		
Maintenance Required	No		
Rehabilitation Required	Yes		
Access Restrictions	No		
Priority	2

**Photograph 1: Outfall #17 with undercutting.**

Stream flow is undercutting the concrete apron. A gabion blanket or high performance geosynthetic turf reinforcement mat should be placed between edge of apron and the edge of river. Concrete may need to be placed below the apron to provide support if erosion extends more than 300 mm below the structure.

The cost of the erosion control remedial work is presented in Table 9 (Appendix B), and is estimated to cost about \$2,200.

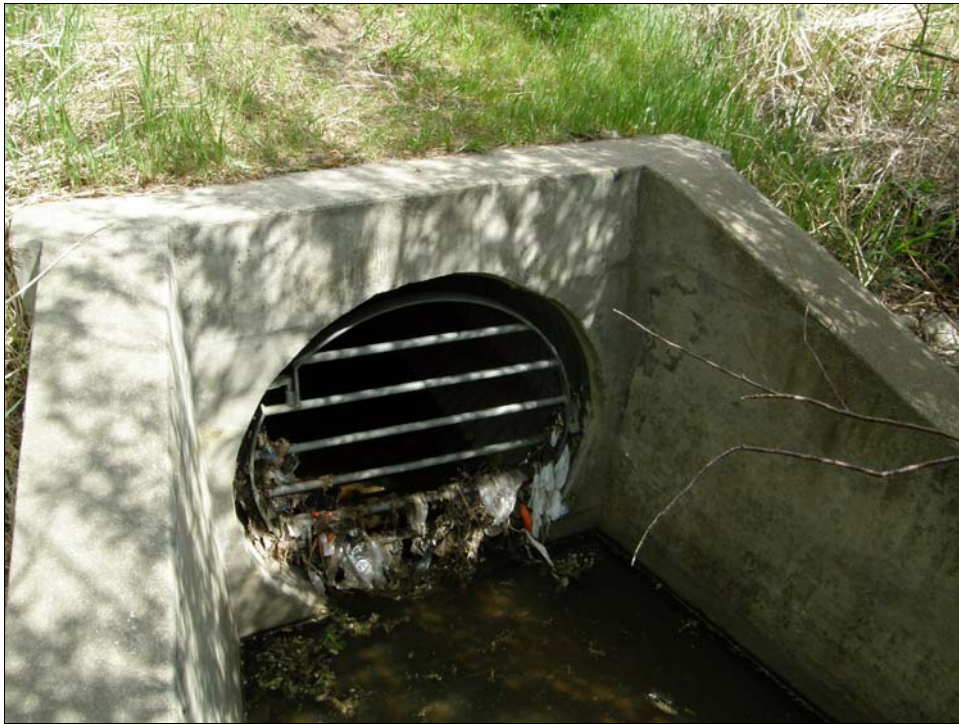
**Photograph 1: Outfall #18.**

STORM SEWER OUTFALL SUMMARY			
Outfall No.	18	Drawing Ref.	Figure 3
Location (UTM)	0384936 6115251	Year	1984
Material	CSP	Diameter (mm)	1200
Location Description	East of Bear Creek and north of 100 Ave.		
Overall Condition		Comments	
Pipe Condition	Good		
Outfall Structure Condition	Good		
Gabions/Rip Rap Condition	Good		
Erosion by River	No		
Erosion by Sewer Flow	Yes	-minor erosion	
Debris Present	Yes	-garbage present within pipe, on grate	
Safety Hazard Identified	No		
Surrounding Slope	Stable		
Maintenance Required	Yes	-garbage should be removed	
Rehabilitation Required	Yes	- minor removal of silt debris but can be delayed until a more significant build-up occurs.	
Access Restrictions	No		
Priority	2

Grass and collected sediment should be cut back from the end of the outfall to improve hydraulic performance. The area between the concrete apron and the creek should be cut down, and re-vegetated. This work can be delayed for up to 3 years.

Garbage should be removed from the grate.

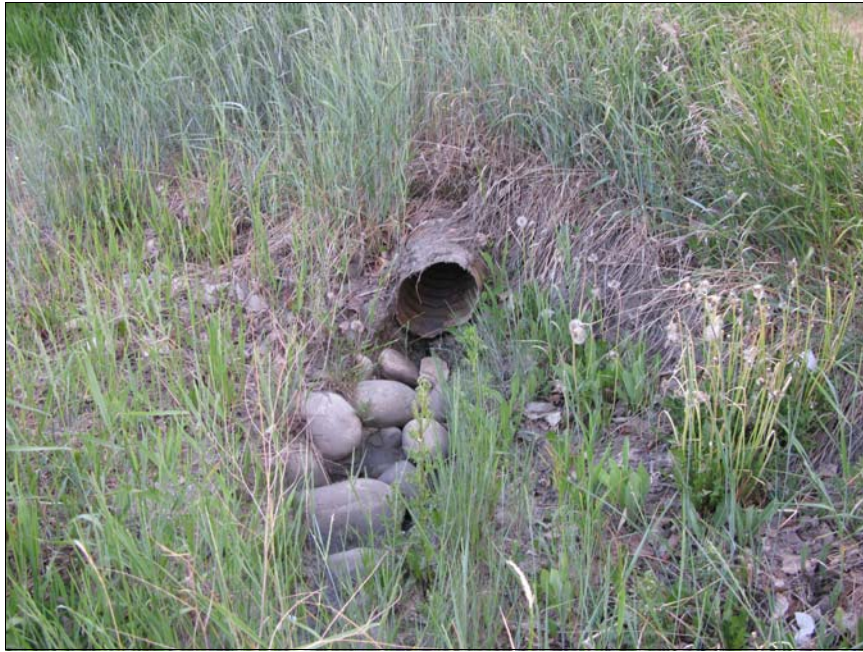
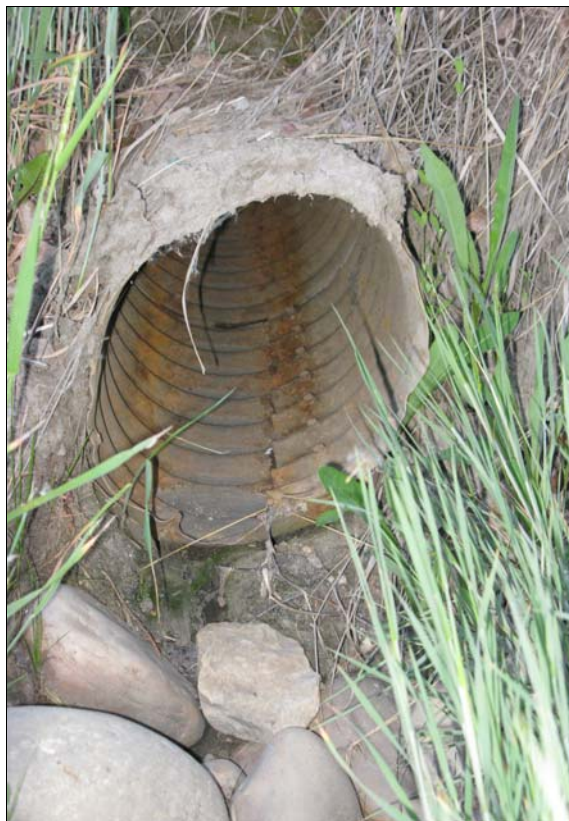
**Photograph 1: Outfall #19.**

**Photograph 2: Slightly rusted pipe.**

The area around the pipe discharge should be sub-excavated, new topsoil and seed applied and an erosion control matting installed to promote a proper vegetative mat to be established.

The cost of the erosion control remedial work is presented in Table 10 (Appendix B), and is estimated to cost about \$4,000. It may be more economical to delay this repair until replacement of the sewer line is necessary.

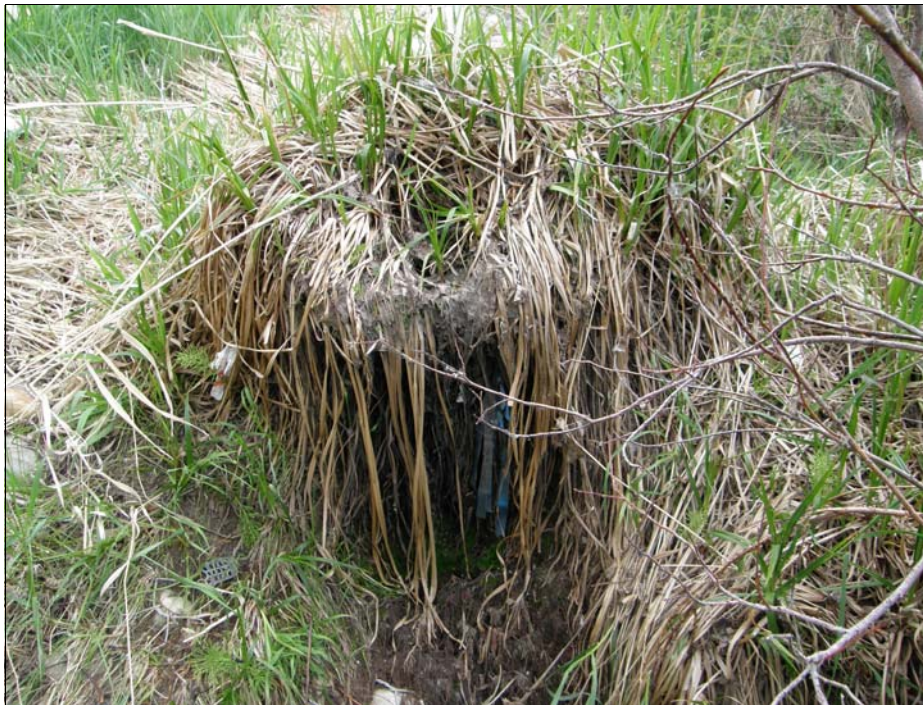
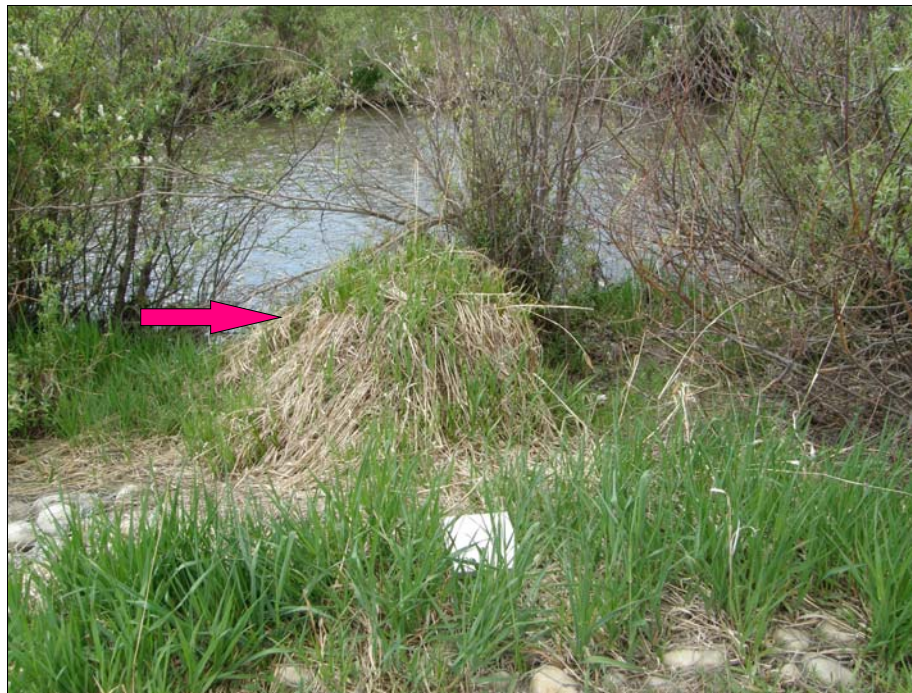
**Photograph 2: Outfall #20.**

The end of the pipe could not be found but is presumed to be blocked. Sediment has pushed through a clean-out manhole. Once cleared out, the manhole and pipe need to be re-inspected.

**Photograph 1: Suspected location of Outfall #20, or clean-out manhole immediately before the outfall.**

The cost of the cleaning and re-inspection work is presented in Table 11 (Appendix B), and is estimated to cost about \$5,000.

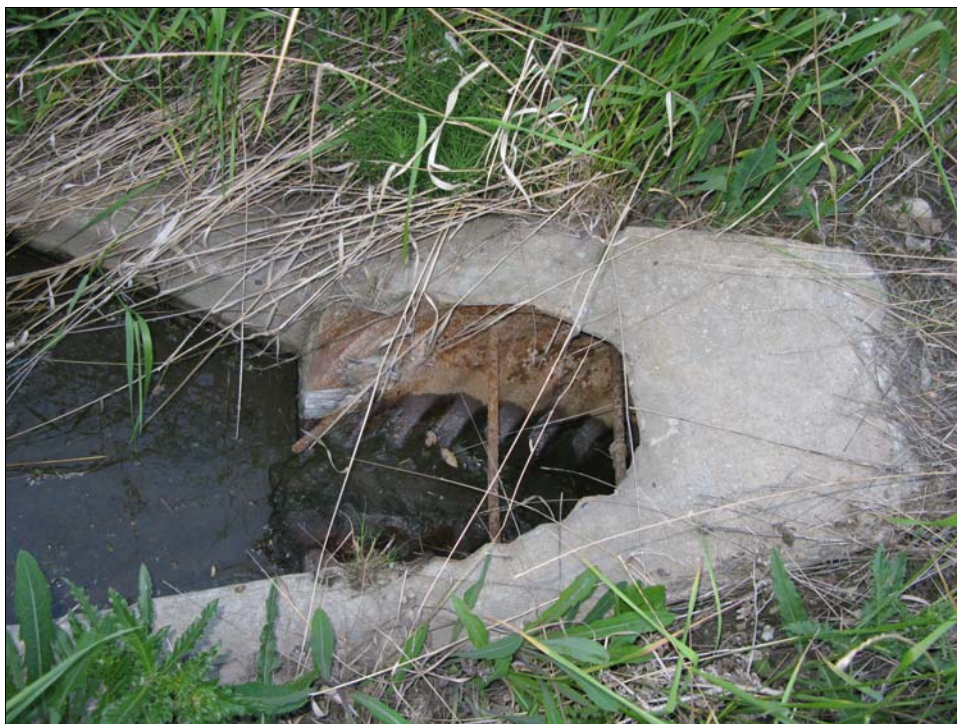
**Photograph 1: Outfall #21.**

STORM SEWER OUTFALL SUMMARY			
Outfall No.	21	Drawing Ref.	Figure 3
Location (UTM)	0384960 6115201	Year	1973
Material	CSP	Diameter (mm)	300
Location Description	West of Bear Creek, within 99 Ave. ROW		
Overall Condition		Comments	
Pipe Condition	Good	-pipe is slightly rusted	
Outfall Structure Condition	Good		
Gabions/Rip Rap Condition	None	- No gabions or other erosion control is present.	
Erosion by River	No		
Erosion by Sewer Flow	Yes	-minor erosion is present to side of outfall	
Debris Present	No		
Safety Hazard Identified	No		
Surrounding Slope	Stable		
Maintenance Required	No		
Rehabilitation Required	No		
Access Restrictions	No		
Priority	4

Continued monitoring is recommended, particularly to check for pipe corrosion. A camera inspection may be necessary within the next 3 years as the pipe is likely nearing the end of its expected life span.

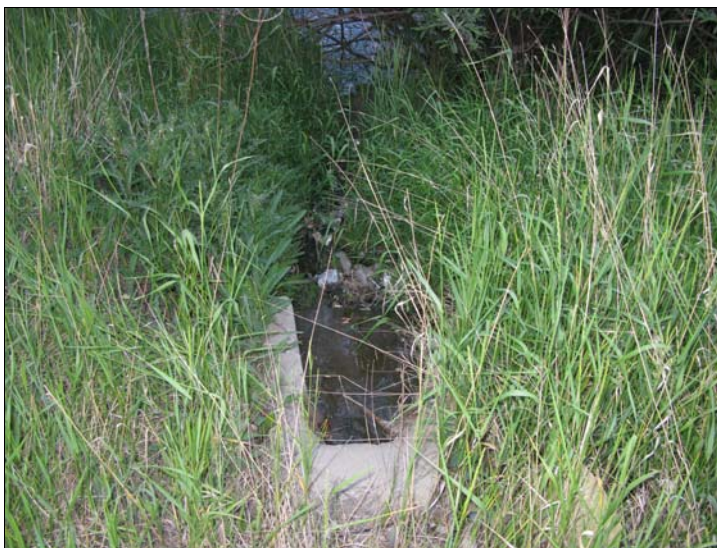
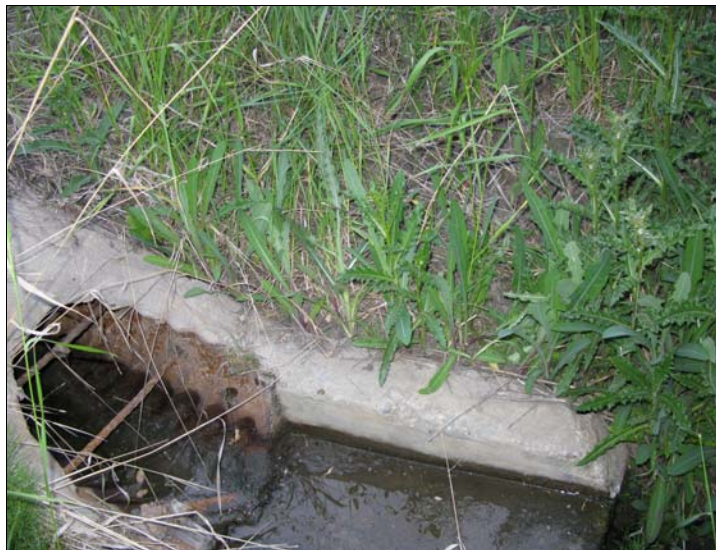
There is a very narrow erosion channel leading down from the apron to the creek that could be infilled with gravel but given the age of the structure and minor nature of the erosion, the work could likely be delayed until such time that the structure needs replacement.

**Photographs 2 and 3: showing the small erosion channel leading down to the creek and the sparse vegetation and weed growth to the sides.**

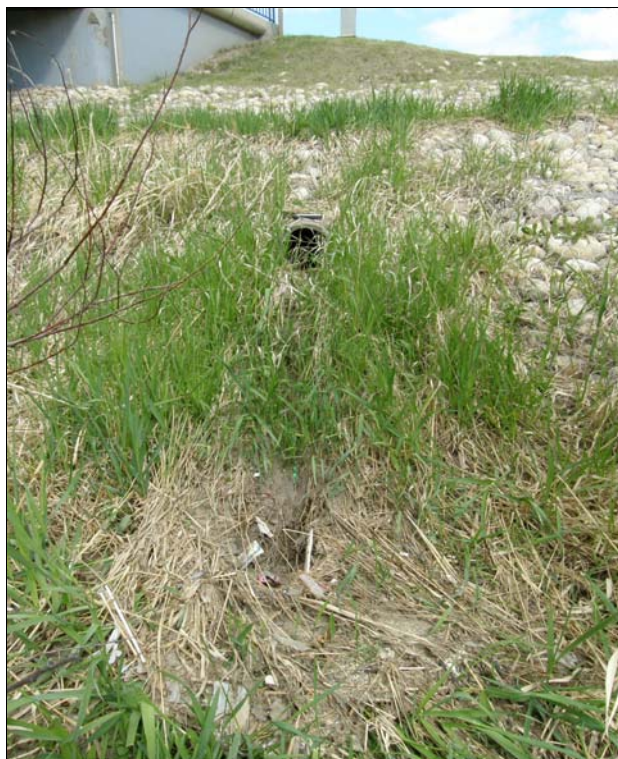
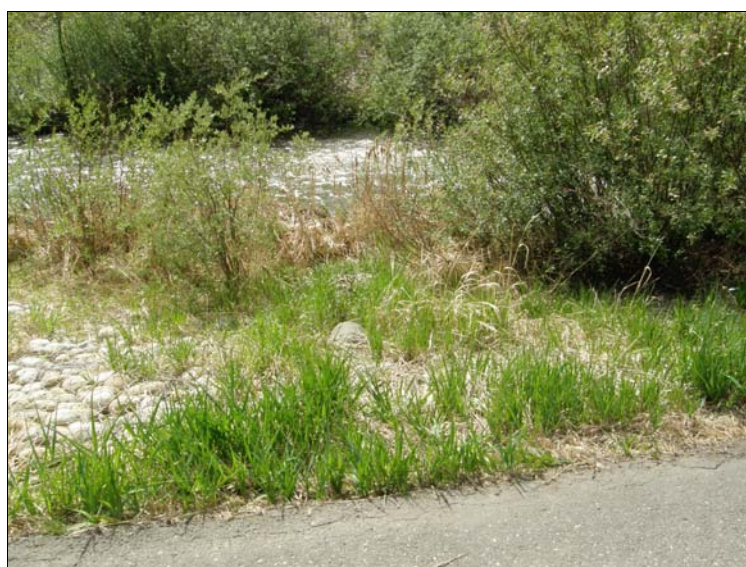
**Photographs 2 and 3: Looking upslope and downslope of the outfall. The rip rap areas are generally poorly vegetated but do not show signs of erosion.**

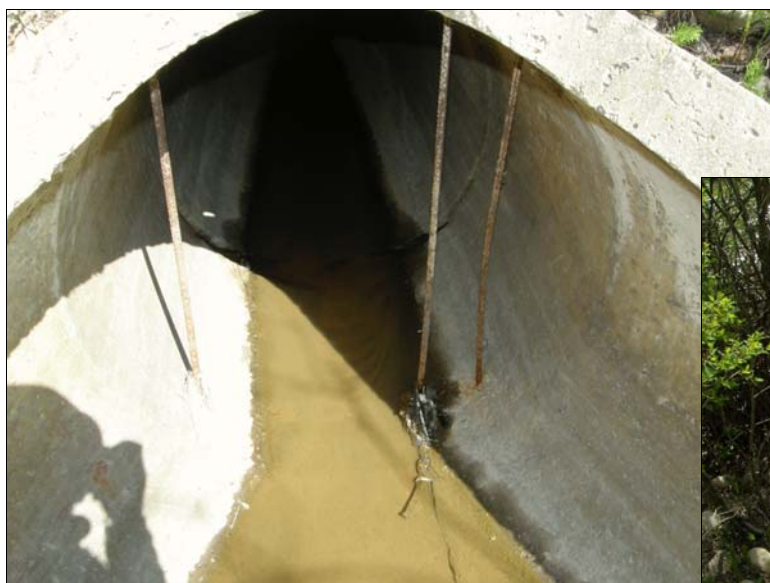
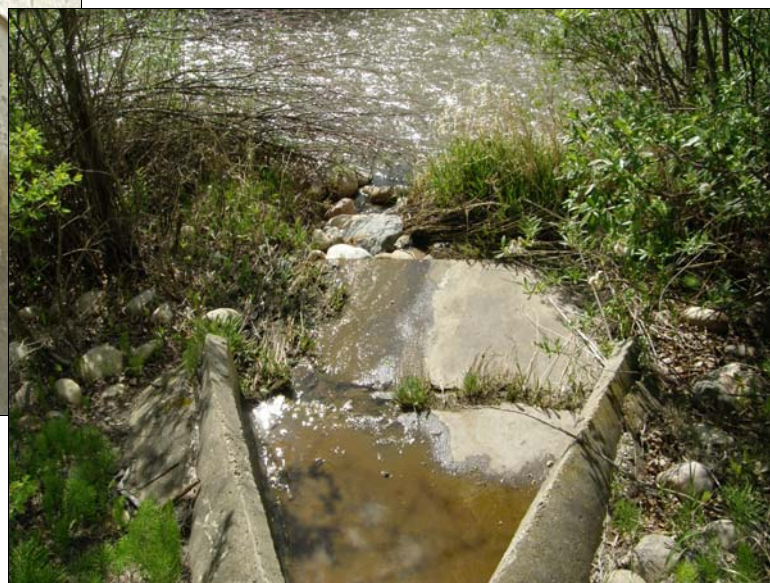
The outfall structure is in good condition, with only one security grate missing from the pipe. Given the potential of vandalism, consideration to installing a new bar to close the pipe opening is recommended.

The slope above the outfall structure leading up to the paved bike path is covered with large rip-rap which is in good condition but there is moderate weed growth and minimal grassy vegetation. Consideration should be given to removing the rip rap, replacing the topsoil and installing an erosion control blanket to help secure a grass vegetation cover.

**Photographs 1 & 2: Outfall #23 with a partially damaged security grate and apron leading down to Bear Creek.**

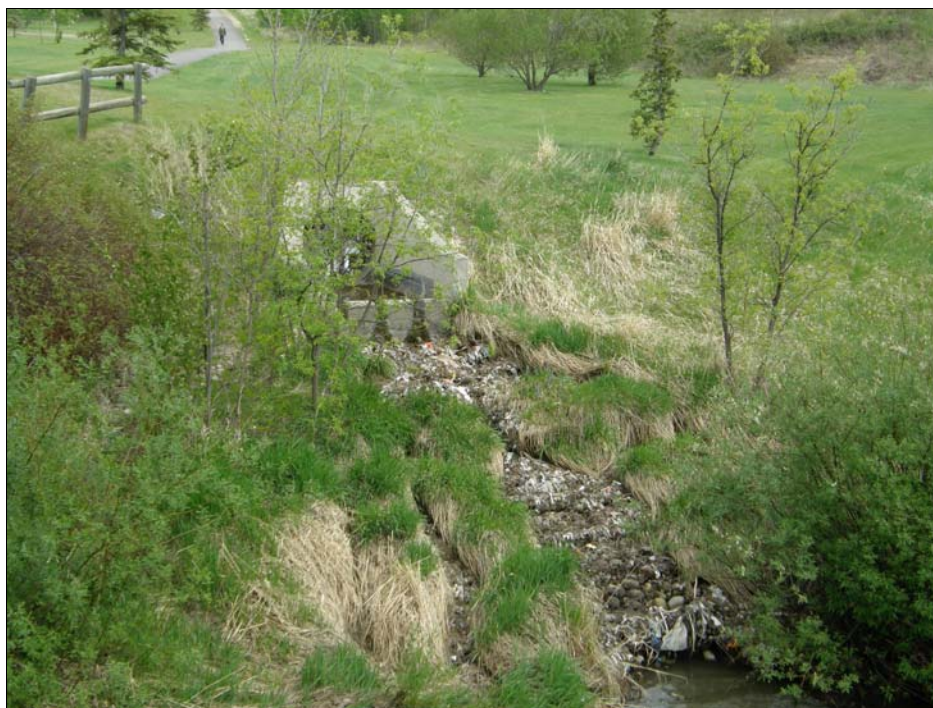
Reconstruction of the erosion control measures is recommended to minimize siltation of the creek, and minimize the potential of a landslide triggered by uncontrolled sewer flow. The overall structure is in excellent condition. The recommended remedial work would include:

**Photograph 1: Looking east from the pedestrian bridge at Outfall #24. The erosion channels are visible to the north and south of the main channel. Garbage is visible along the length of the channel.**

- Excavate and remove all existing erosion control gabions;
- excavate and re-contour the slope below the apron to remove erosion channels;
- install a gabion blanket immediately below the apron;
- install new topsoil and grass seed throughout the remedial area;
- cover the main discharge channel with high performance turn reinforcement mat which should extend into Bear Creek; and
- plant aquatic vegetation in the fringe where the flow channel enters the creek.

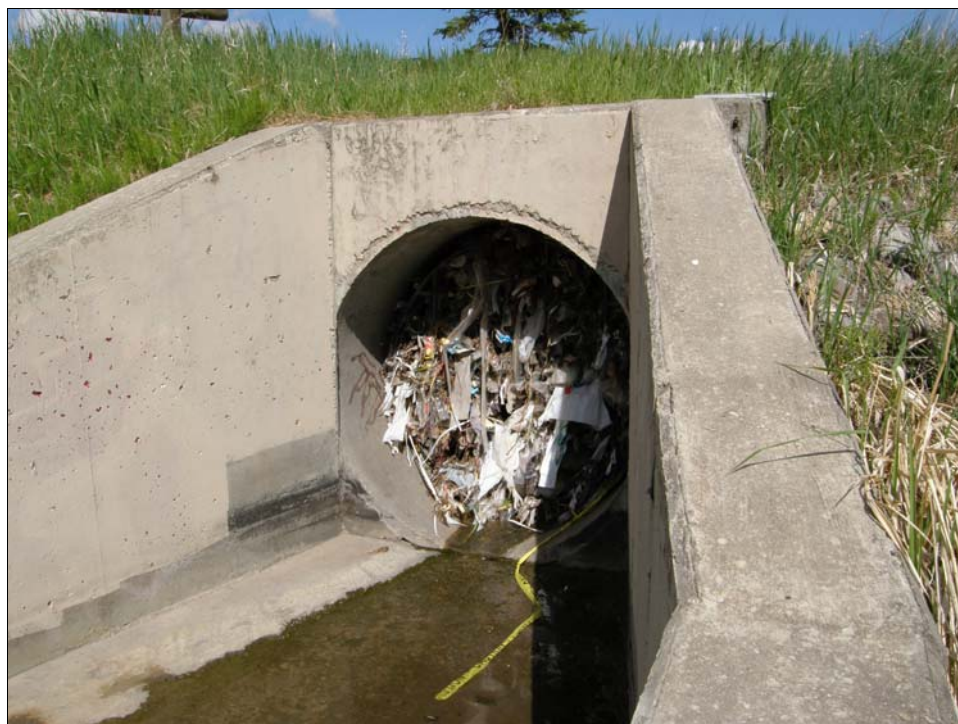
**Photograph 2: Large amounts of garbage were present in the pipe.**

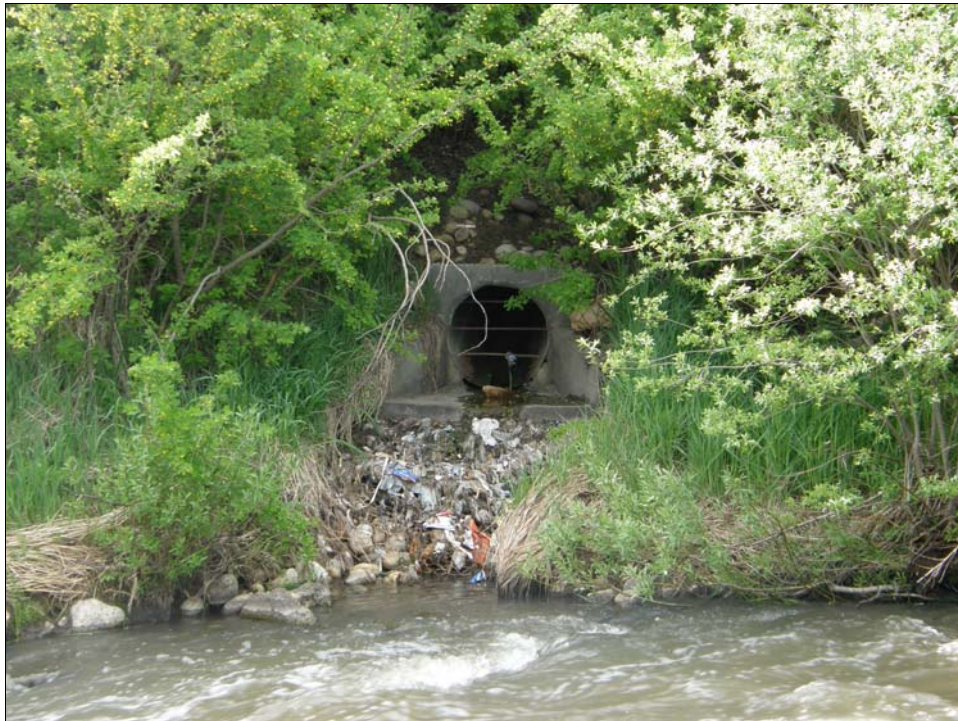
Minor clearing of plastic debris recommended. Closer inspection of the outfall recommended but thinning of the underbrush would be required.

**Photograph 1: Looking west at Outfall #25 as viewed from the pedestrian bridge.**

Periodic yearly inspection to monitor for erosion and garbage debris is recommended.

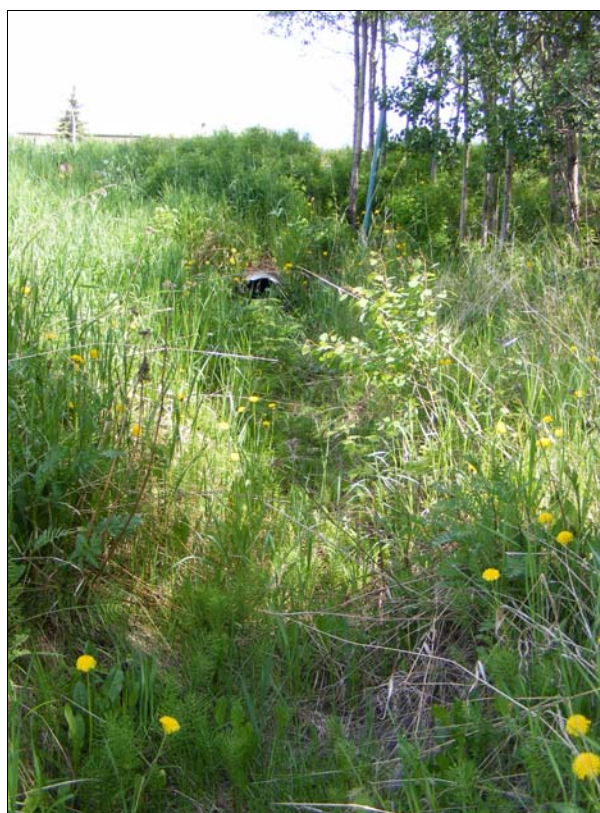
Outfall looks to have only minimal flow. Periodic inspection to assess for changes over time is recommended. A small gully has formed below the outfall, about 200 mm deep but it is well vegetated and is not currently eroding.

**Photograph 2: showing the slope leading down from the outfall discharge with a shallow erosion channel approximately 200 mm deep but well vegetated. Minor weed growth visible.**

Removal of the old CSP culvert lying in the grass above the outfall is recommended.

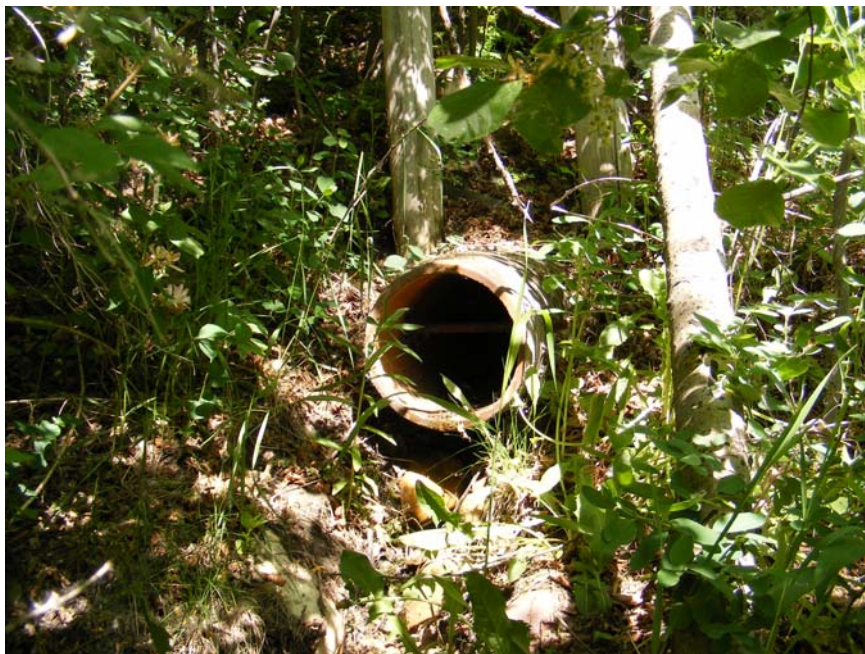
**Photograph 1: Outfall #27.**

This outfall only has 2 catch basins feeding into it. The flow volume is relatively low and the discharge point is well above Bear Creek, with any flow directed into the trees located on the uppermost valley wall.

Minor erosion was observed below the pipe but given the very steep slope and thick vegetation tree cover, establishing additional vegetation or rip-rap facing would be very difficult. It is recommended that the slope be inspected for erosion damage every 2 years but long term consideration should be given to complete decommissioning of this outfall and directing drainage to 101 A Street.
