# 2009 BEAR CREEK CORRIDOR OUTFALL INSPECTION REPORT

BEAR CREEK CORRIDOR  
GRANDE PRAIRIE, ALBERTA

PARKLAND GEOTECHNICAL LTD.

MARCH 16, 2010

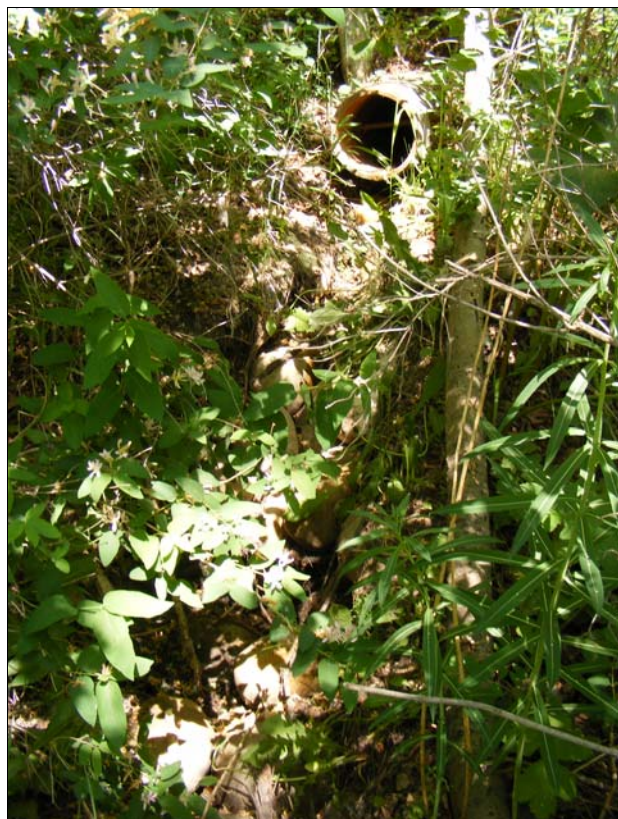
Minor erosion was observed below the pipe but given the very steep slope and thick vegetation tree cover, establishing additional vegetation or rip-rap facing would be very difficult. It is recommended that the slope be inspected for erosion damage every 2 years but long term consideration should be given to complete decommissioning of this outfall and directing drainage to 101 A Street.

**Photograph 2: Steep slope leading down from the outfall, with coarse rip rap embedded in the slope.**

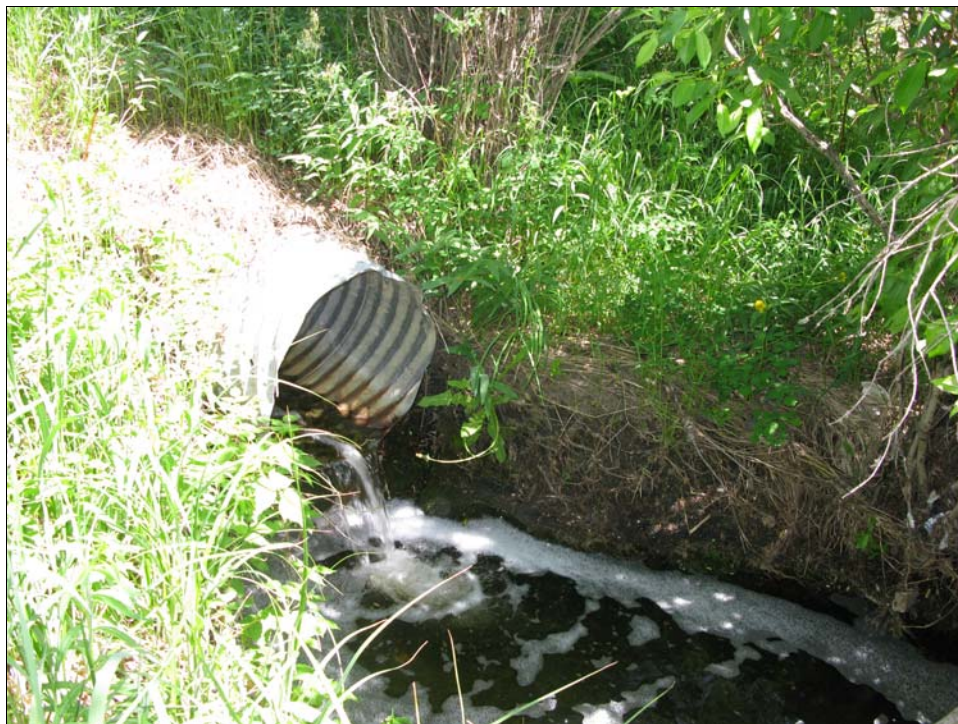
The CSP outfall is in good condition but the observed water flow is significantly higher than expected given that only 2 catch basins feed into this outfall. The foam on the water suggests a potential discharge from a sanitary sewer connection. It is also possible that the City GIS drawing is inaccurate and that Outfalls 28 and 29 have been mis-labeled. A detailed inspection, possibly including CCTV is recommended.

A relatively deeply incised channel leads downslope from the outfall. This erosion channel should be backfilled and erosion control measures installed as the present sewer flow may be sufficient to cause downcutting and lead to slope instability.

**Photograph 1: Outfall #28 and eroded trench.**

- Hand clearing of fallen trees and dead vegetation;
- backfilling the channel with gravel fill;
- add topsoil and grass seed; and
- install erosion control matting suitable for steel slope applications.

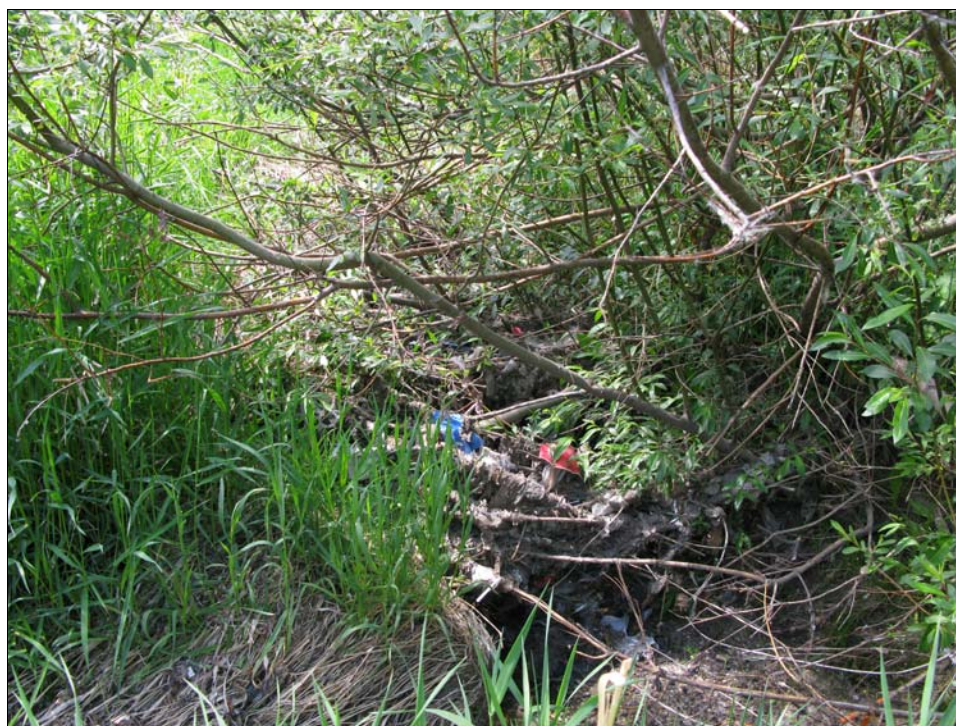
**Photograph 2: Fallen vegetation and debris.**

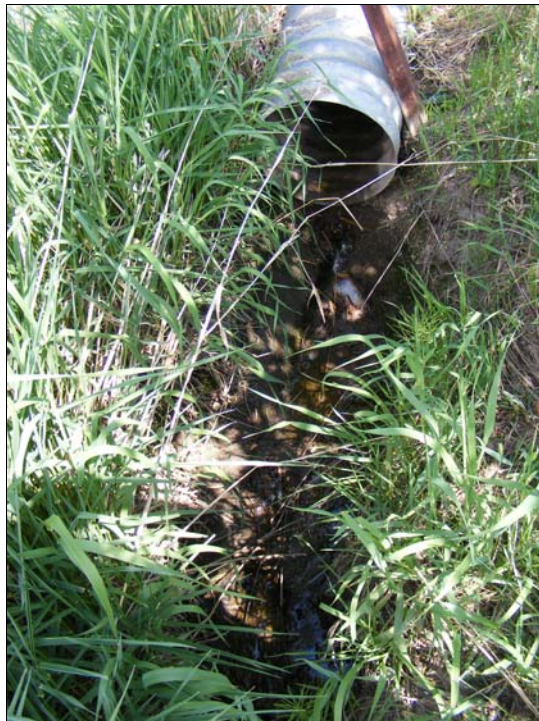
**Photograph 2: Outfall #30 and erosion trench.**

- the end of the CSP culvert be cut back to reduce the exposed pipe length;
- add a small concrete flared end with integral apron;
- backfill the eroded trench with 20 mm crush gravel and hand compact;
- cut back existing topsoil about 1 m on either side of the trench and below the current culvert extension;
- re-grade site using 100 mm topsoil and add grass seed; and
- install erosion control mat to help establish vegetation growth.

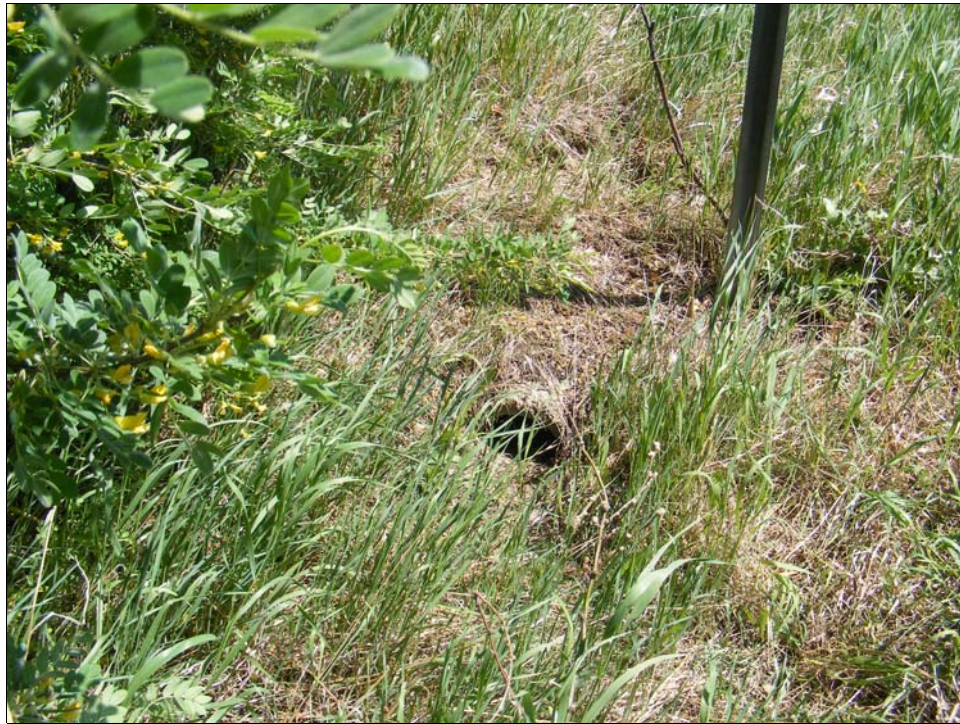
**Photograph 1: Outfall #31 and debris.**

Cleaning of pipe is recommended to remove flow restriction.

ParklandGEO recommends that the City consider tying Outfall #31 to Outfall #30 to eliminate future maintenance issues (Outfall #30 is located less than 13 m from Outfall #31). This can be accomplished with the recommended repairs to Outfall #30.

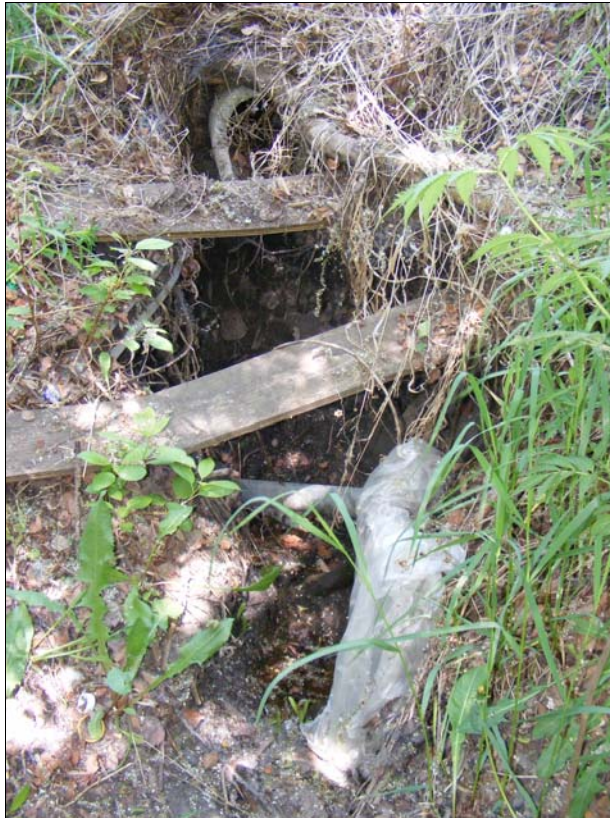
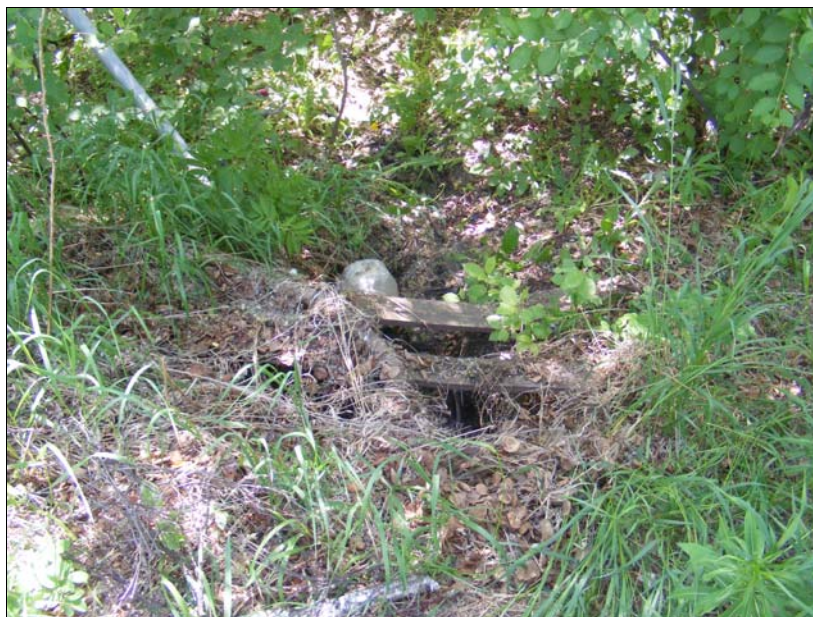
**Photograph 1: Outfall #32 with eroded trench and debris.**

**Photograph 2: Outfall #32 with eroded trench and debris.**

- Remove all debris and dead vegetation;
- Backfill the erosion trench with 20 mm gravel and compact with hoe pack or hand equipment;
- spread 100 mm topsoil and seed;
- Repair cracked concrete pipe with epoxy sealer or replace pipe end; and
- Install erosion control mat.

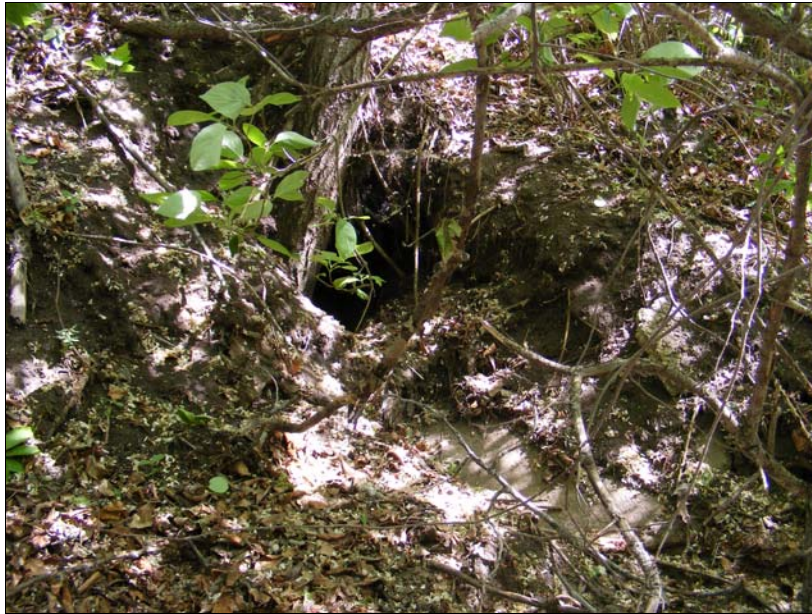
**Photograph 1: Outfall #34 partially covered with soil and vegetation; unstable slope above and below outfall.**

Given the proximity to Outfall 35 to the south (about 19 m), re-routing this outfall and decommissioning the pipe would be less costly and have lower long term risk of triggering a slope failure at this location.

Remedial measures should include: open cut or HDD installation of a new line to drain into Outfall 35; decommission Outfall 34 and backfill the pipe with concrete; and plant additional vegetation at Outfall 34 to minimize future erosion.

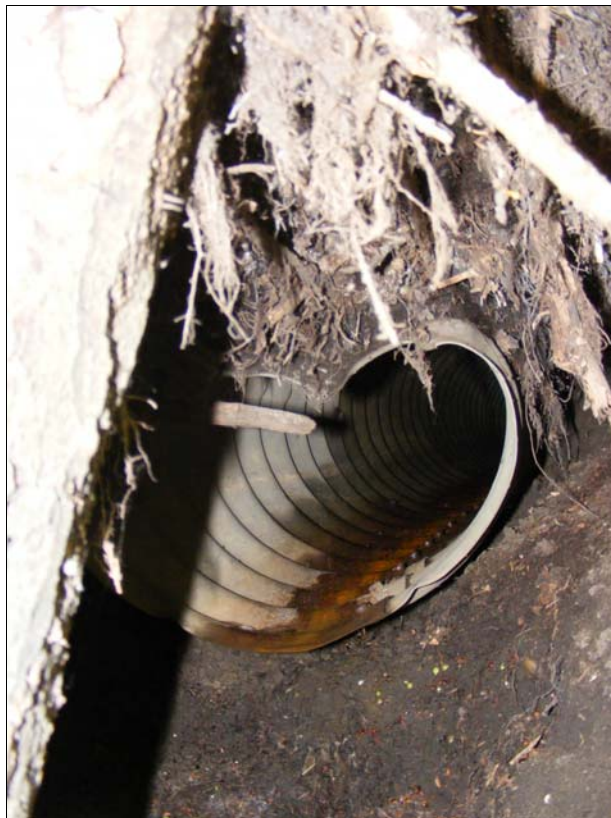
**Photograph 2: Damaged pipe.**

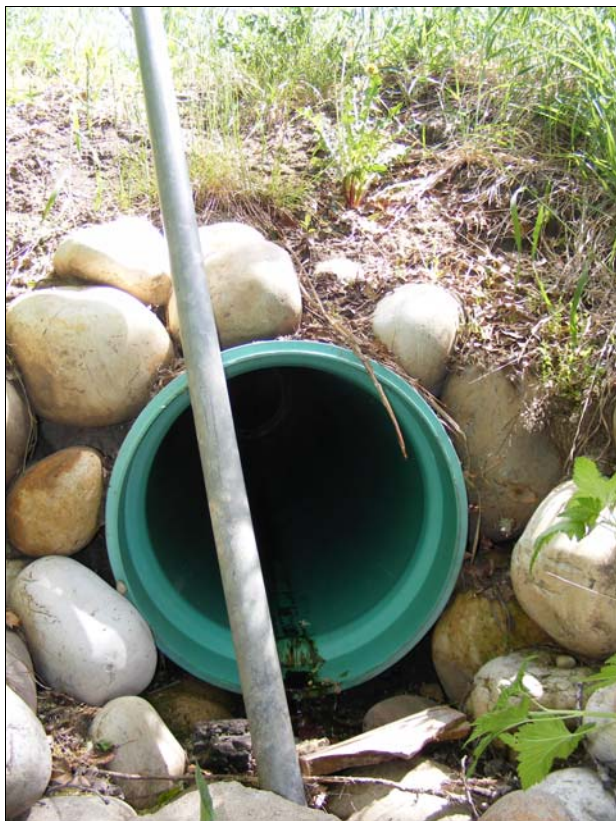
Original date of installation is 1963 but new PVC is present, indicating a more recent upgrade. Continued periodic monitoring is recommended every 3 to 4 years.

**Photograph 1: Outfall #35 showing the newer PVC pipe, rip rap and marker post.**

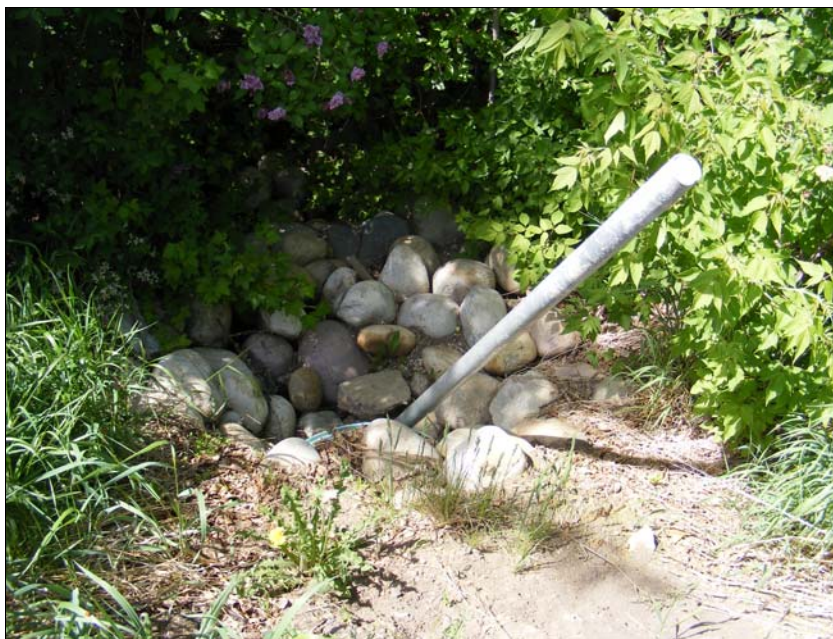
**Photograph 2: Looking from the upper slope down to the outfall. Rip rap and a marker post were present. Bare soil at the top requires topsoil and seeding.**

Additional topsoil and grass seed should be added to the area above the pipe to minimize weed growth.

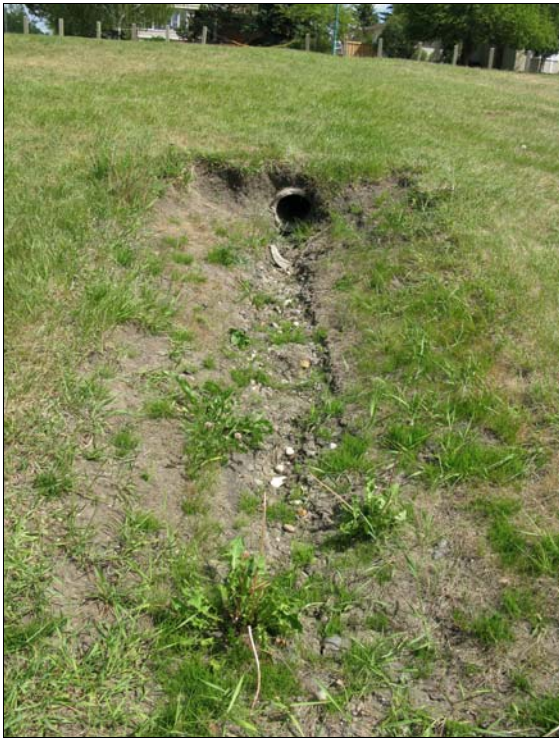
**Photographs 1 and 2: Outfall #36 showing soil erosion and lack of vegetation below the outfall, as well as cracked pipe.**

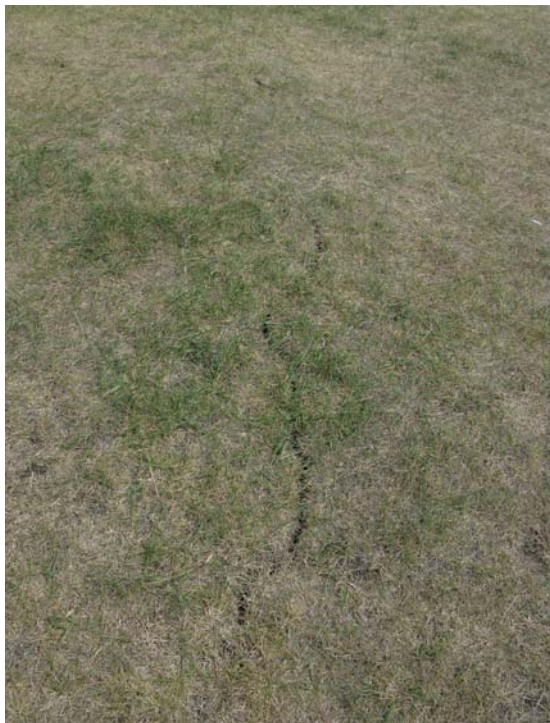
Tension cracks near the top of slope should be surveyed and backfilled. Yearly monitoring of the outfall and slope is recommended. Although the slope is not very steep, the presence of tension cracks suggest possible movement that should be monitored. A slope failure is unlikely to damage the roadway or houses further east but stabilization may be required.

**Photograph 3: Tension crack along top of slope. The crack may be due to dry conditions but monitoring is recommended as cracks were not observed on other slopes in the area.**

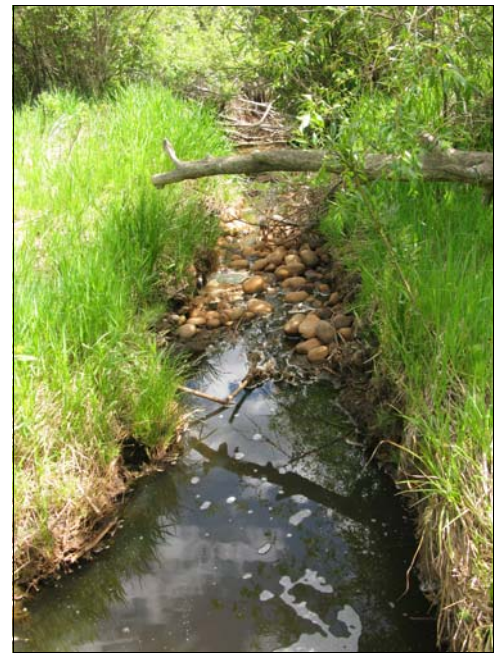
The sewer flow has caused erosion of the drainage channel leading down from the outfall for approximately 6 m. Extensive repairs are not necessary but adding additional large diameter rock would minimize future undercutting.

**Photographs 1 & 2: Outfall #37 and eroded soil/rip rap.**

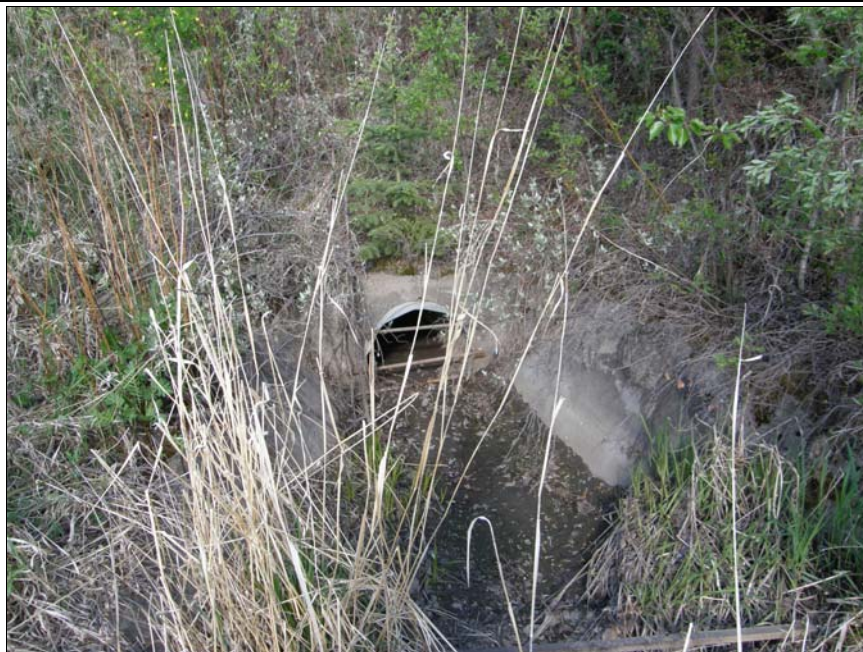
**Photograph 1: Outfall #42 showing the soil blocking the pipe and covering the apron. The area is generally overgrown with vegetation.**

An erosion control system should be installed leading down from the outfall to the river.

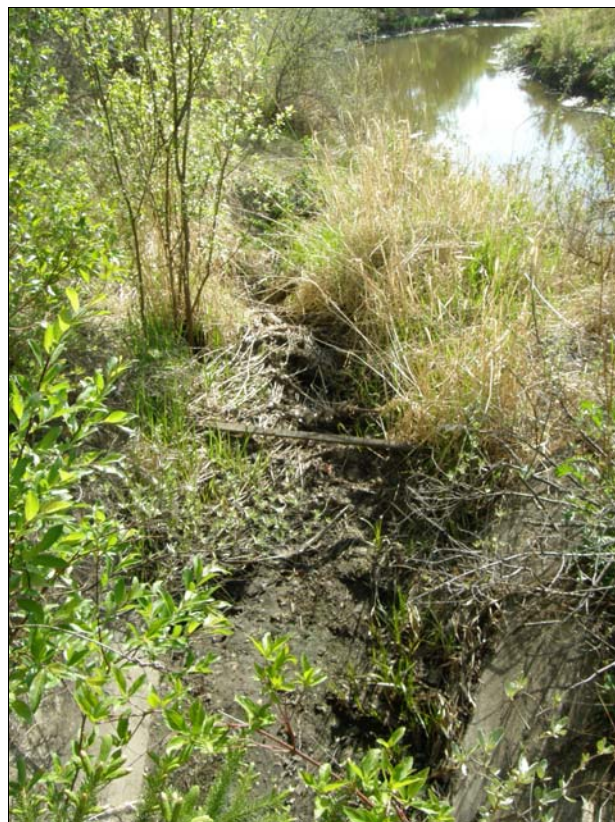
**Photograph 2: showing erosion below the outfall.**

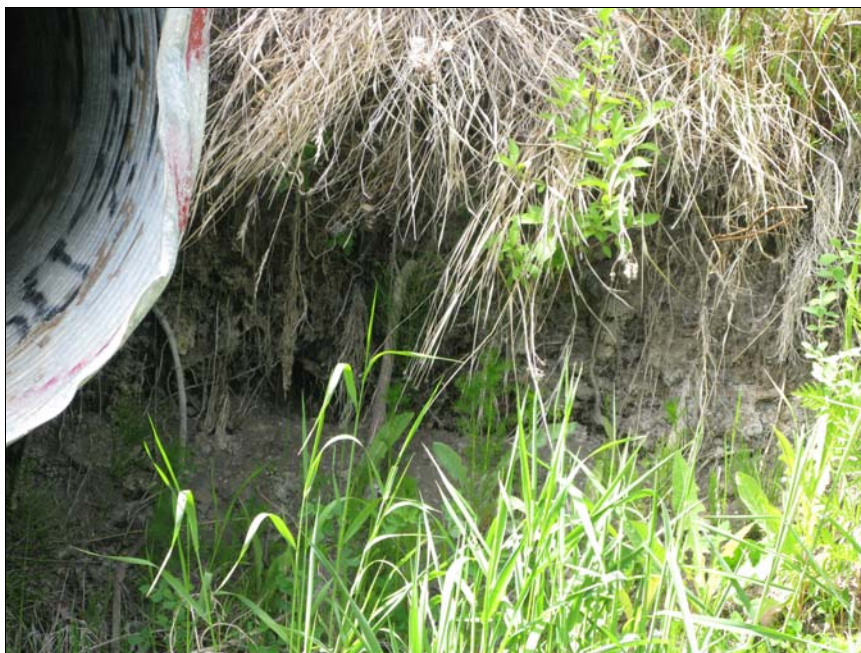
**Photograph 2: Soil erosion to the side of the outfall.**

Construction of a proper concrete outfall structure with erosion control measures is recommended. A detailed engineering design and tender will be required due to the scale of the work program.

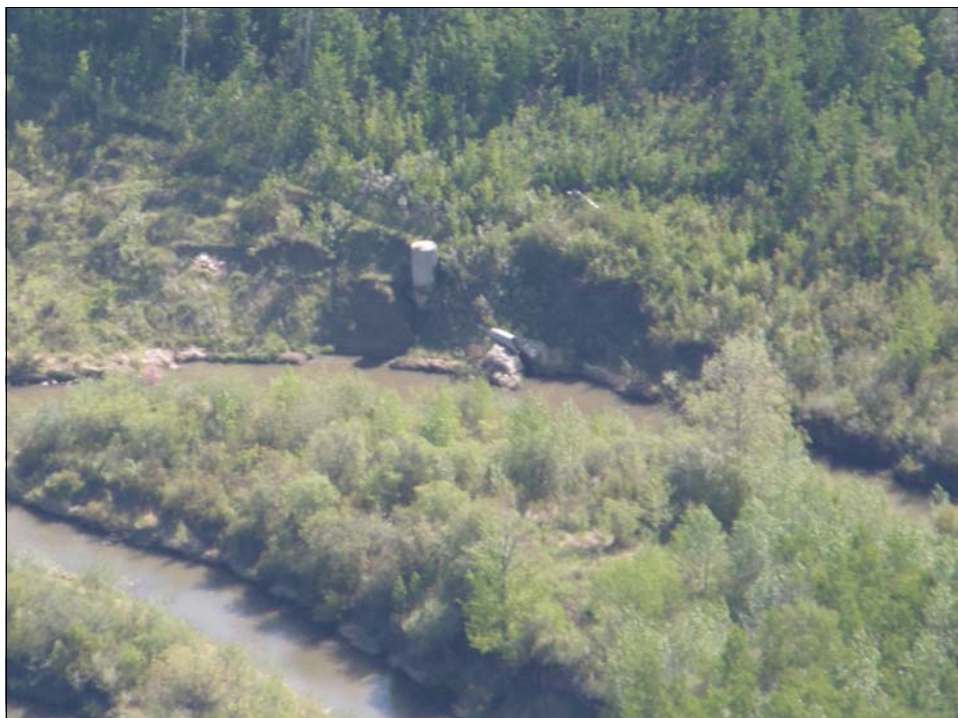
**Photograph 1: Outfall #46 with concrete drop structure and visible soil erosion.**

A detailed geotechnical investigation is on-going which will present slope and outfall rehabilitation options and costs.

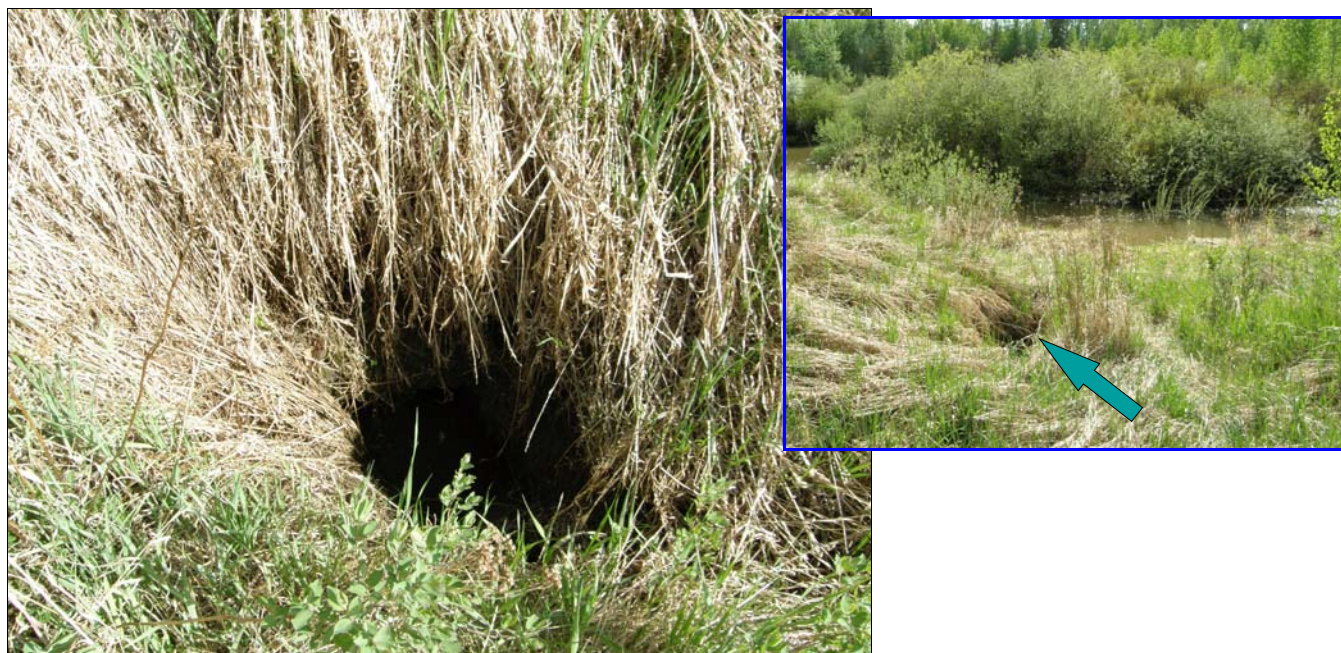
**Photograph 1: showing a large void near the location of abandoned Outfall #47. The inset shows the location in proximity to Bear Creek.**

Plugging of any old pipe may be necessary.

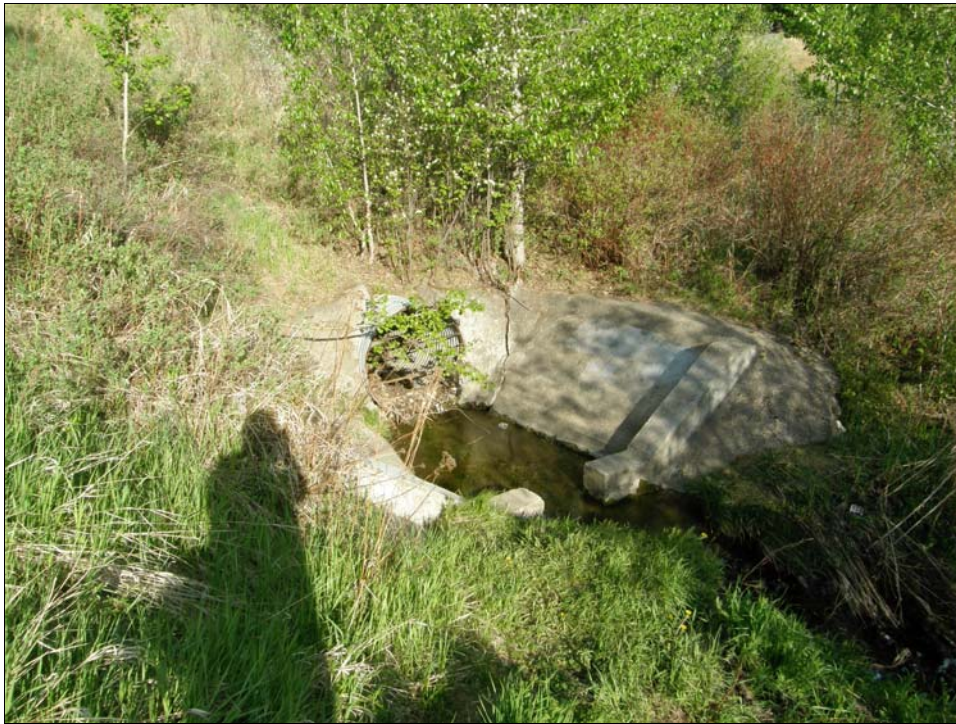
**Photograph 1: Outfall #48.**

Concrete apron should have cracks sealed to minimize deterioration.

Erosion control measures consisting of a geotextile blanket and seeded topsoil should be added to the flow channel extending from the outfall down to the creek. Only minor hand clearing would be required to facilitate installation of the erosion control measures.

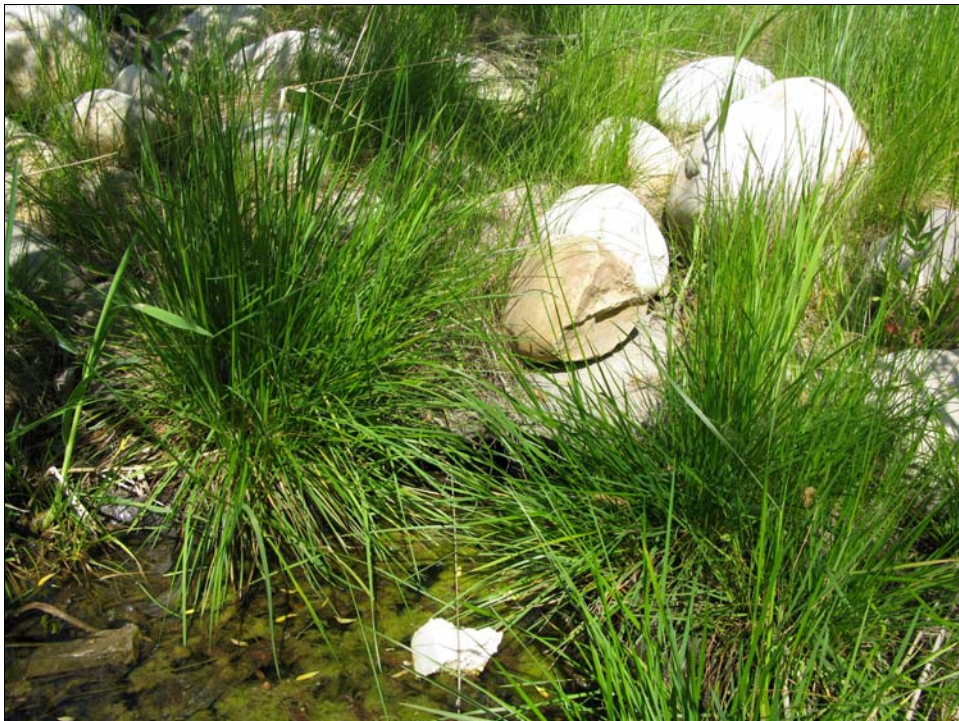
**Photograph 2: Outfall #50.**

This is a relatively new outfall and the shifting of the apron away from the pipe is likely due to settlement of the embankment fill for the 68 Avenue bridge. Continued periodic monitoring for other evidence of settlement is recommended.

Reconstruction of the outfall, including the erosion control mechanisms are required. Replacement of rip-rap with hard-armor erosion control blankets and vegetation supported by matting is recommended. Backfilling and re-contouring the erosion gullies is required. A detailed erosion control plan is also required.

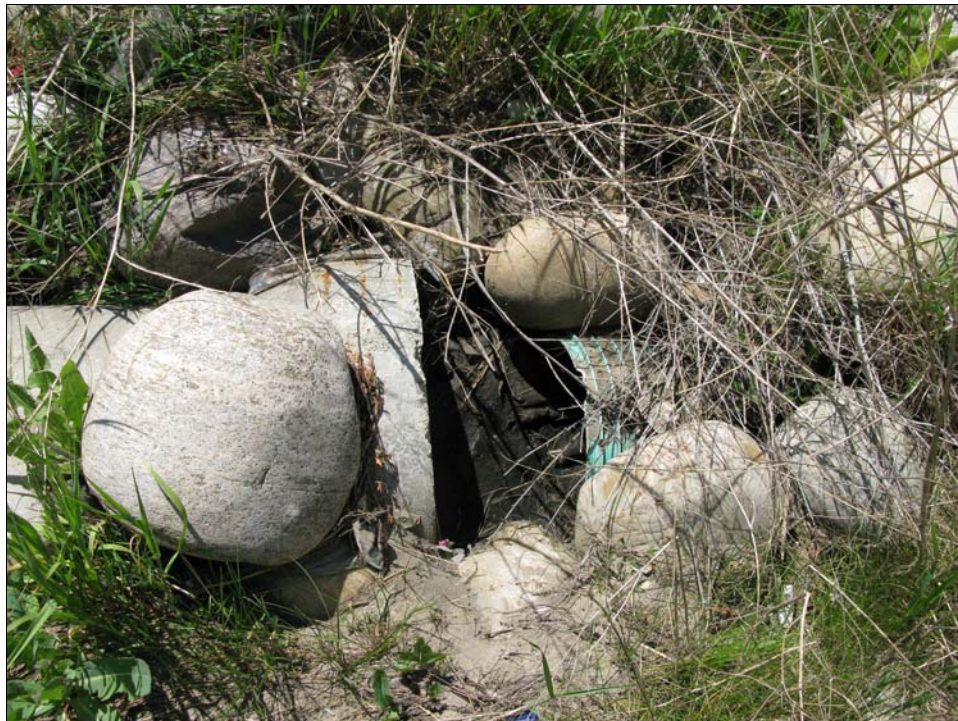
Erosion was noted above and beside the outfall, but this should be minimized with the establishment of a good grass cover. Elimination of weeds will be necessary to ensure that the planted grass species can be established. The apron needs to be re-set into proper location.

**Photograph 2: Concrete apron structure separated from the pipe, likely due to creep movement of the new embankment fill.**

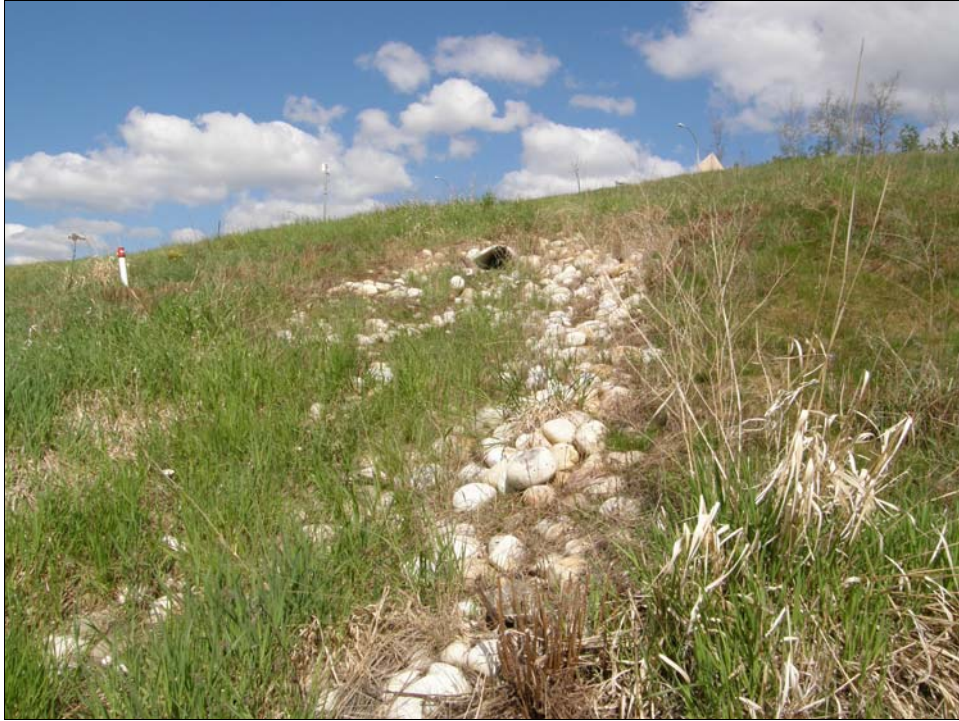
This outfall is in good condition with no evidence of erosion or other problems that would require maintenance or rehabilitation.

**Photograph 1: Looking north to Outfall #52, with 68 Avenue above the slope.**

Periodic monitoring every 12 to 18 months is recommended to assess performance.

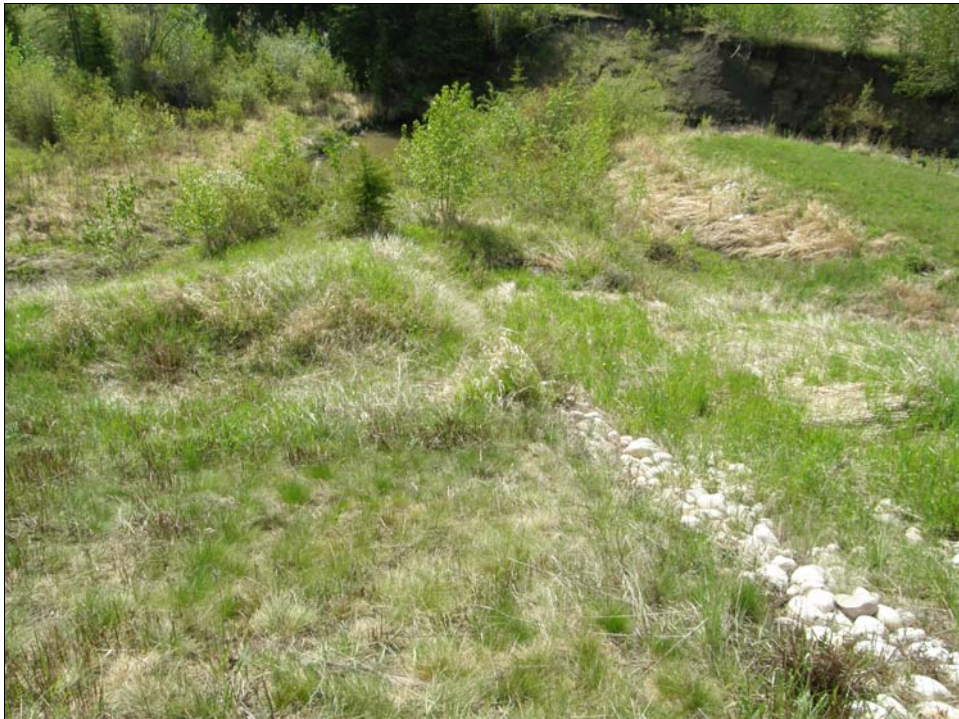
**Photograph 2: Looking down to Bear Creek from Outfall #52.**

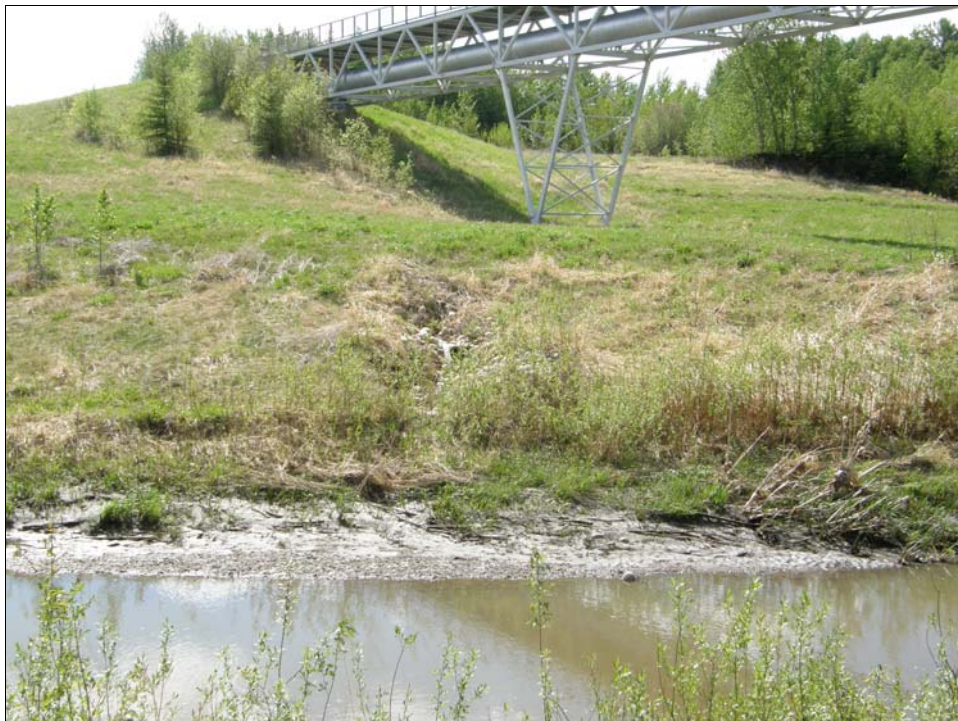
The outfall is in good condition with only a small slump noted immediately downstream of the outfall, on the north side. The addition of grass seed, and a light coconut straw matting to assist with seed germination will help stabilize the slump.

**Photograph 2: Outfall #53 taken from the west bank of the creek.**

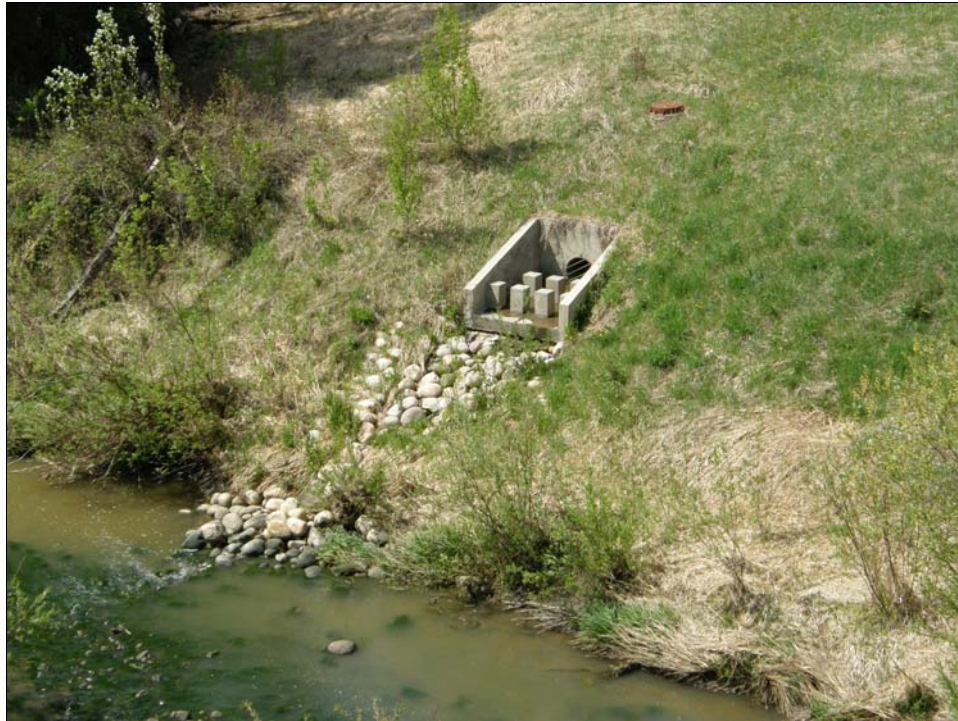
The outfall is in good condition with the only issue being a void located below the apron that may undermine support for the outfall structure over time.

**Photograph 1: Outfall #54 on the west side of Bear Creek, taken from the adjacent footbridge.**

We recommend that the outfall be inspected in 2010 and if gap below structure has not increased then use grout to fill void. If void is larger, redesign of the erosion control measures will be required.

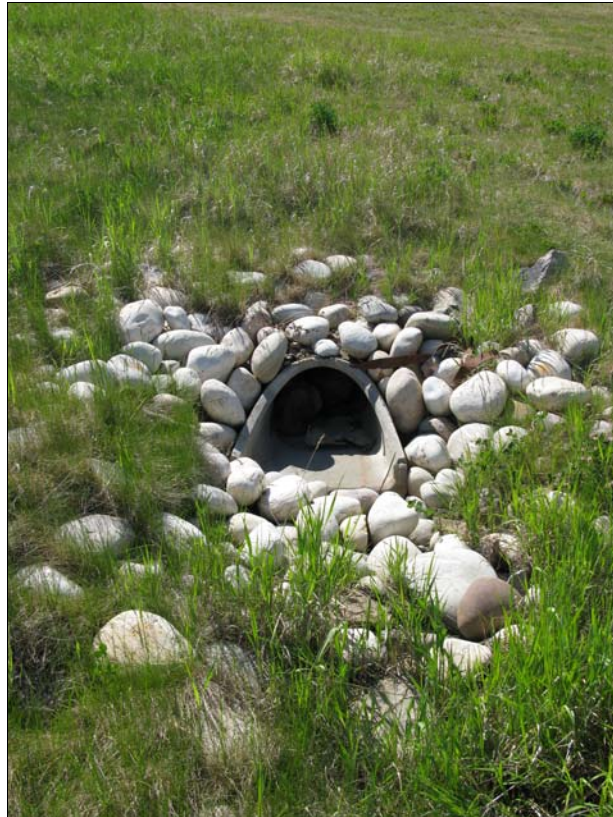
**Photograph 1: Outfall #1.**

Debris in pipe partly due to vandalism. Hand clearing required.

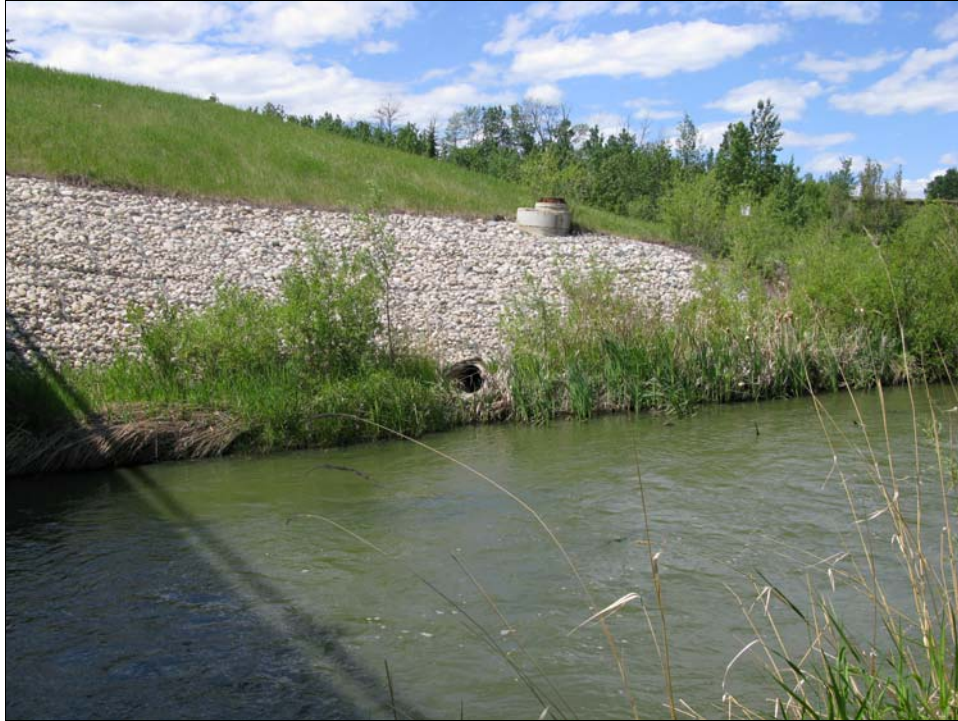
Outfall in good condition. No repairs necessary. Inspect every 3 to 4 years.

Photograph 1: Outfall #57 on the west side of Bear Creek, immediately north of 84 Avenue bridge.

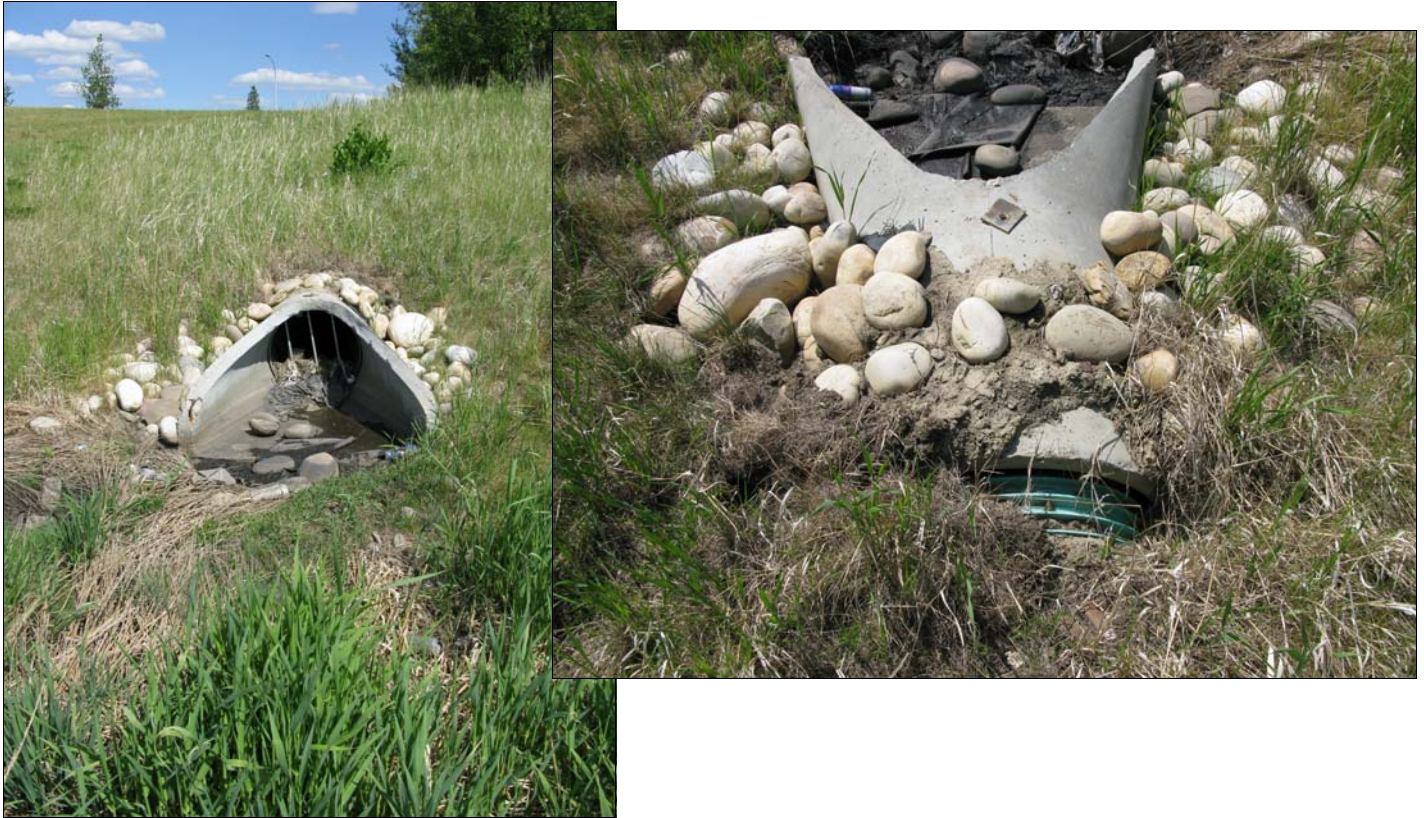
**Photograph 1: Outfall #58.**

Concrete apron has separated from pipe. Apron must be re-installed, erosion control measures upgraded to include geotextile erosion control blankets and vegetation. Garbage and debris to be removed.

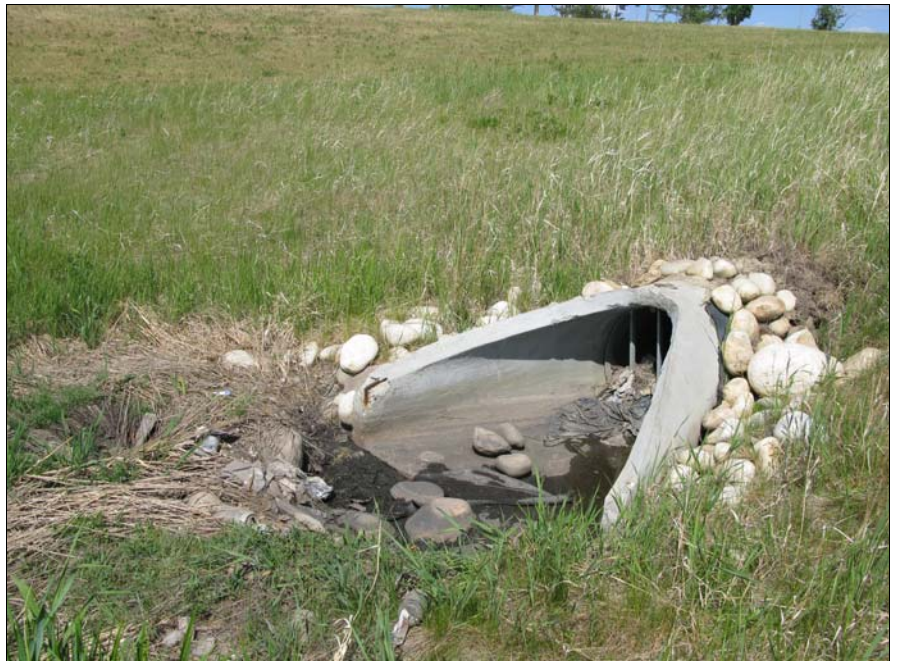
**Photograph 2: Concrete apron separated from pipe.**
