BEAR CREEK CORRIDOR ASSESSMENT CITY OF GRANDE PRAIRIE

Report Prepared for:
CITY OF GRANDE PRAIRIE

Prepared by:
MATRIX SOLUTIONS INC.

Version 1.0
September 2018
Grande Prairie, Alberta

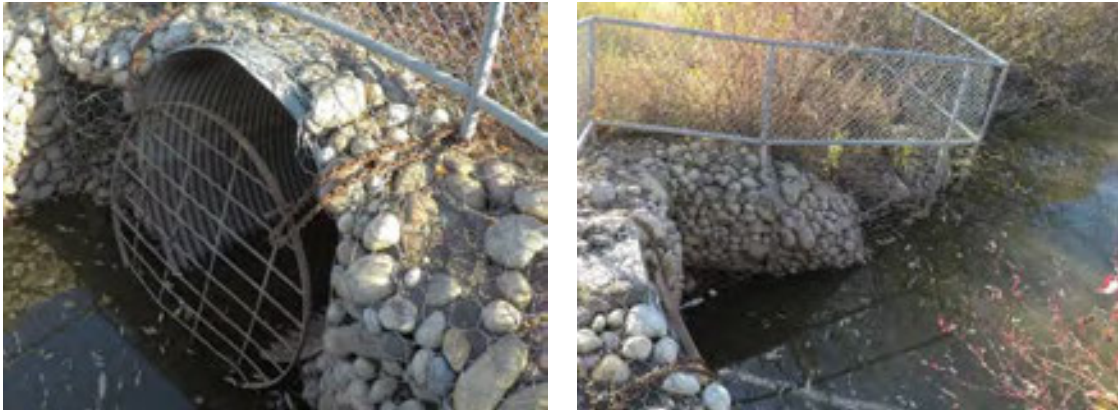
4.1 Outfall 1

Inspected: 2-Oct-2017

- Remove gabion baskets from headwall and wing walls
- Engineer a design so that the toe is protected from scour action and a base is provided for the outfall and pipe
- Replace the outfall structure as per the engineering design
- Refer to Table 14 for general recommended actions based on type of failure

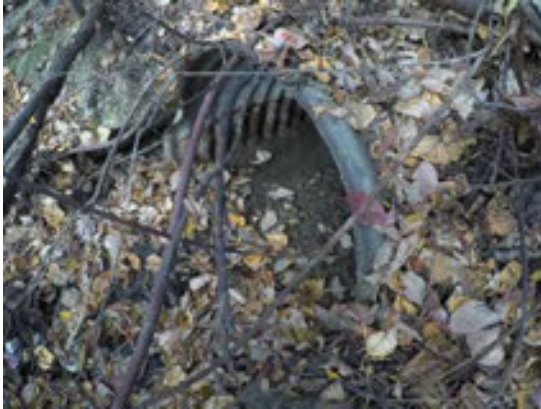
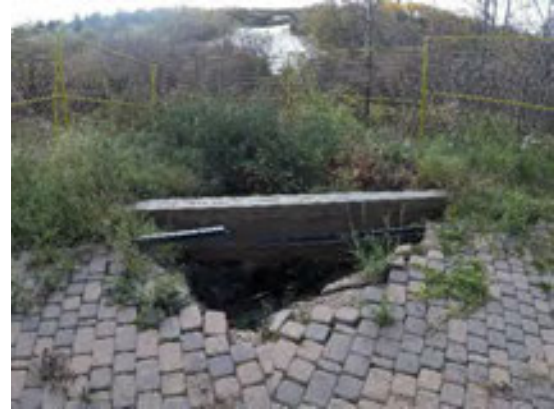
4.2 Outfall 5

Inspected: 2-Oct-2017

- Conduct a detailed inspection of the sewer line to determine the current condition and potential damage along the line affecting the slope stability
- Assess slope stability to determine causes of failure
- Refer to Table 14 for general recommended actions based on type of failure

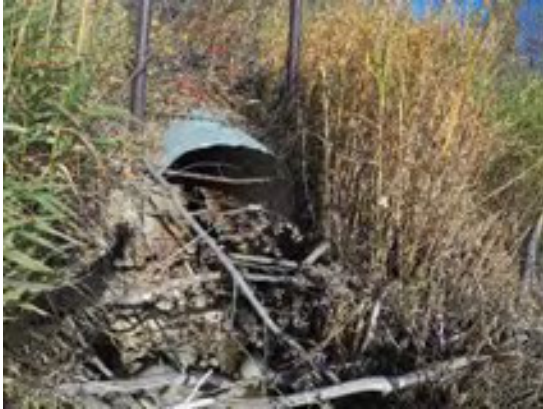
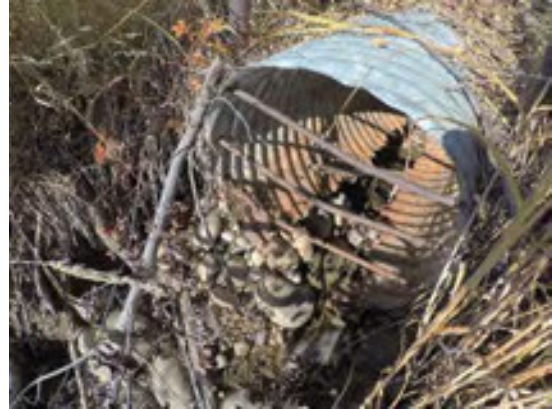
4.3 Outfall 8

Inspected: 2-Oct-2017

- Replace the segment of pipe that is corroded
- Reconstruct the base for the pipe and install a permanent ESC cover at the outlet
- Assess slope stability to identify soil failure patterns
- Refer to Table 14 for general recommended actions based on type of failure

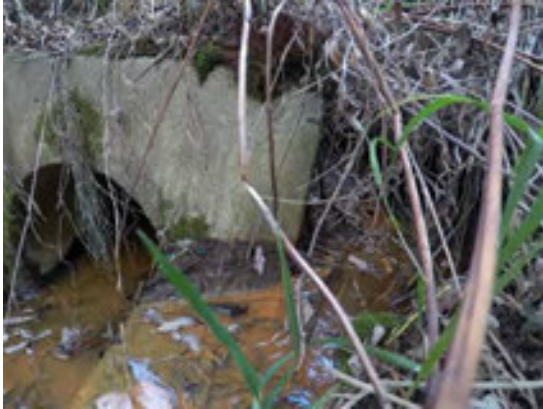
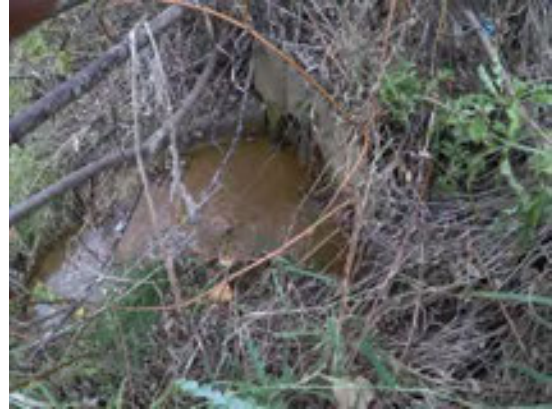
4.4 Outfall 14

Inspected: 6-Oct-2017

- Clear outfall from surrounding vegetation and conduct a detailed inspection along the pipeline to verify if the pipe is broken
- Investigate source of orange matter observed in the sewer flow
- Regrade and repair outfall damages and reinstall/replace outfall structure; provide permanent ESC protection along the channel
- Refer to Table 14 for general recommended actions based on type of failure

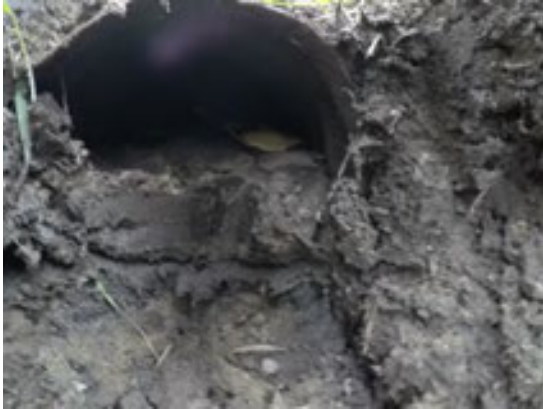
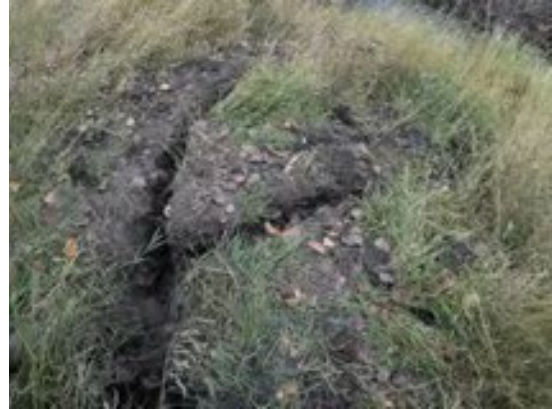
4.5 Outfall 19

Inspected: 6-Oct-2017

- Uncover the pipe and remove sediment; conduct a detailed inspection to identify additional issues and proceed with repair works as needed
- Provide ESC protection at the outlet due the steep slope at this location

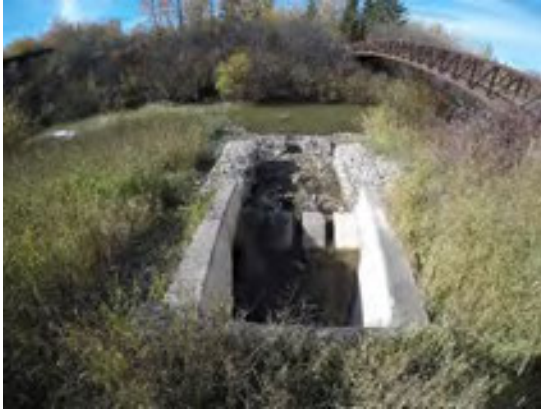
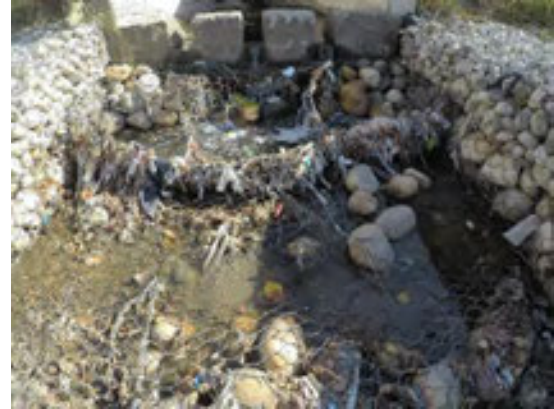
4.6 Outfall 24

Inspected: 6-Oct-2017

- Regrade discharge channel, place base material at the eroded locations, and repair damaged gabion baskets and mattresses along the wingwalls and discharge channel
- Patch rills along the concrete apron and pipe to avoid rebar exposure
- Remove garbage from the gabions and mattresses
- Refer to Table 14 for general recommended actions based on type of failure

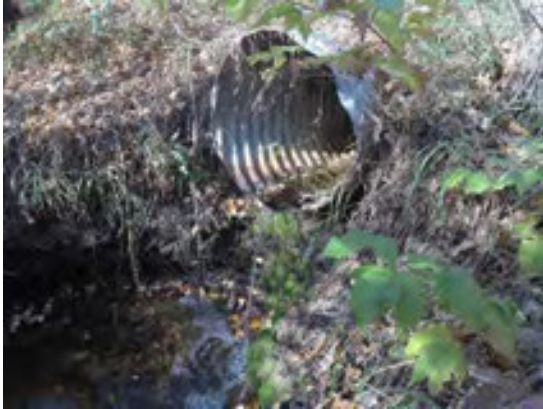
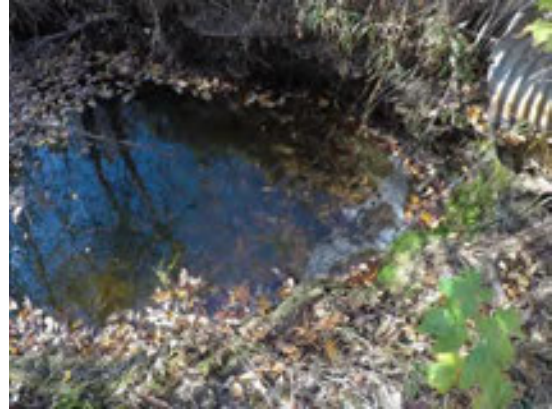
4.7 Outfall 28

Inspected: 3-Oct-2017

- Regrade the slope to stabilize bank erosion and the vertical walls around the pipe
- Provide a concrete outfall structure sized in relation to the size of the pipe and sewer flows
- Include shore and channel protection in the outfall design
- Refer to Table 14 for general recommended actions based on type of failure

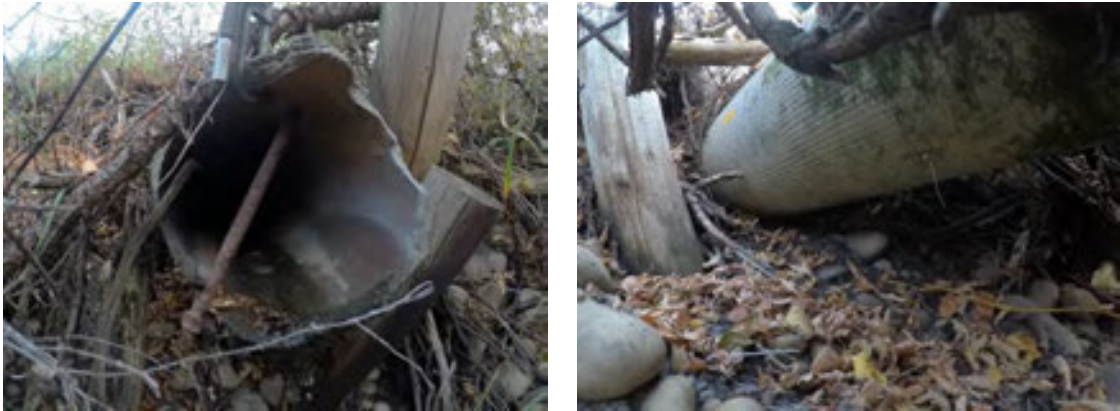
4.8 Outfall 33

Inspected: 4-Oct-2017

- Replace the section of broken pipe and regrade around the pipe to provide a base for the outlet
- Refer to Table 14 for general recommended actions based on type of failure

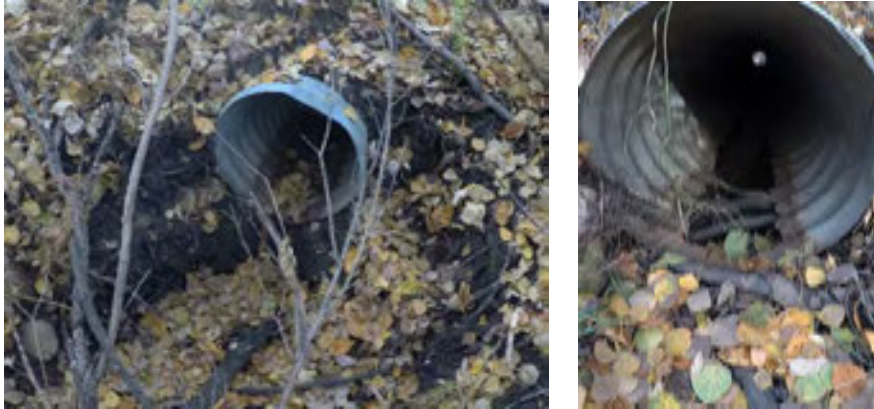
4.9 Outfall 39

Inspected: 4-Oct-2017

- Replace culvert because of severe corrosion
- Regrade and install permanent ESC protection on both sides of the culvert
- Consider installing handrails on both sides of the pathway to prevent users from falling in the channel
- Refer to Table 14 for general recommended actions based on type of failure

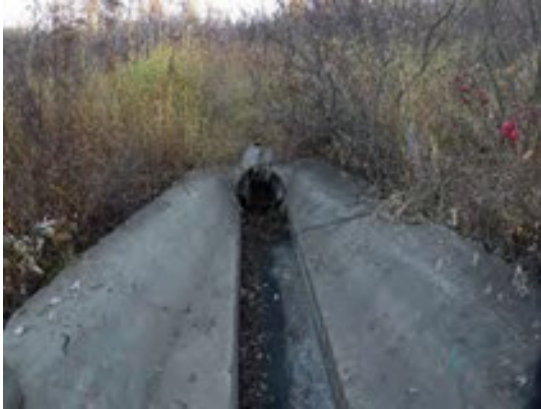
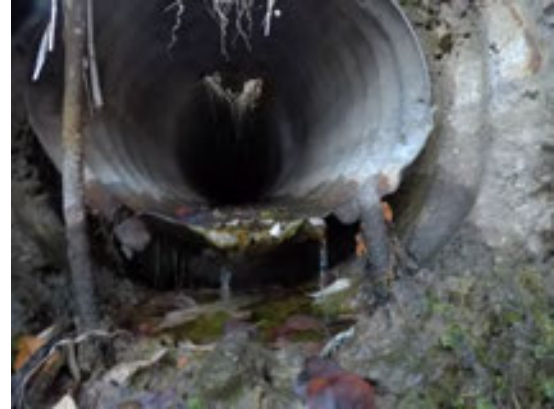
4.10 Outfall 41

Inspected: 5-Oct-2017

- Conduct a geotechnical assessment to determine further causes of bank instability to propose engineered solution
- Replace the damaged sections of the pipe, concrete outfall, and gabion mattresses.
- Refer to Table 14 for general recommended actions based on type of failure

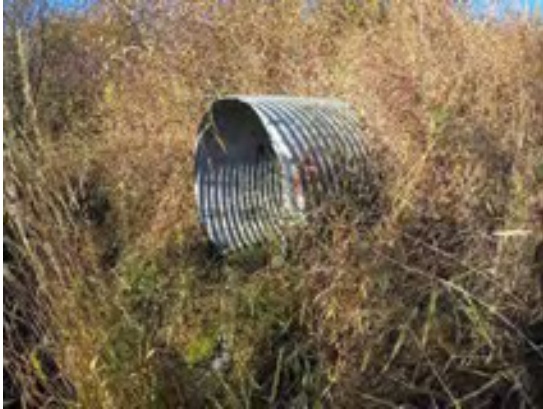
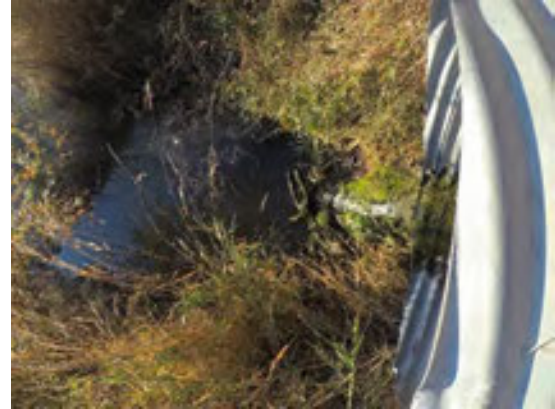
4.11 Outfall 44

Inspected: 5-Oct-2017

- Remove the riprap and debris from the creek to ensure unrestricted flow and reduce potential scour of the left bank to minimize changes on the creek channel
- Regrade the slope to stabilize bank erosion and regrade the vertical walls around the pipe
- Provide a concrete outfall structure due to the size of the pipe and sewer flows
- Include shore and channel protection in the outfall design
- Refer to Table 14 for general recommended actions based on type of failure

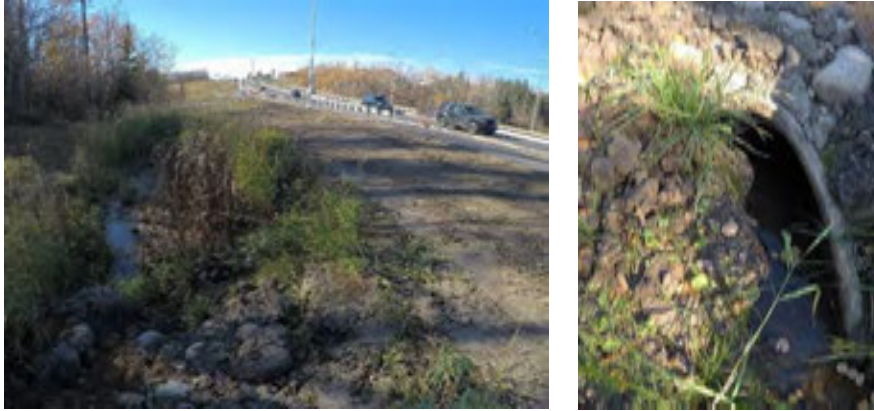
4.12 Outfall 50

Inspected: 5-Oct-2017

- Conduct a pipe and outfall inspection after the completion of the construction and complete rehab works as required
- Remove garbage from grate

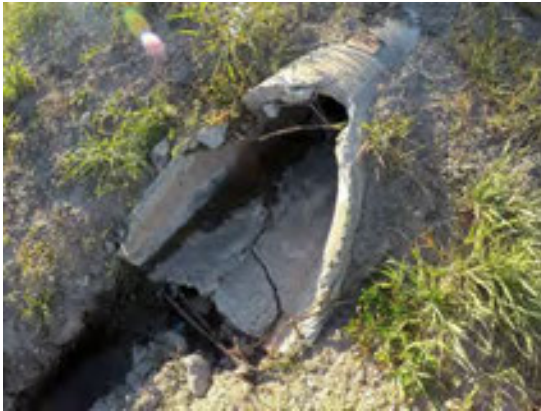
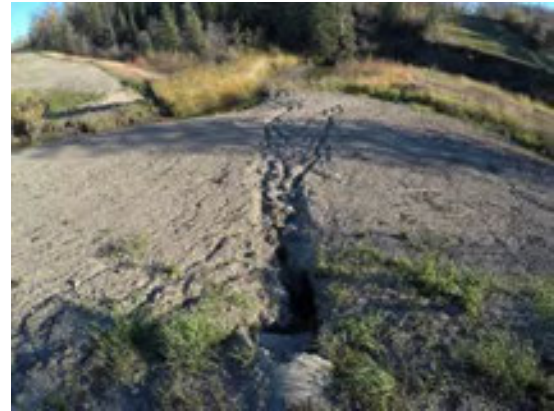
4.13 Outfall 52

Inspected: 5-Oct-2017

- Conduct a pipe inspection after the completion of the construction
- Regrade and provide vegetation coverage on the slope
- Replace the flared end
- Provide ESC protection along the discharge channel
- Refer to Table 14 for general recommended actions based on type of failure

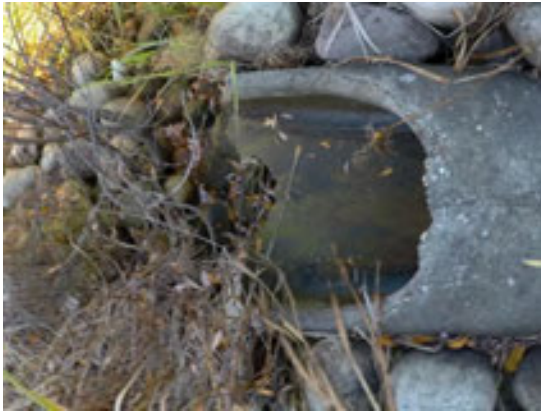
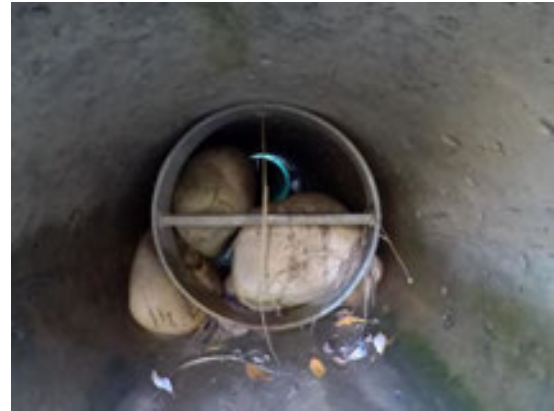
4.14 Outfall 53

Inspected: 5-Oct-2017

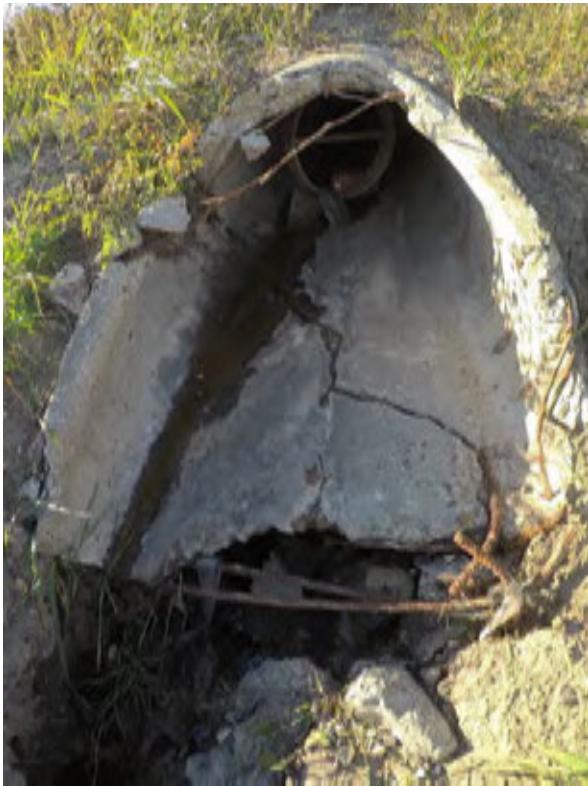
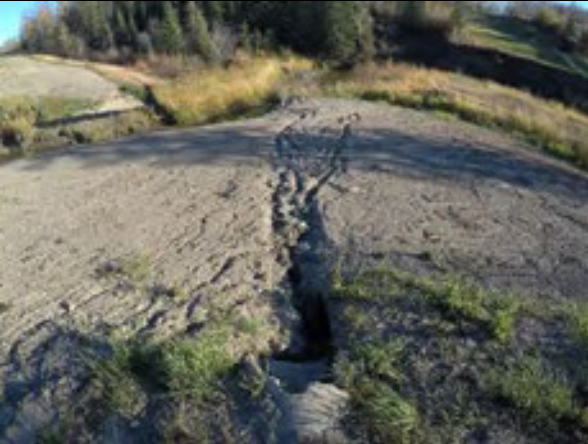
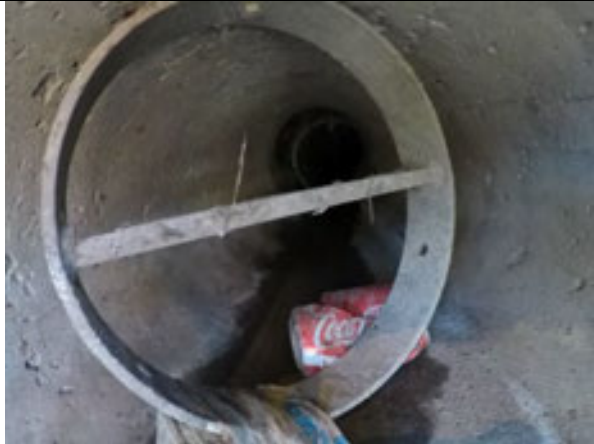
Outfall 52:

52	Sewer erosion, Sewer/pipe damage	<ul style="list-style-type: none"> The pathway parallel to 68 Ave. was under construction, bare soils were exposed The flared end was severely broken, and the rebar was exposed and corroded Rill erosion downstream of the outfall along the bare soils on the slope was observed 	<ul style="list-style-type: none"> Conduct a pipe inspection after completion of works Regrade and provide vegetation coverage on the slope Replace the flared end Provide ESC protection along the discharge channel
53	Sewer erosion	<ul style="list-style-type: none"> The flared end was disconnected from the pipe and severely damaged The grate was blocked by riprap cobbles A shiny, thick, yellow fluid was observed from the sewer Moderate erosion around the outfall suggested some slope stability issues 	<ul style="list-style-type: none"> Regrade, replace the flared end, and clear the grate of debris Monitor erosion along the channel once unrestricted flow is re-established Investigate the source of the rare flow observed, verify if sewer is connected to sanitary or another non-stormwater line Conduct a geotechnical slope assessment to address the instability of the slope

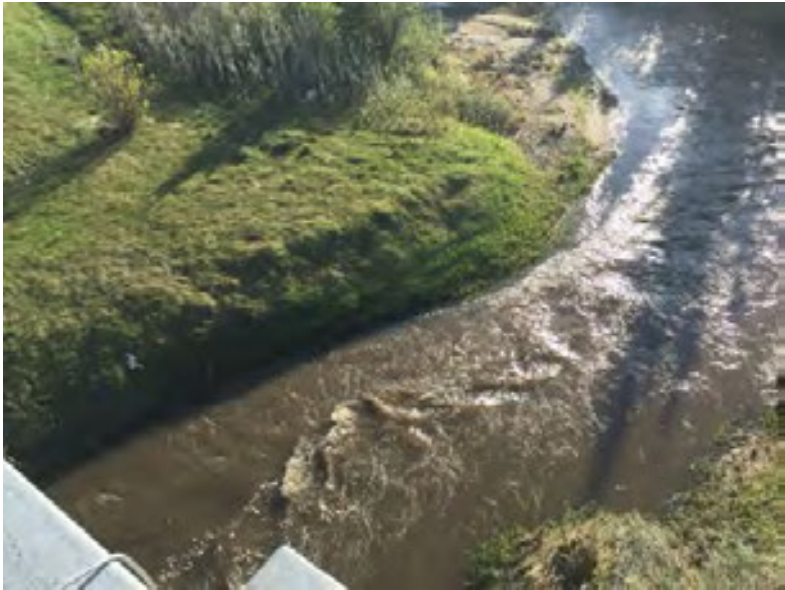
1. South Bear Creek bridge - downstream.

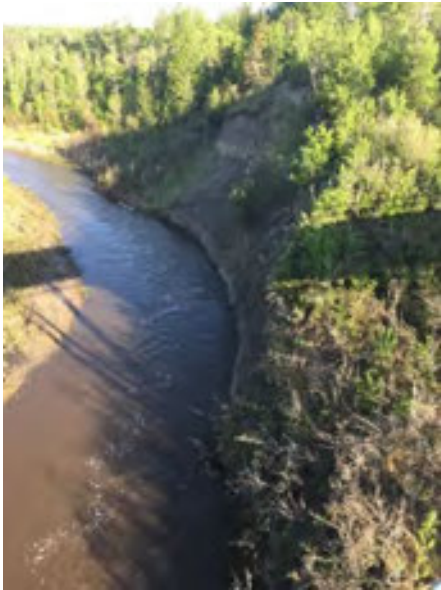
2. South Bear Creek bridge - upstream meander scar.

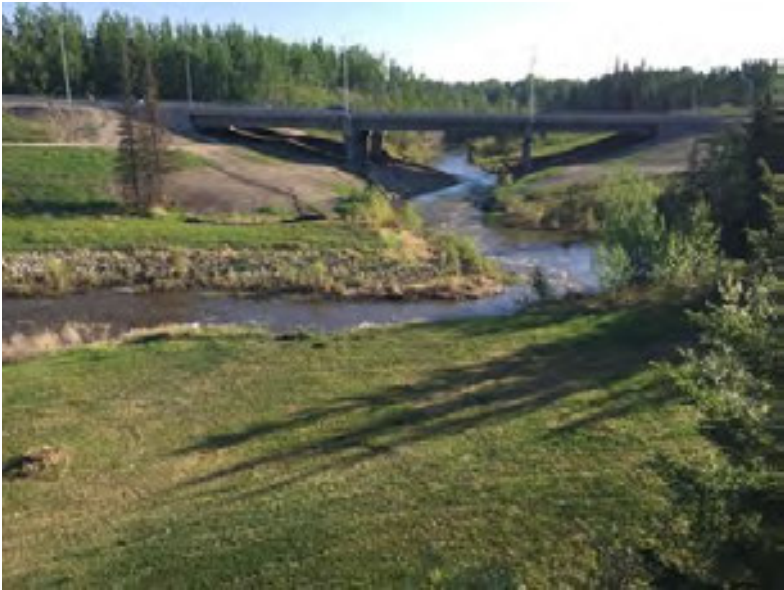
3. 68 Avenue bridge.

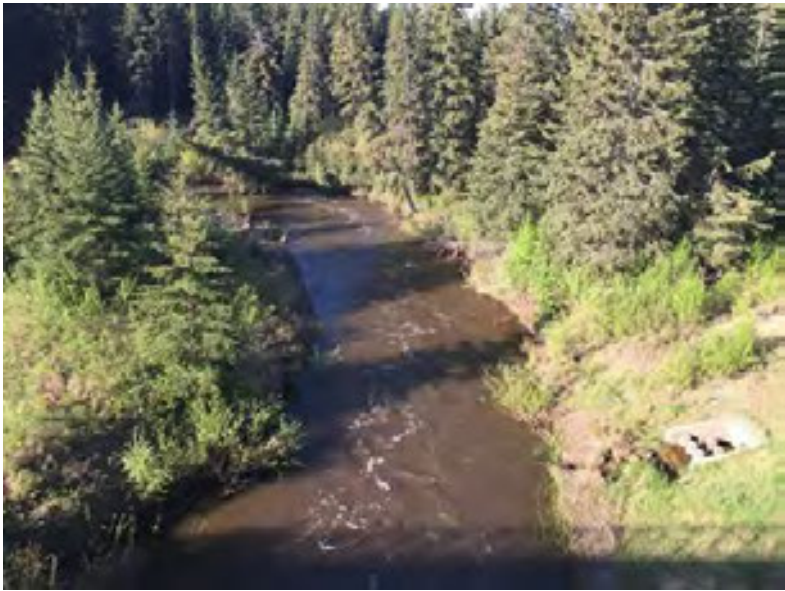
4. Outfall 52 near 68 Avenue bridge.

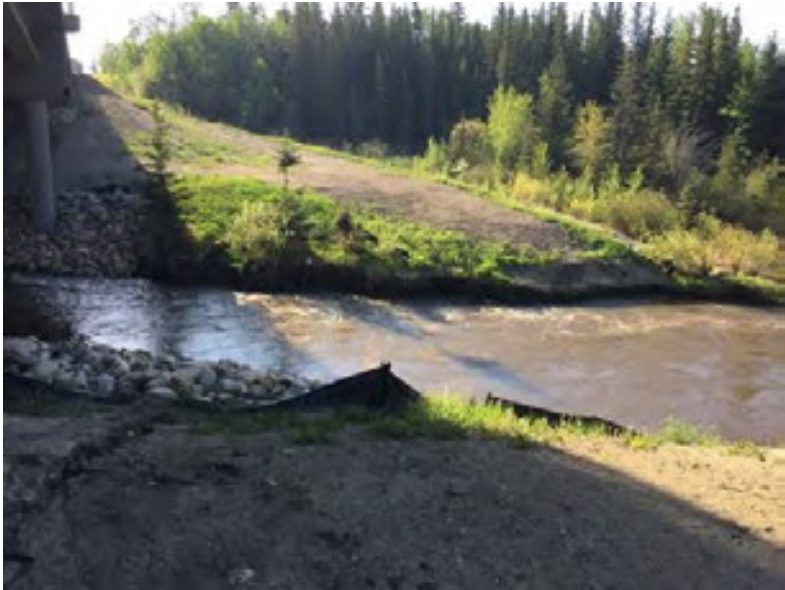
7. Erosion along embankment toe, below 68 Avenue bridge, left bank.

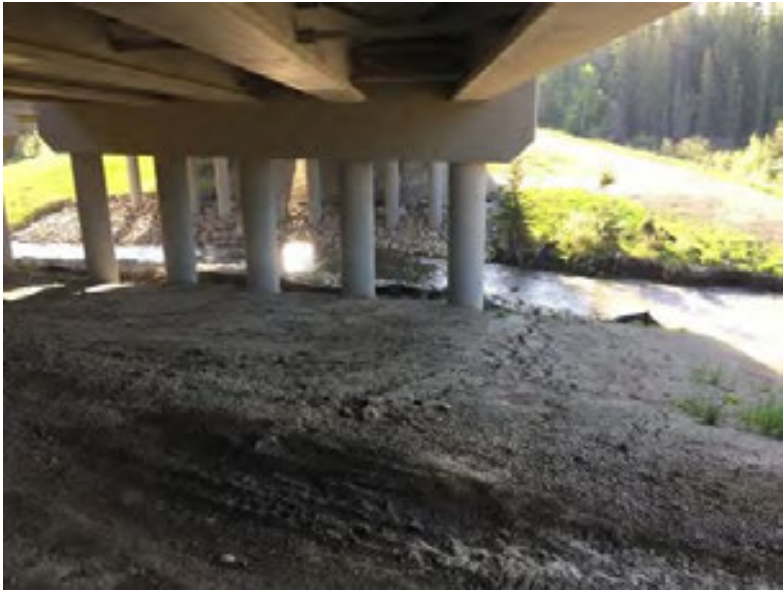
8. 68 Avenue bridge opening.

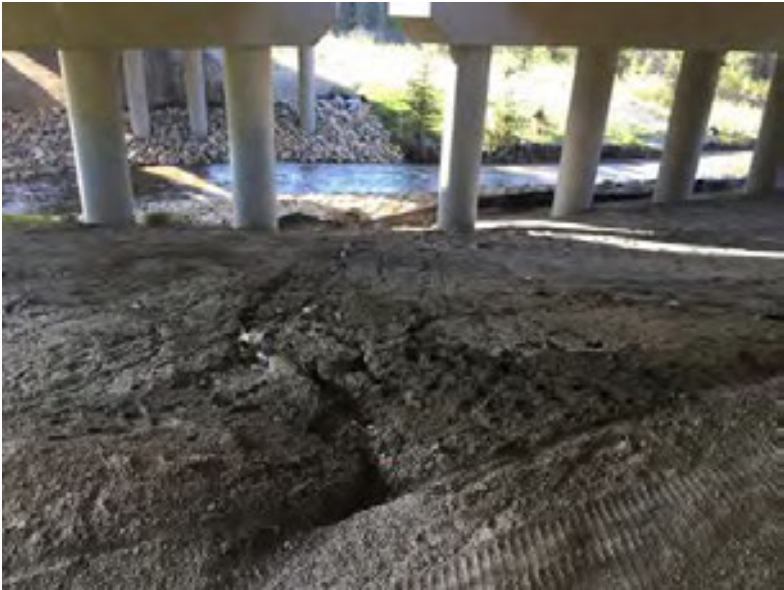
9. Drainage issue under 68 Avenue bridge.

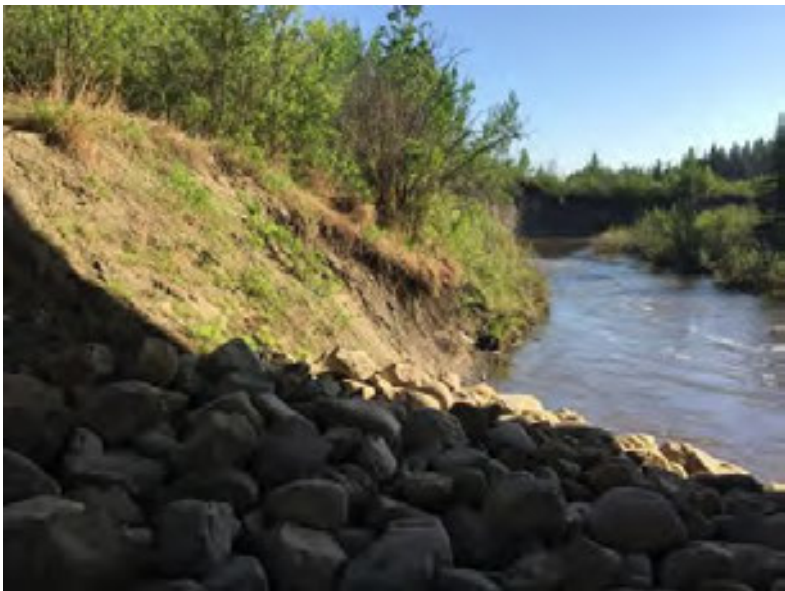
10. Upstream erosion near rock embankment upstream of 68 Avenue bridge, right bank.

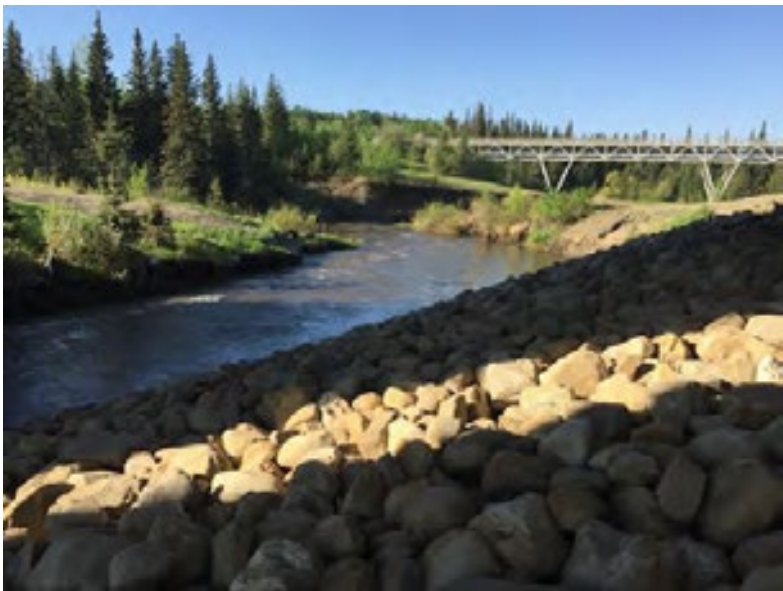
11. Rock embankment under 68 Avenue bridge.

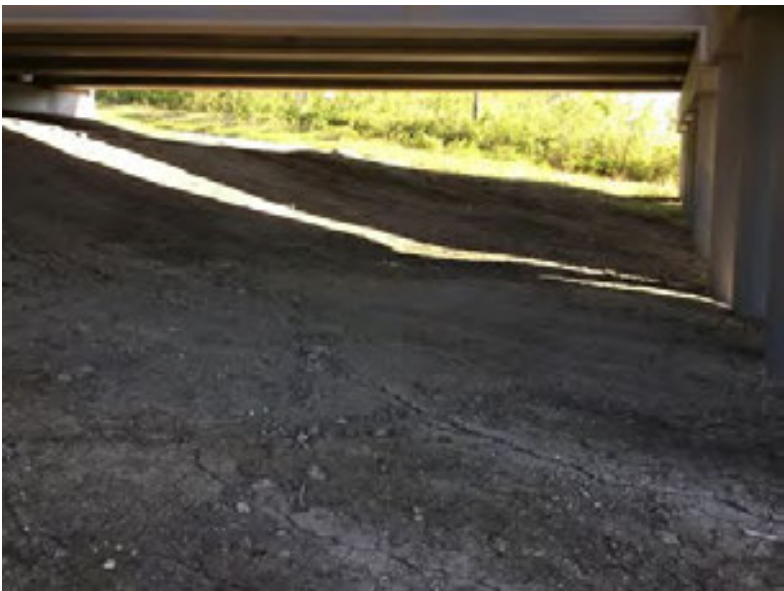
12. Fill material under 68 Avenue bridge.

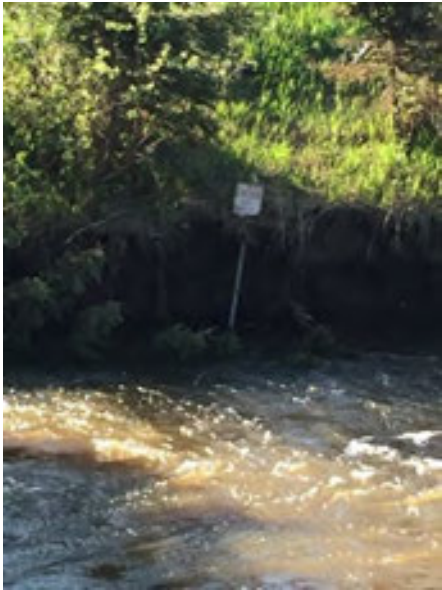
13. Caution: buried water line downstream of 68 Avenue bridge.

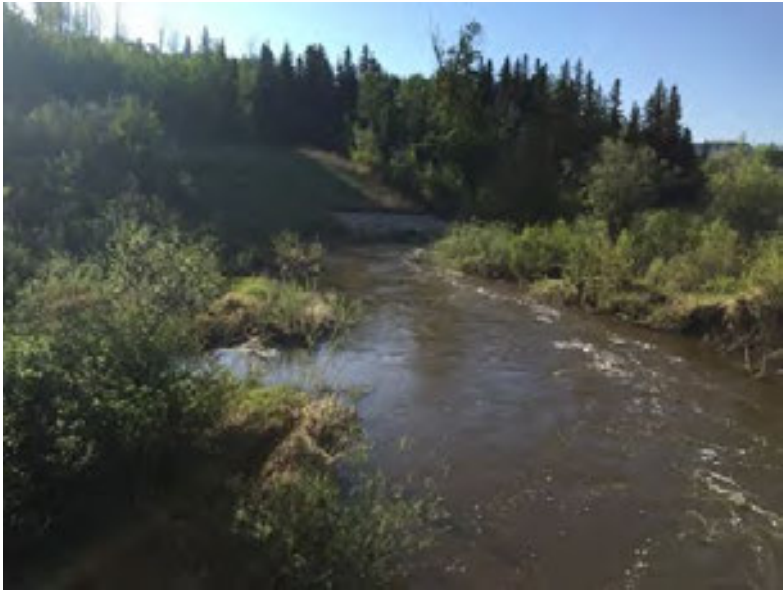
14. Bank protection and slope rehabilitation near 72 Avenue (photograph from pedestrian bridge).

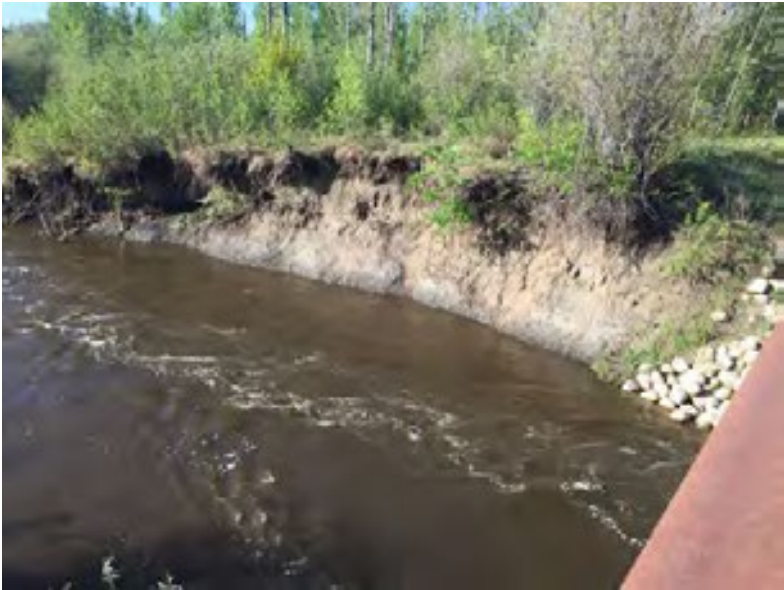
15. Erosion at pedestrian bridge near 72 Avenue.

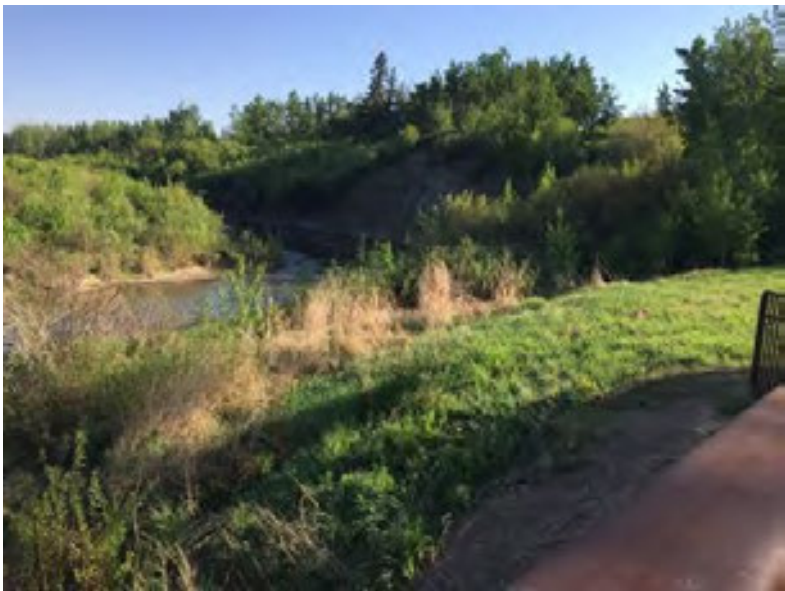
16. Upstream channel conditions at pedestrian bridge near 72 Avenue.

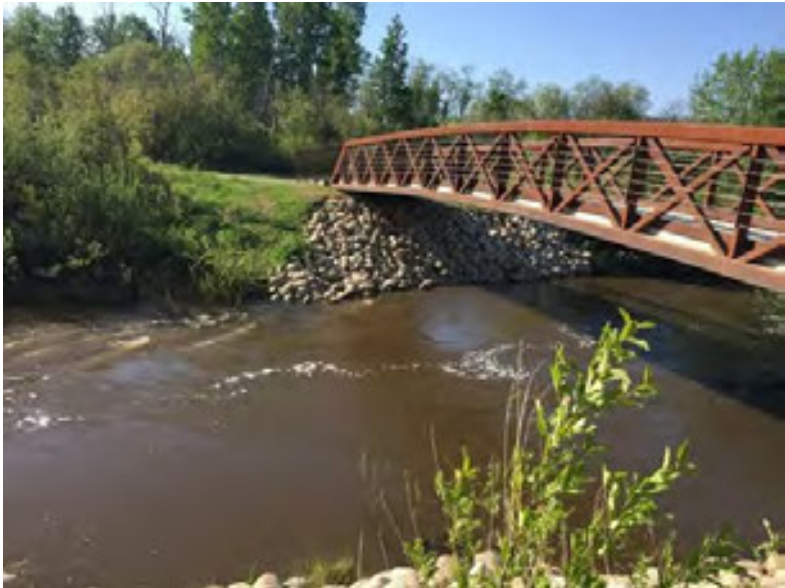
19. Pedestrian bridge near 79 Avenue.

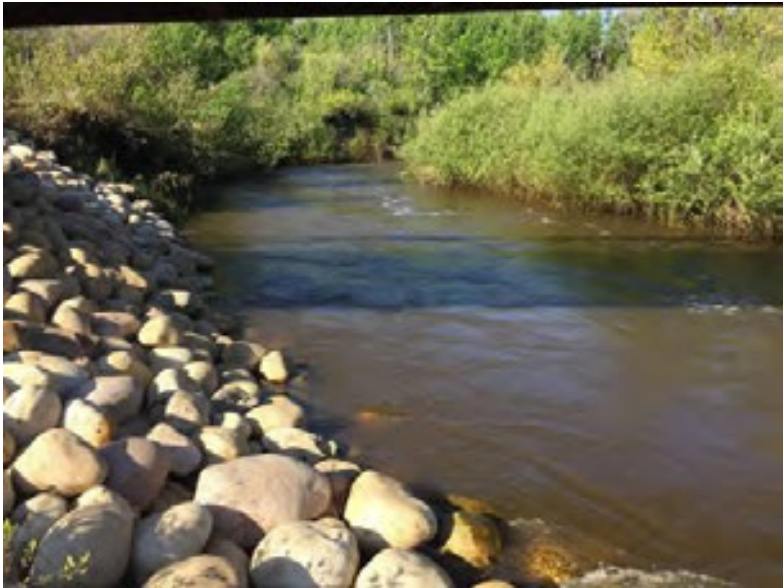
20. Erosion protection at pedestrian bridge near 79 Avenue.

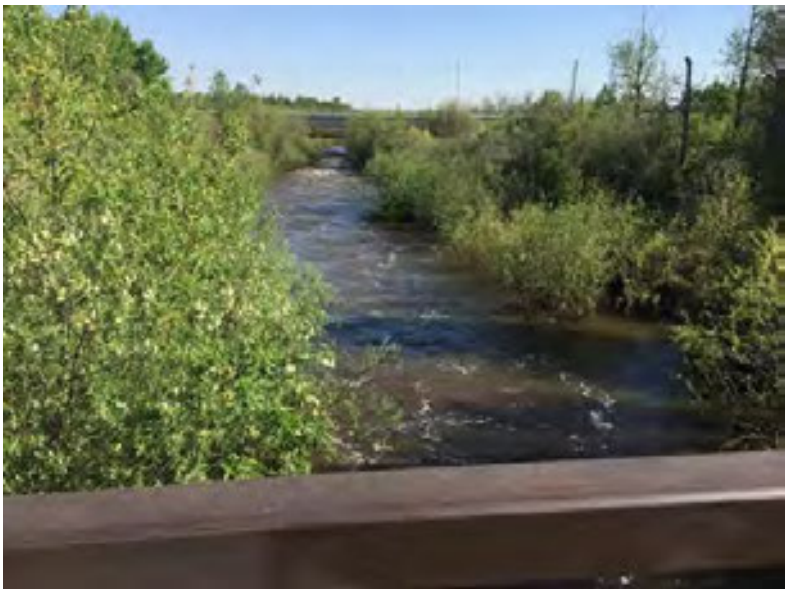
22. Bank conditions upstream of pedestrian bridge near 84 Avenue bridge.

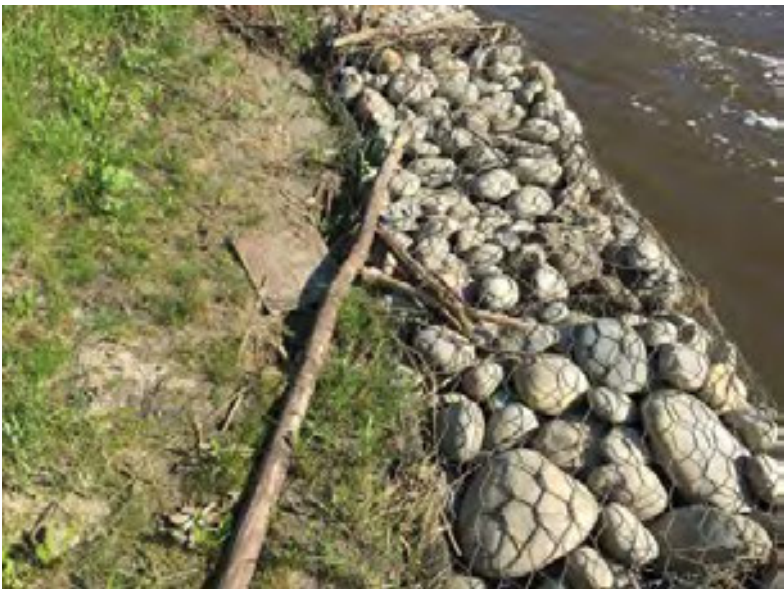
24. Gabion bank protection details.

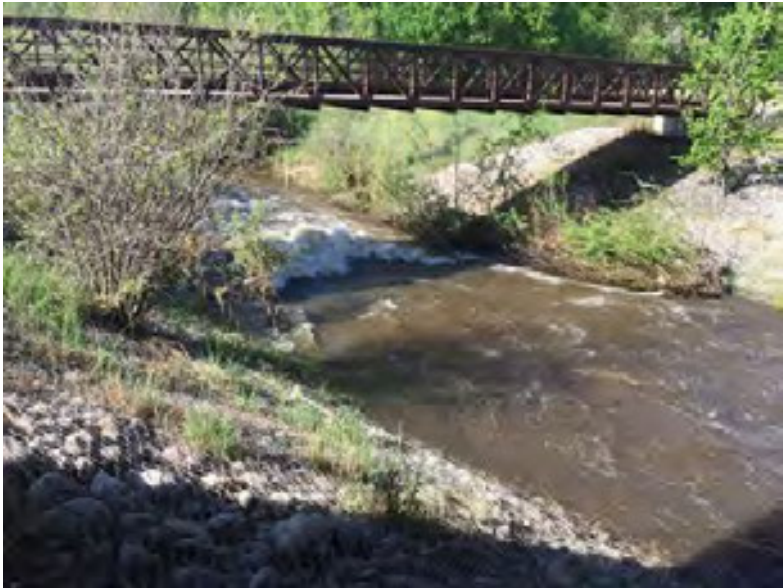
26. Pedestrian bridge and standing wave at 84 Avenue bridge.

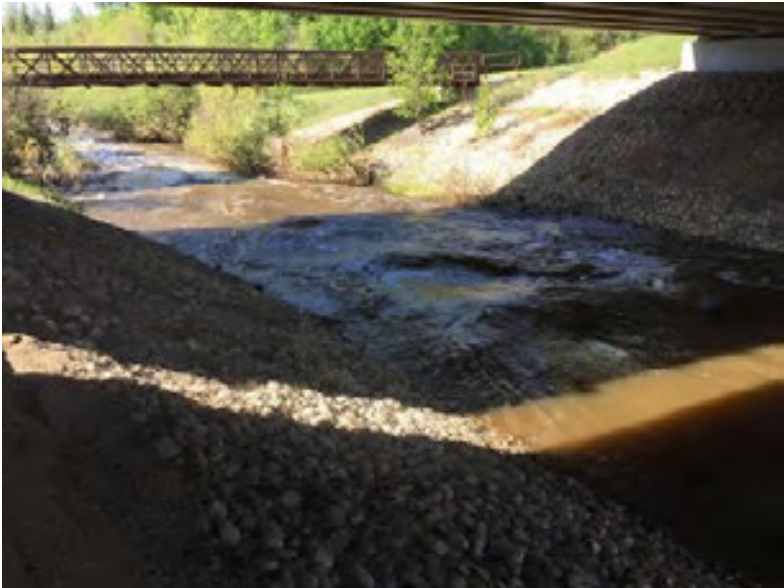
27. Pedestrian bridge and river head drops at 84 Avenue bridge.

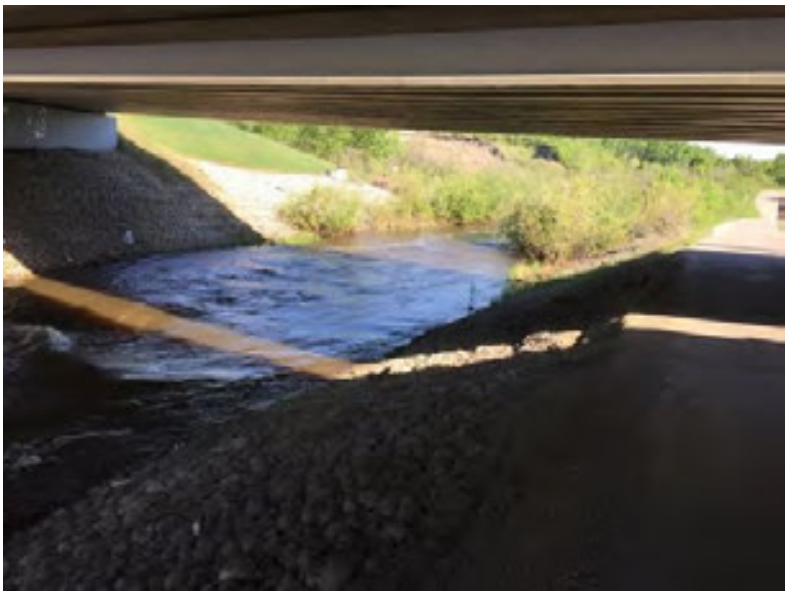
28. 84 Avenue bridge.

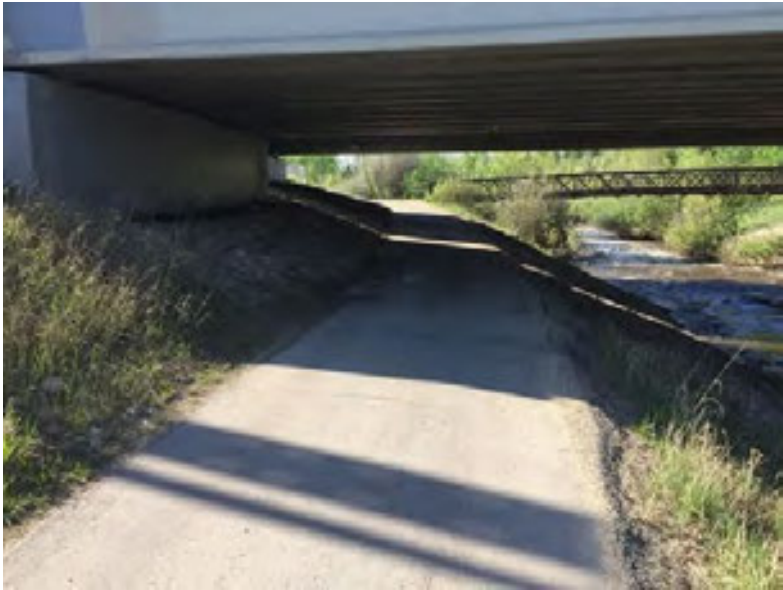
32. 84 Avenue bridge pathway, facing downstream.

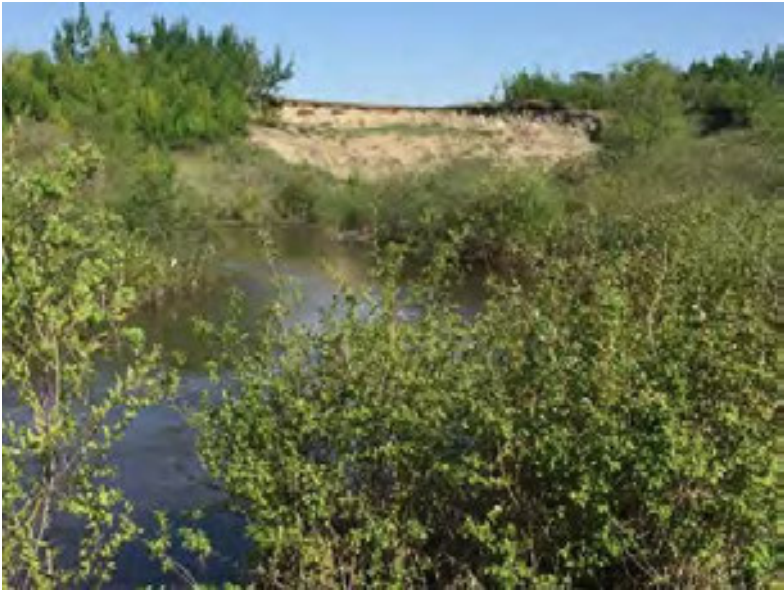
33. Meander scar along west valley wall near 84 Avenue bridge.

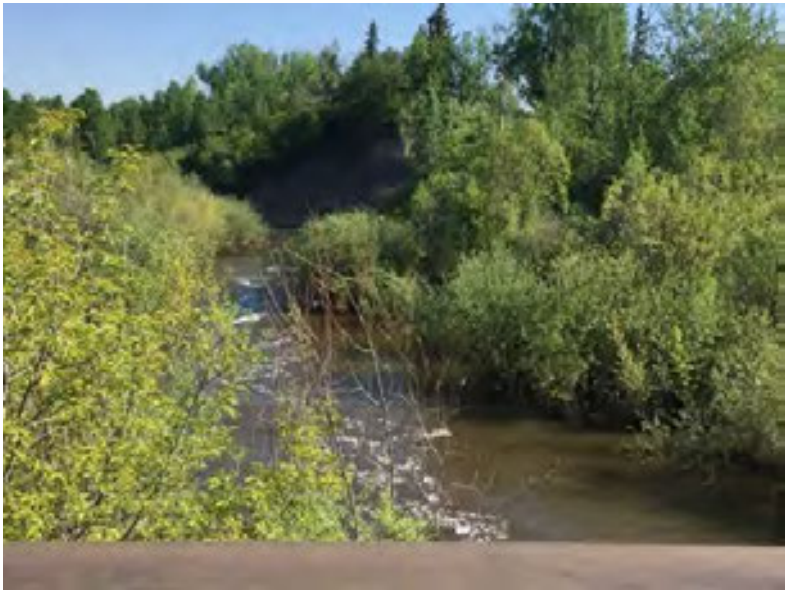
34. Bank conditions near pedestrian bridge near 89 Avenue.

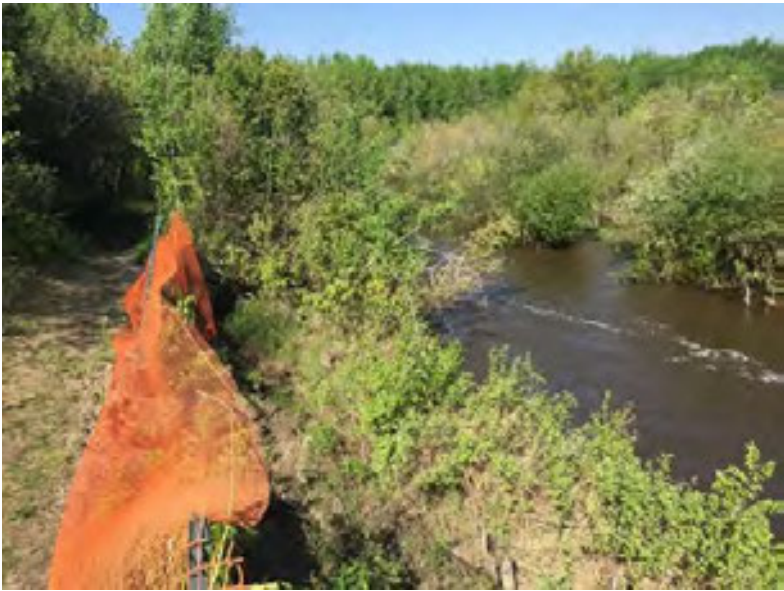
36. Train closure near 89 Avenue.

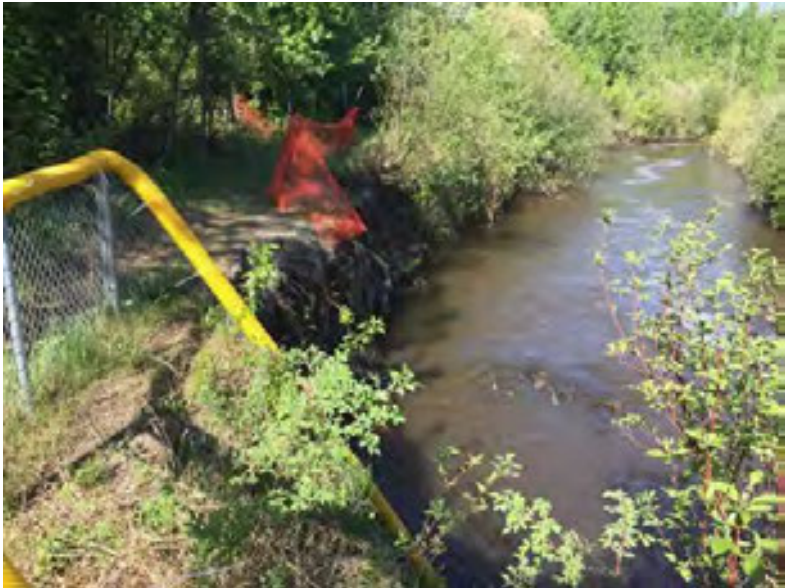
37. Upstream trail closure near 89 Avenue.

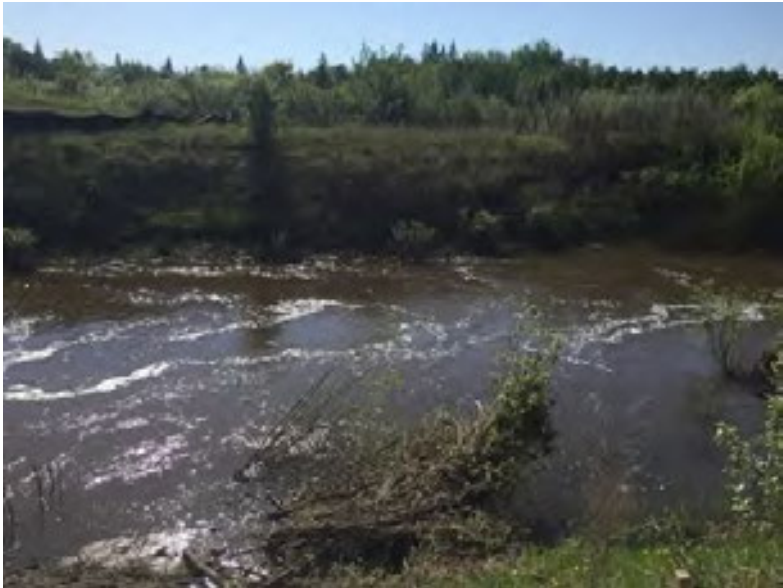
38. Relic embankment from former pipe crossing.

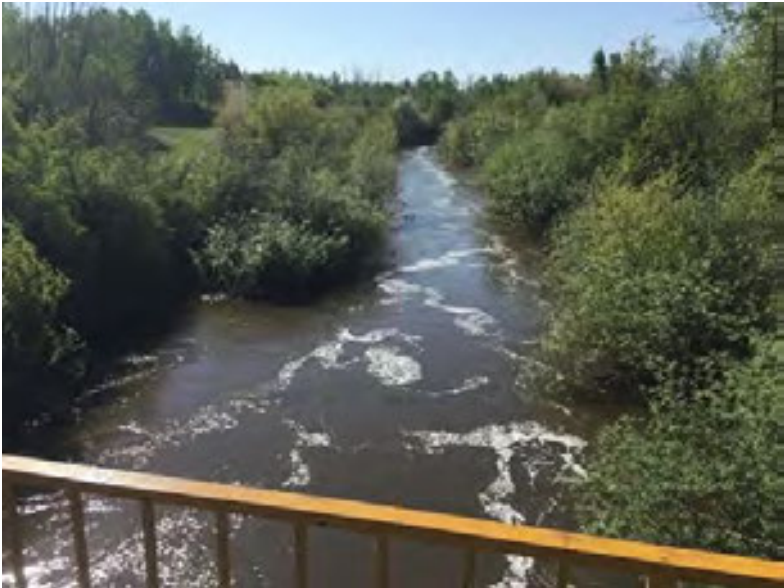
39. Downstream bank conditions at pedestrian bridge near 94 Avenue.

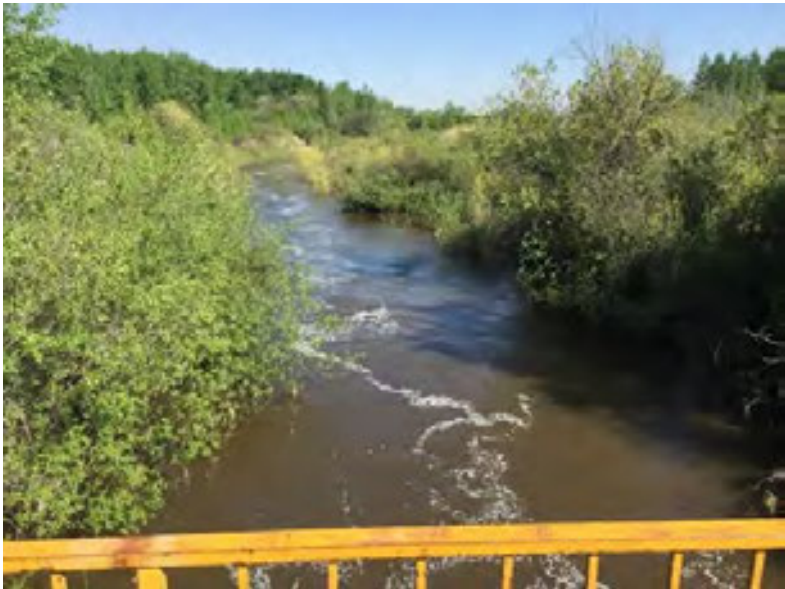
40. Upstream bank conditions at pedestrian bridge near 94 Avenue.

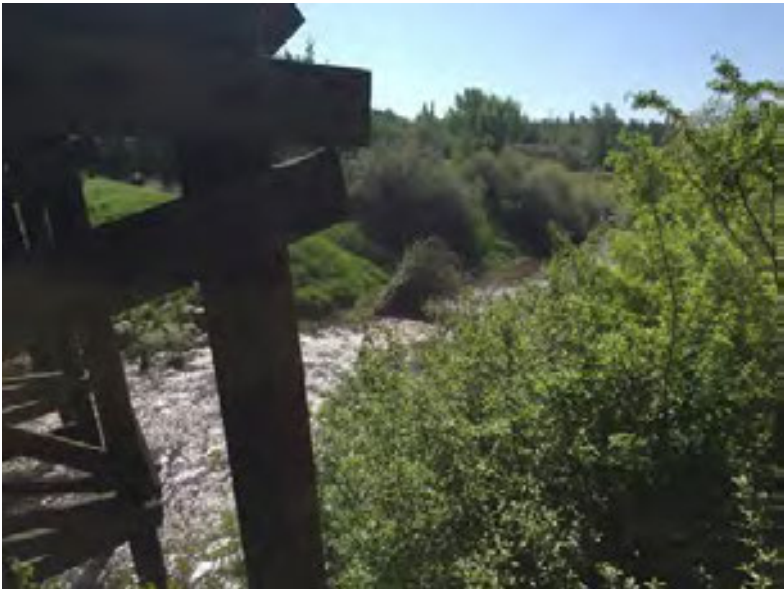
42. Bear Creek at old rail bridge.

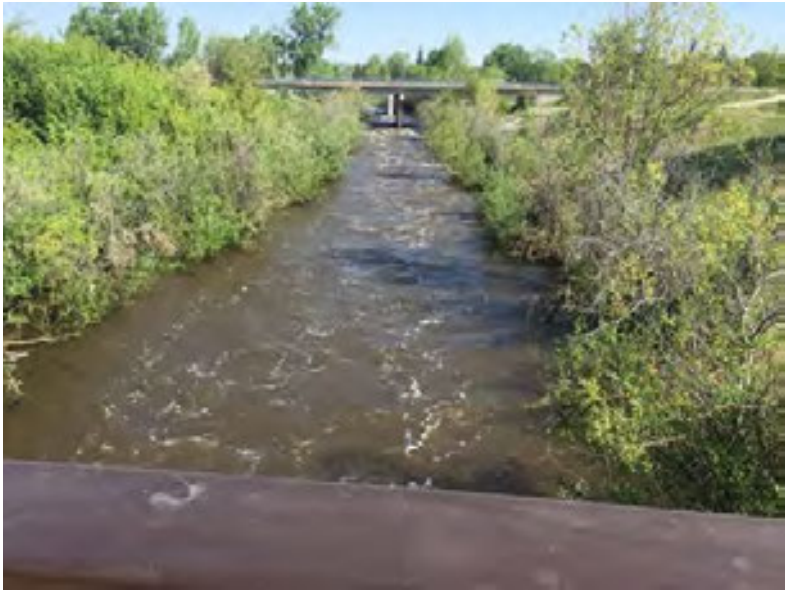
43. Bank conditions upstream of pedestrian bridge near 99 Avenue bridge.
