BEAR CREEK CORRIDOR ASSESSMENT CITY OF GRANDE PRAIRIE

Report Prepared for:
CITY OF GRANDE PRAIRIE

Prepared by:
MATRIX SOLUTIONS INC.

Version 1.0
September 2018
Grande Prairie, Alberta

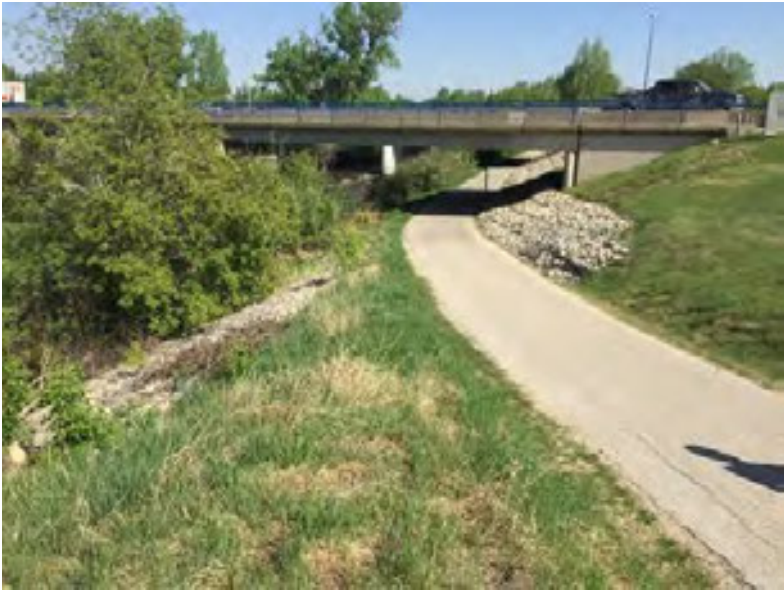
45. Pathway approach to 99 Avenue bridge, south side.

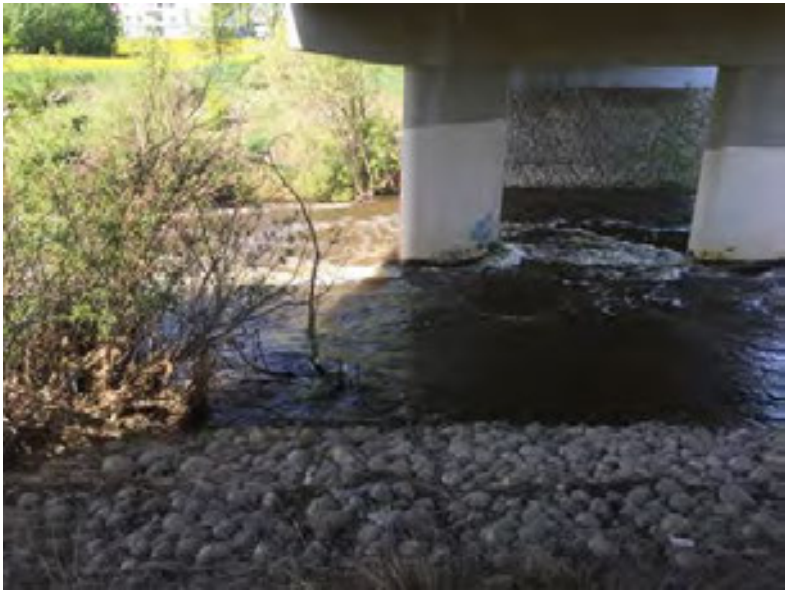
46. Potential scour at 99 Avenue bridge pier.

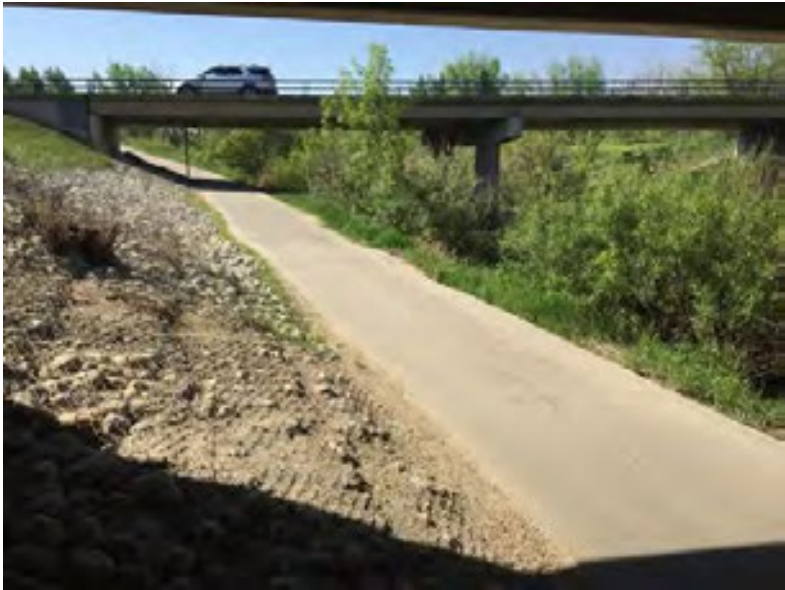
49. Pathway between 99 Avenue bridge and 100 Avenue bridge, facing south.

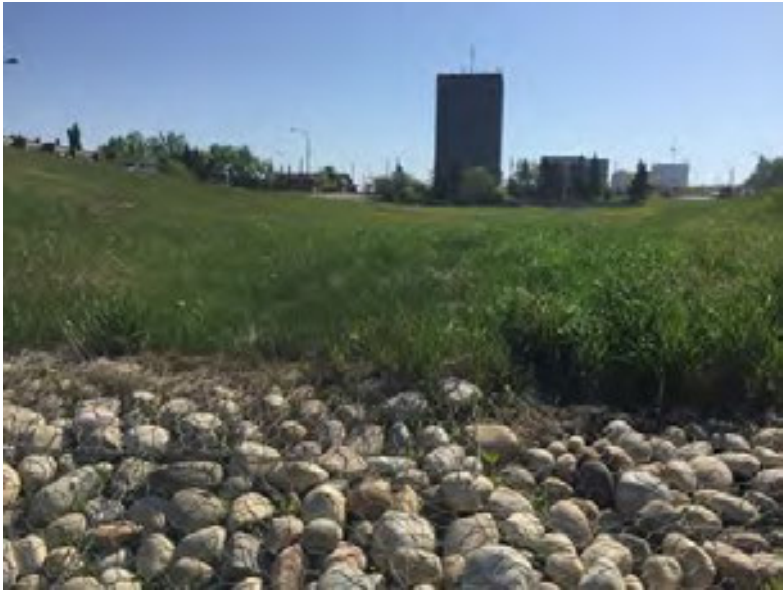
50. Local drainage to pathway between 99 Avenue bridge and 100 Avenue bridge.

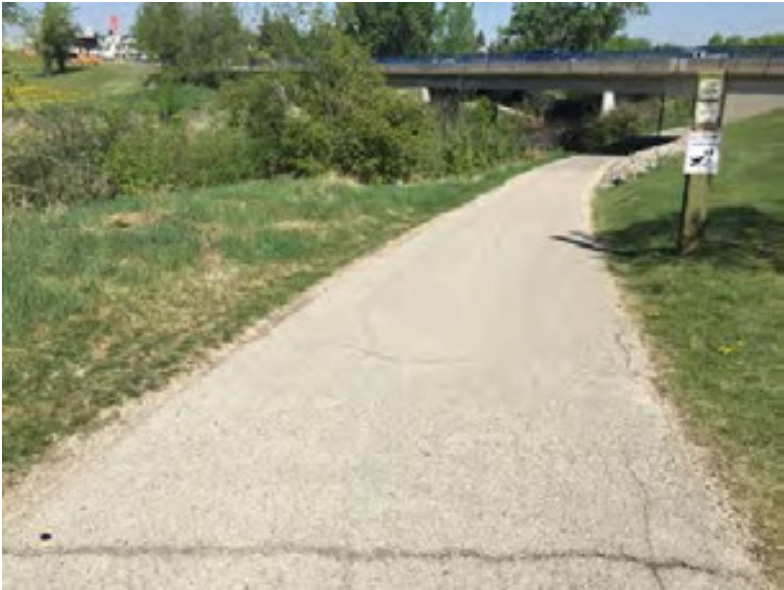
51. Pathway approach to 100 Avenue bridge.

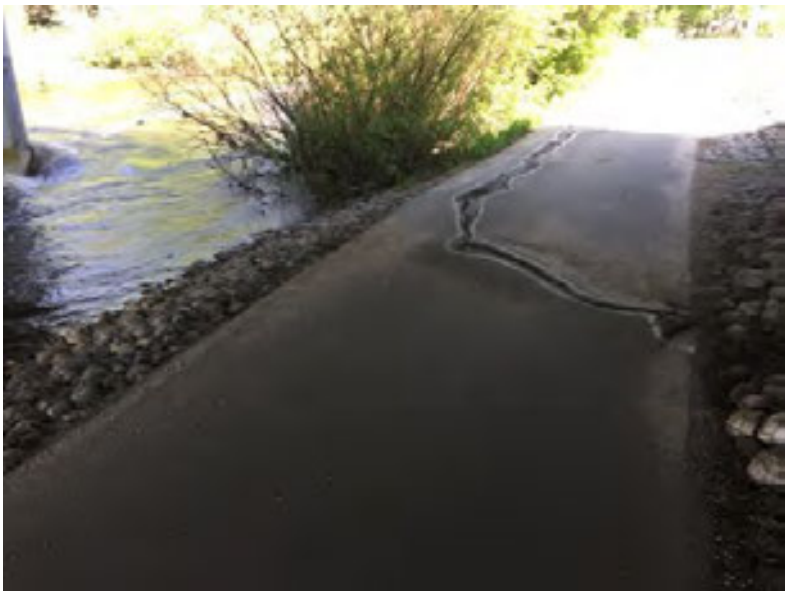
52. Pathway buckling under 100 Avenue bridge.

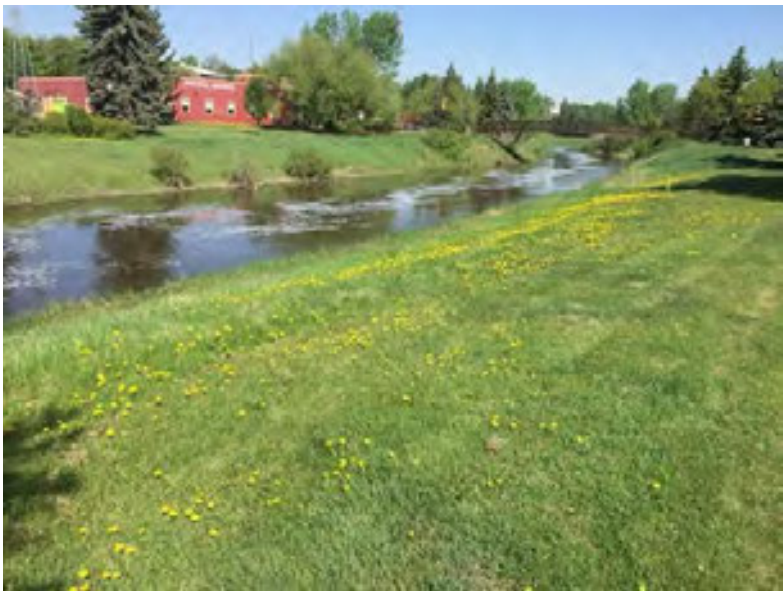
53. Bank conditions upstream of 100 Avenue bridge near museum.

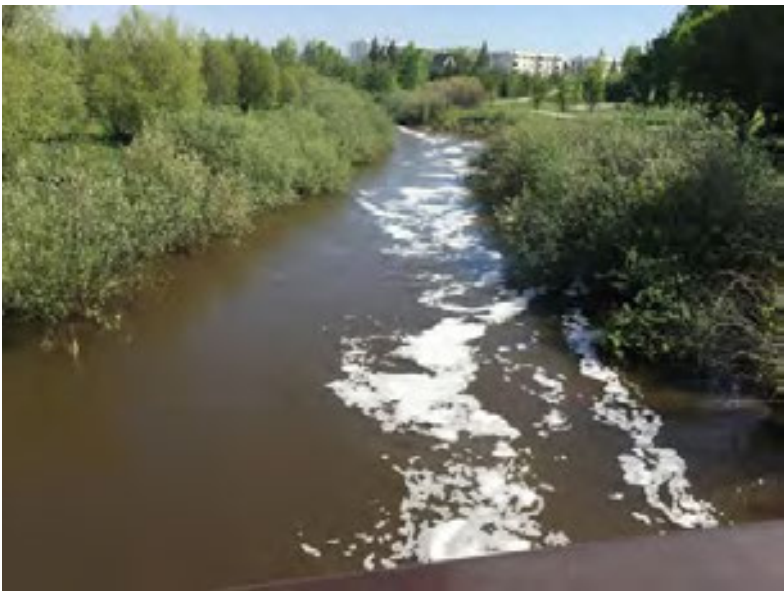
54. Bank conditions upstream of pedestrian bridge near dam.

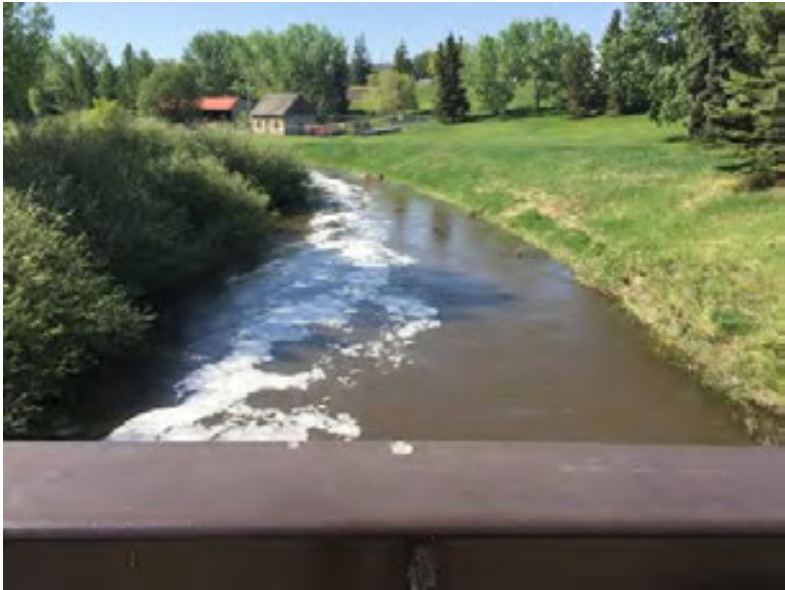
55. Bank conditions downstream of pedestrian bridge near dam.

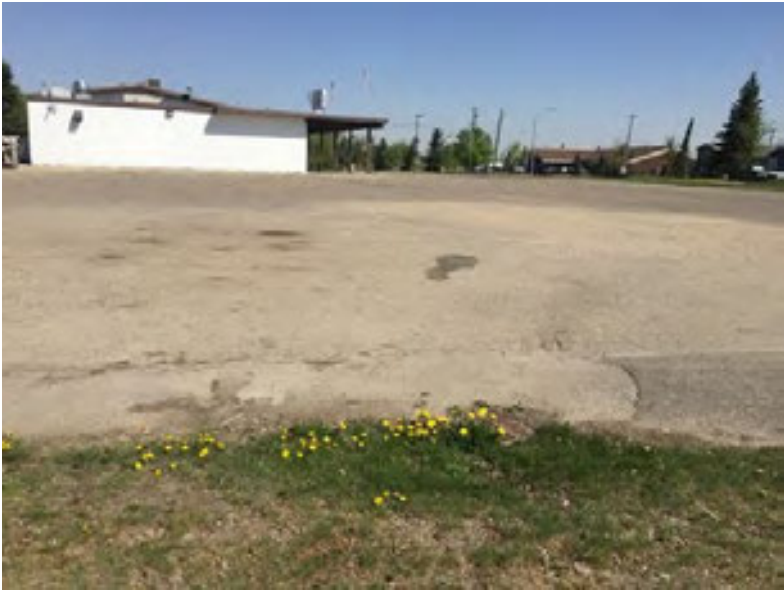
57. Local drainage at Elks Lodge along reservoir.

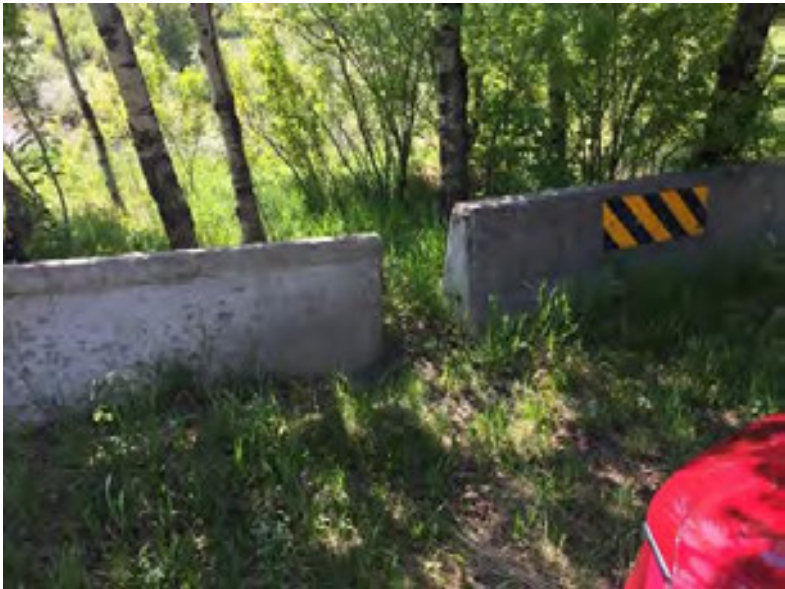
64. Path of local drainage from 102 Street to meander scar.

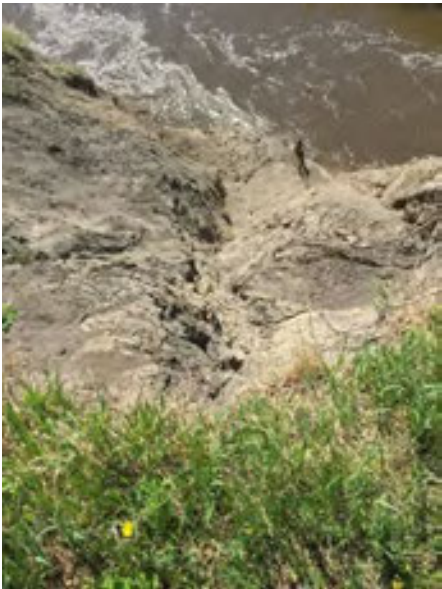
66. Gully below 102 Street.

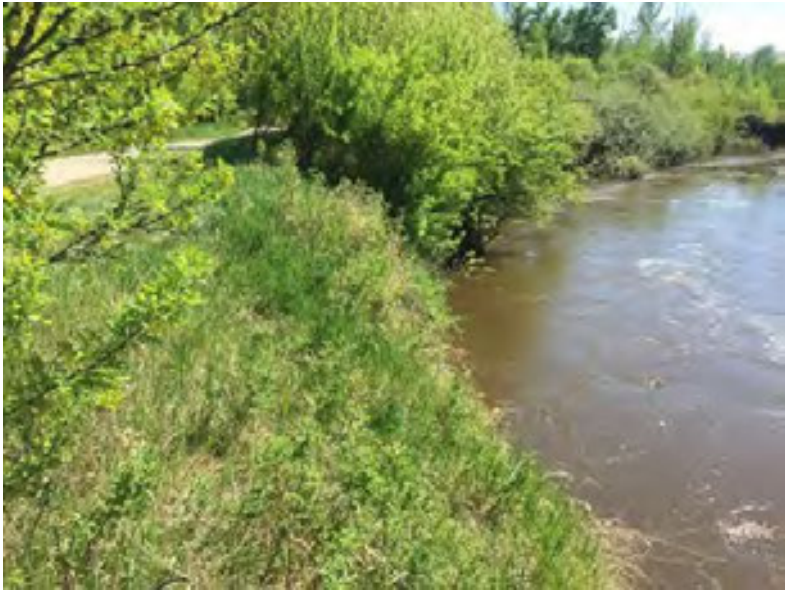
67. Pathway at bank erosion near 88 Avenue.

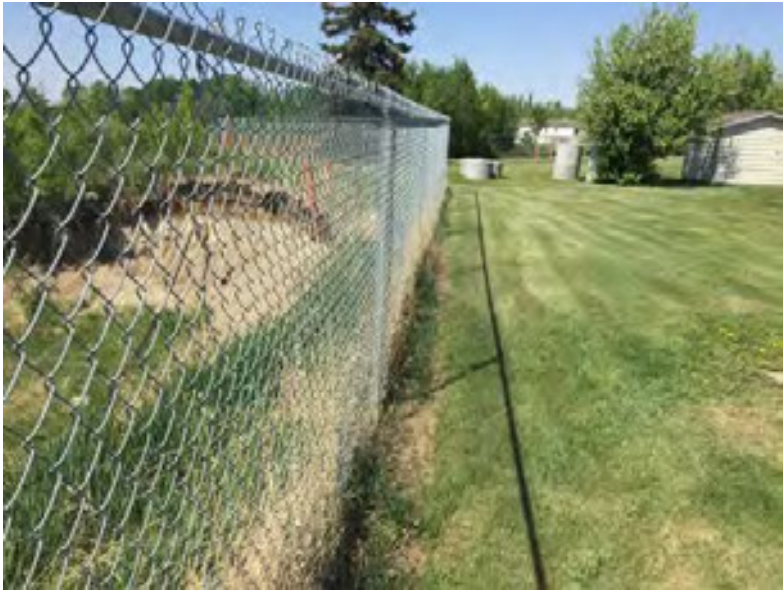
68. Landslide near trailer park.

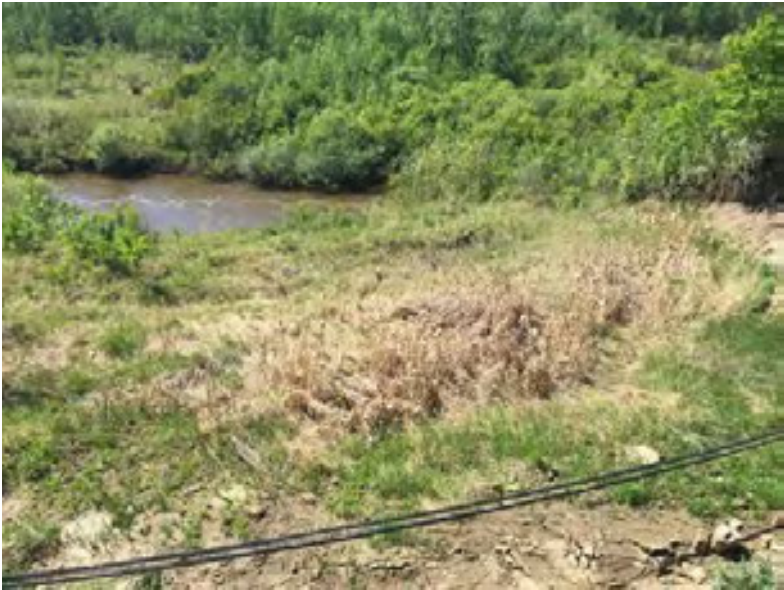
69. Suspended utilities at landslide near trailer park.

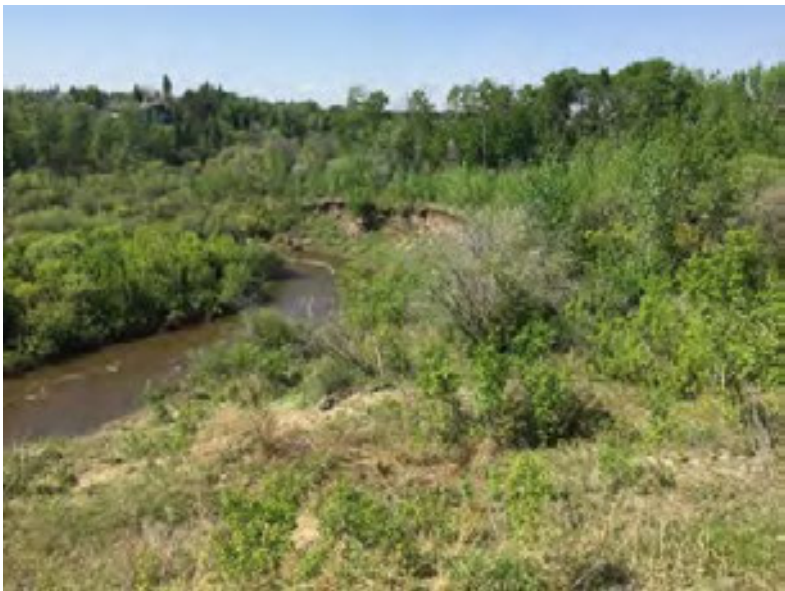
70. Upstream erosion near landslide at trailer park.

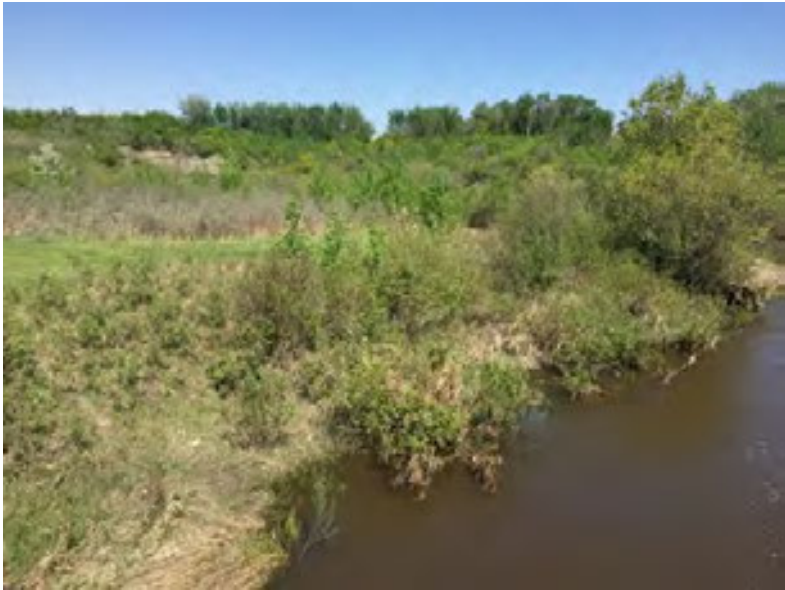
73. Bank conditions upstream of pedestrian bridge near 79 Avenue.

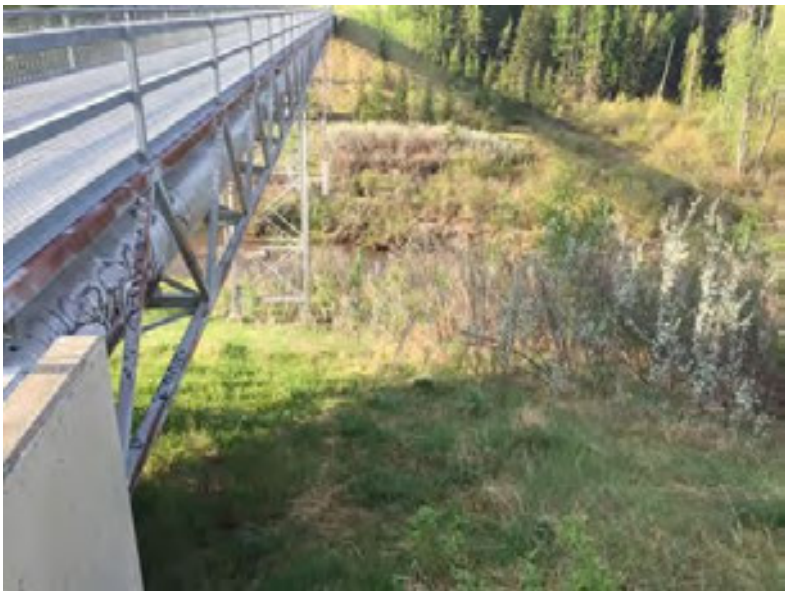
76. South Bear Creek utility/pedestrian bridge upstream side.

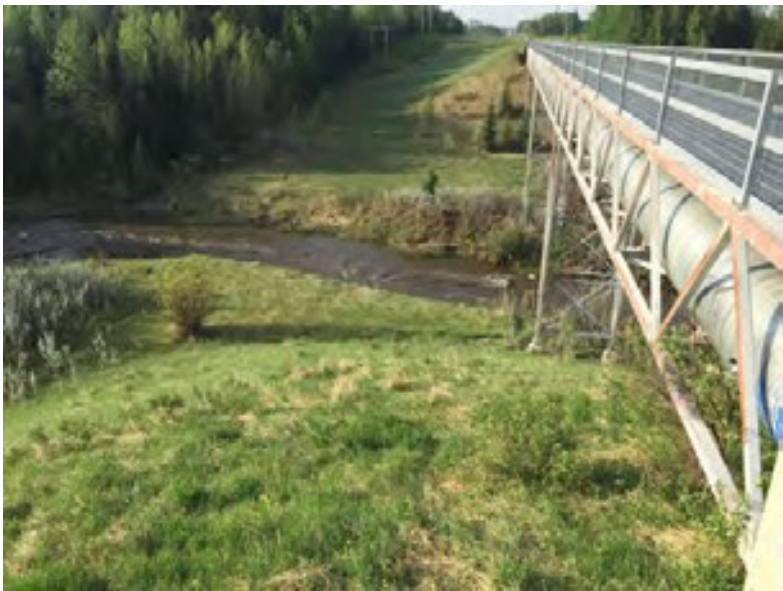
77. South Bear Creek utility/pedestrian bridge downstream side.

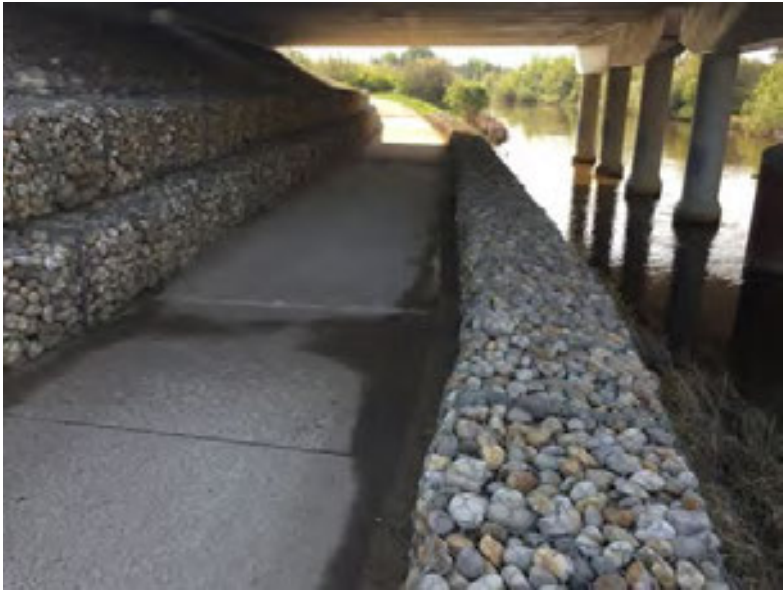
80. Pathway and gabion wall under bridge at 108 Street.
